The Acropolis Restoration News

19-20 • February 2023

V. Eleftheriou - 2019-2020, The progress of the restoration works on the Acropolis

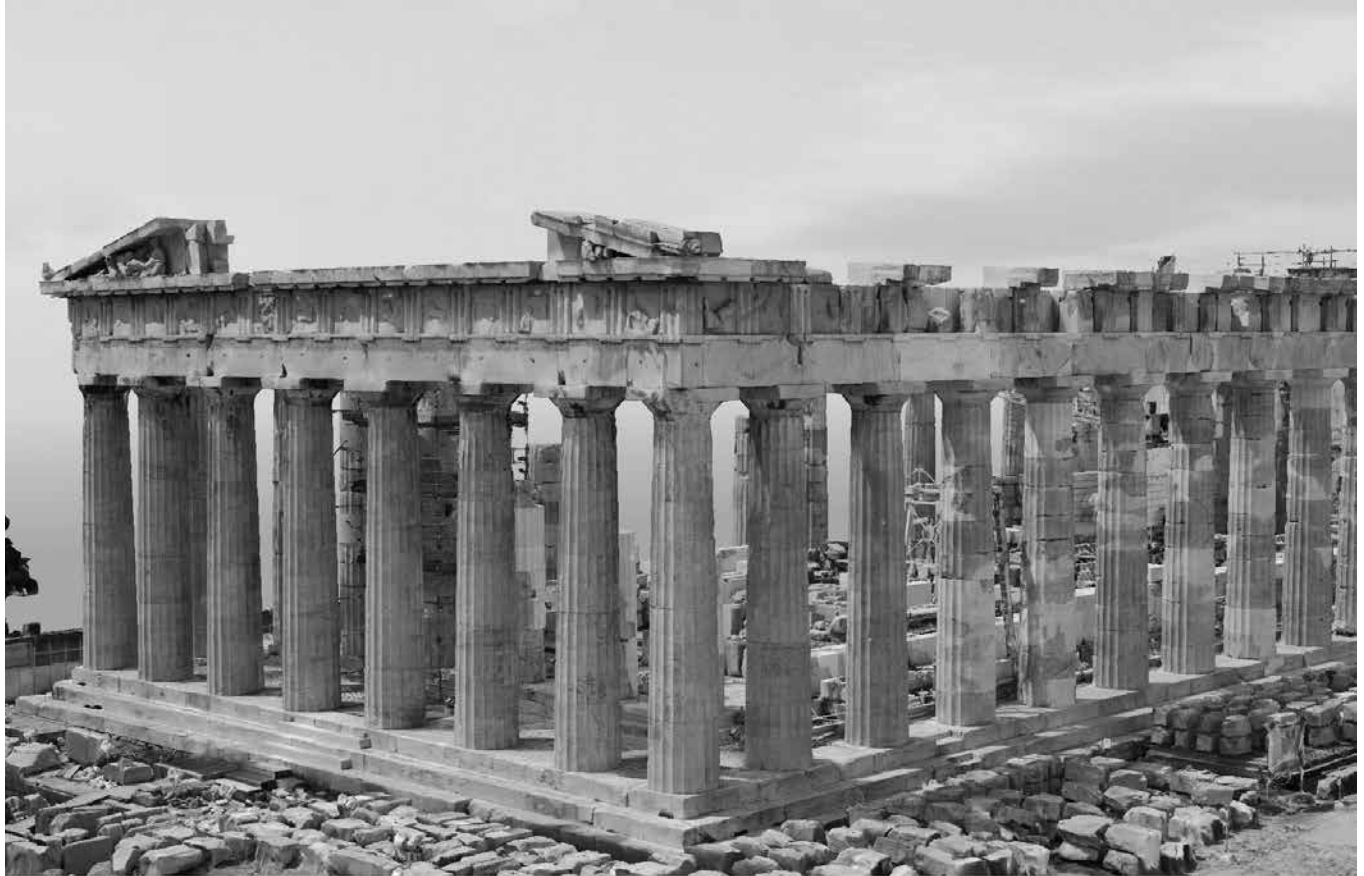
A 3D model of the Parthenon. Photographs: S. Gesafidis. Construction of the 3D model: D. Mavromati, 2020

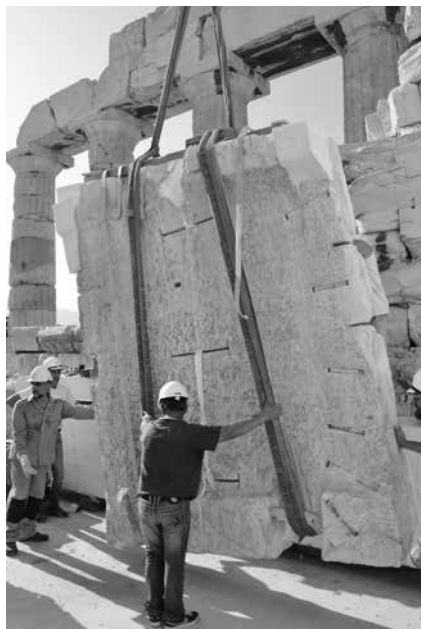
The central orthostate of the tympanum of the west Parthenon pediment during the restoration works. Photo V. Manidaki, 2020

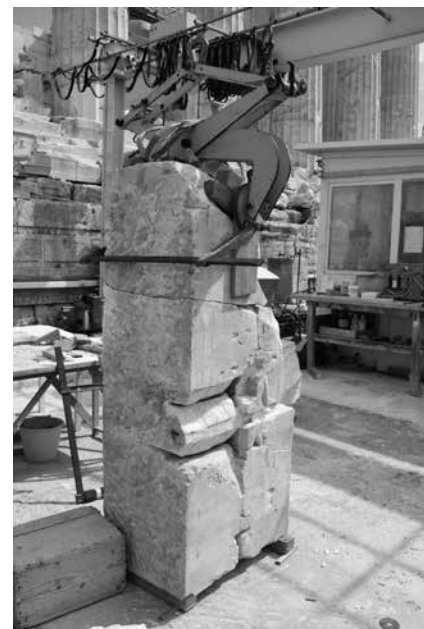
Works of structurally reconstructing a block (Δ.TA.3.3) of the retaining wall of the west Parthenon pediment. Photo K. Skaris, 2020

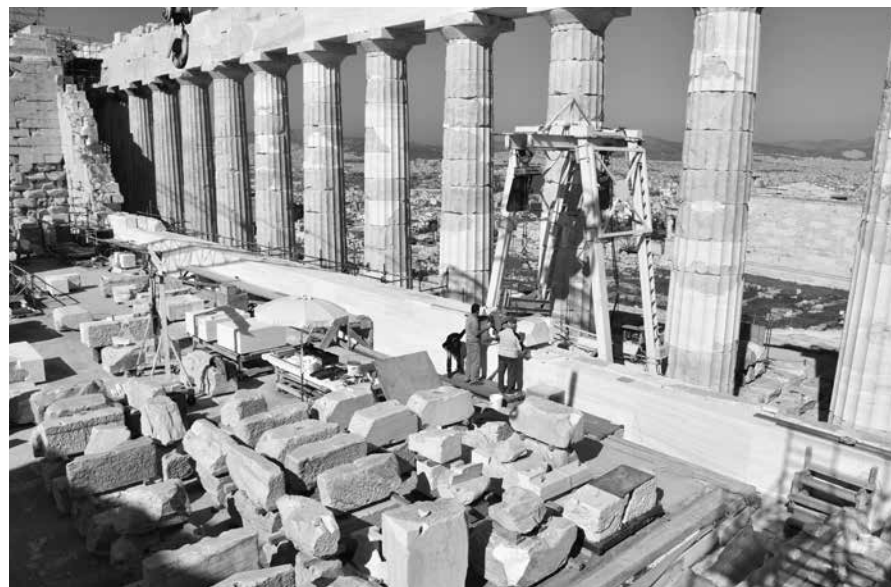
Restoration works on the first row of the north wall of the Parthenon cella. Photo T. Souvlakis, 2020

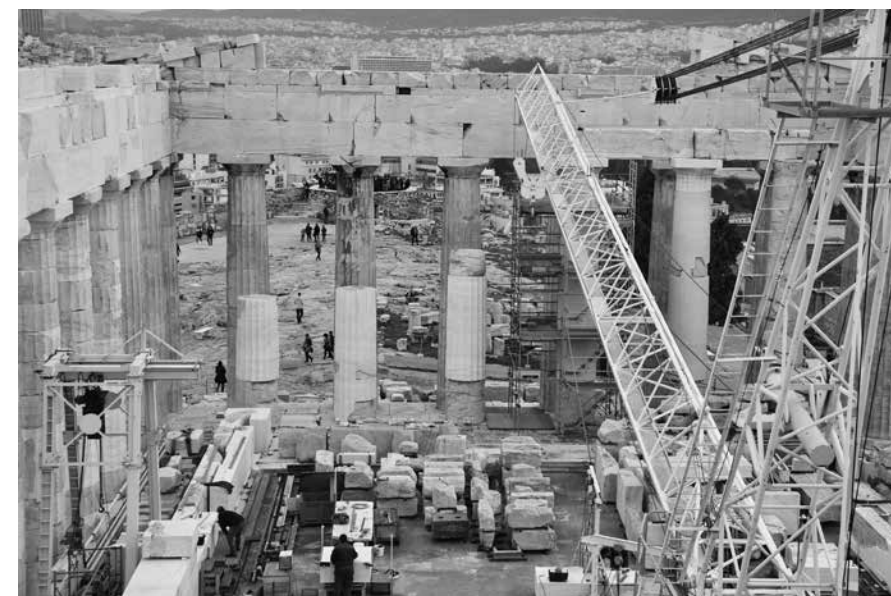
A view of the Pronaos from the west. We can see the first three from the north columns where the carving of the flutes has been completed. Photo T. Souvlakis, 2020

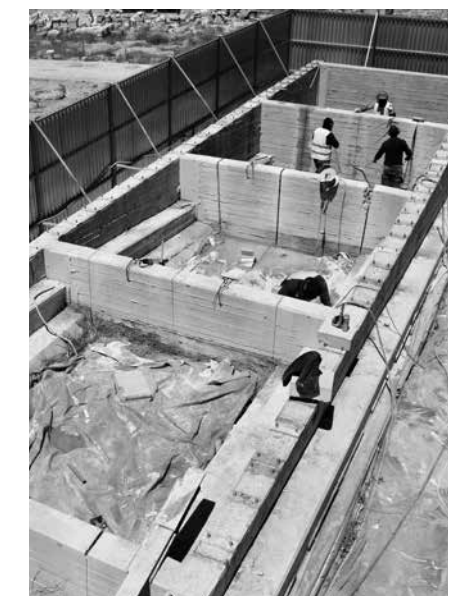
Dismantling works conducted on the crane base located west of the Parthenon. Photo R. Christodouloupoulou, 2020

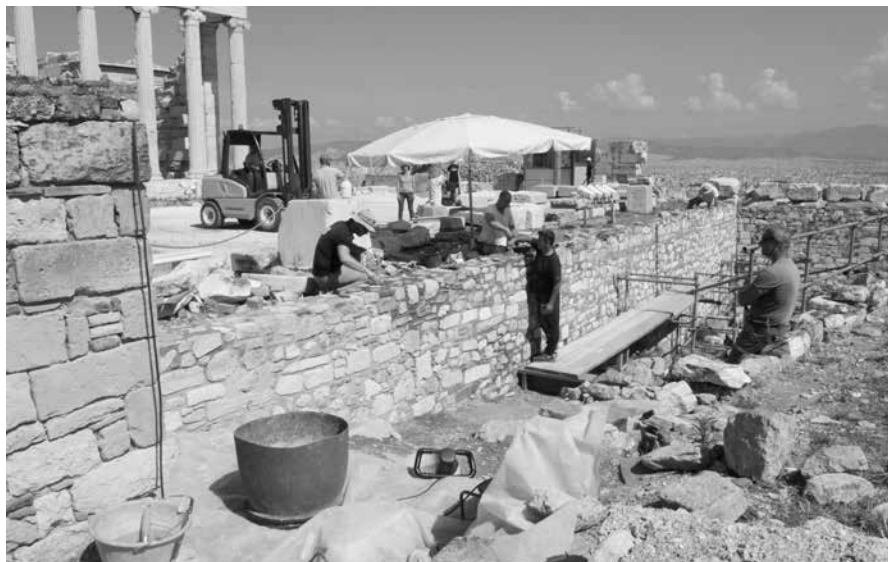
Restoration works on the retaining walls in the area of the Mycenaean ascent. Photo Ch. Pinatsi, 2019

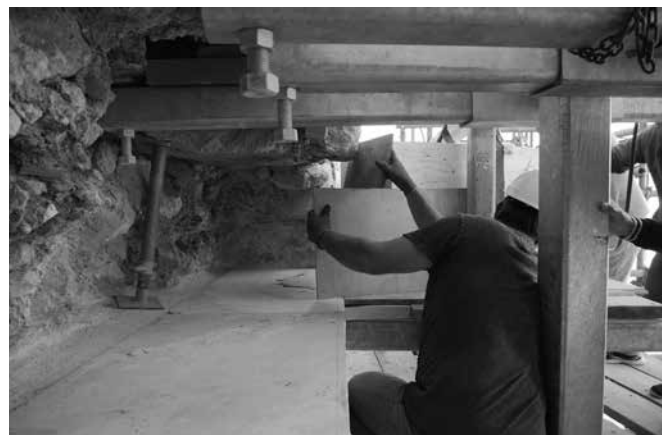
Placing a new block on the area B17 of the north wall. Photo K. Mamalougas, 2019

In the area B17 of the north wall the works completed followed the study of K. Mamalougas and D. Michalopoulou and had to be appropriately modified after removing later additions and discovering the bad conservation state. In 2020, after modifying the Project Fiche, the restoration of the retaining walls in the area of the Mycenaean ascent on the east of the Erechtheion started, because they presented serious degradation problems. The proposal “Consolidation and enhancement of the retaining walls of the Mycenaean ascent” by D. Michalopoulou, Ch. Pinatsi and C. Koutsadelis, includes the dismantling of the upper layers of the walls, the reconstruction of the upper ending of the west retaining wall, consolidation works on the upper level of the east retaining wall and finally local reconstructions using ashlar stones and compatible mortar.

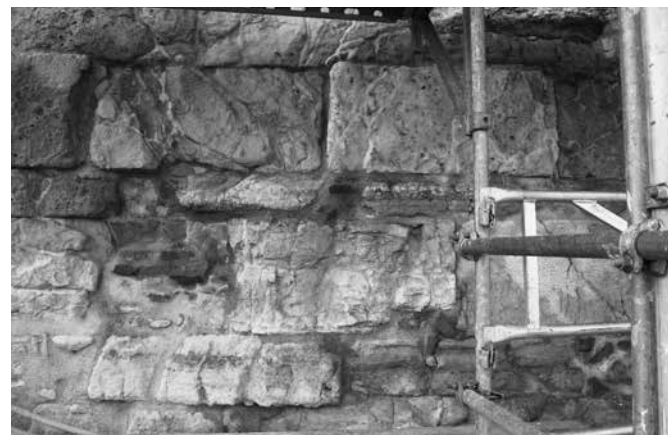
Consolidation and conservation works on the north wall, in the area of the elevator. Photo K. Mamalougas, 2019

After carrying out a public tender, the consolidation works on the north wall, in the area B14 close to the elevator, where some small stones had fallen and the area was closed for the visitors of the archaeological site, were contracted out. YSMA carried out conservation works on the sur-

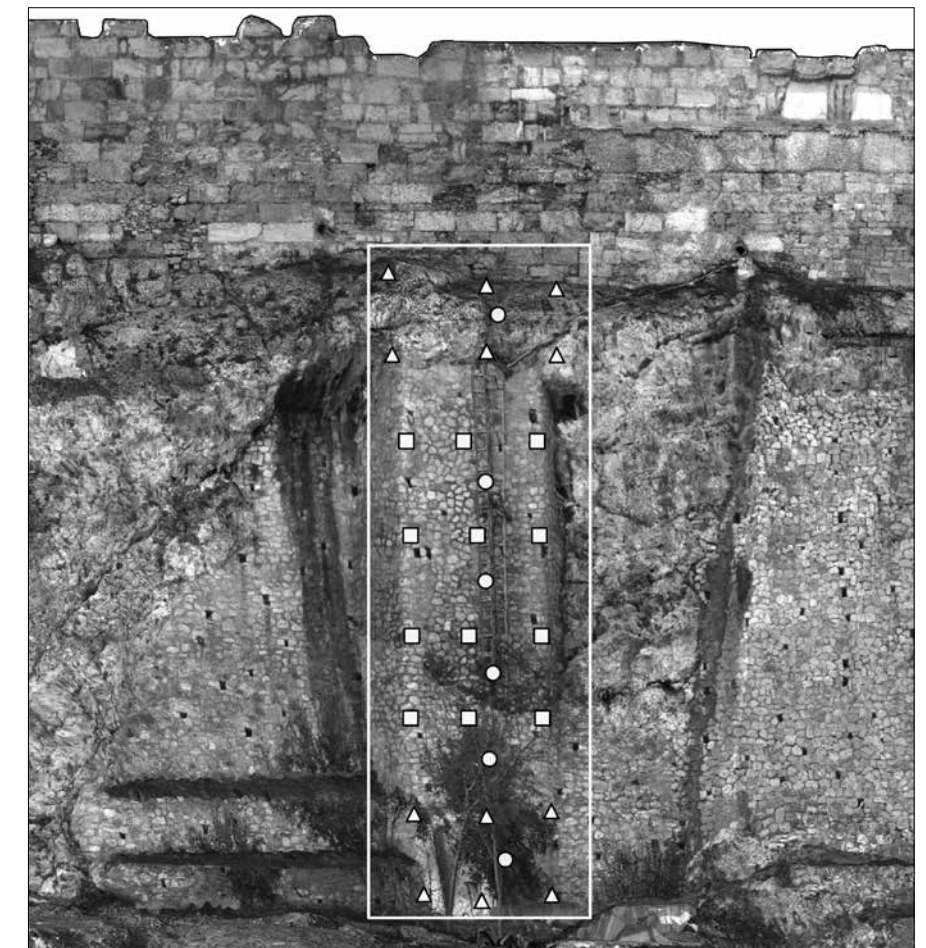
Orthophotomosaic of the wall and the rocky substratum in the area of the elevator, on which the methods of anchoring the wall are indicated.

△ Passive anchors of a length of 12 m. □ Passive anchors of a length of 3 m. ○ Drainage holes
Photos: Up2Metric IKE. Processing and production of model: S. Kyparissi.
Acropolis Restoration Service, 2019

the elevator for people with disabilities on the Acropolis of Athens” had been approved, funded by Onassis Foundation, and supervised by YSMA, the company “Lithodimos” conducted works to reinforce the wall, constructed in the middle of the 1930s by N. Balanos, to support the new elevator. On a surface of around 110 m, a number of 24 passive anchors of a diameter of 25 mm were placed, in a grid of 2,0X2,5 m, out of which 12 had a length of 12 m and were placed in two zones, on the base and on the rock above the wall, and 12 more of a length of 3 m, in the zone considered to occupy an identified geological chasm. Moreover, seven drainage holes were opened, whereas a galvanised mess

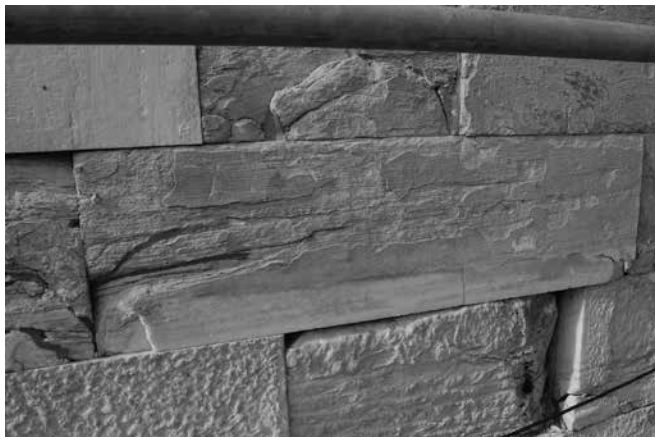
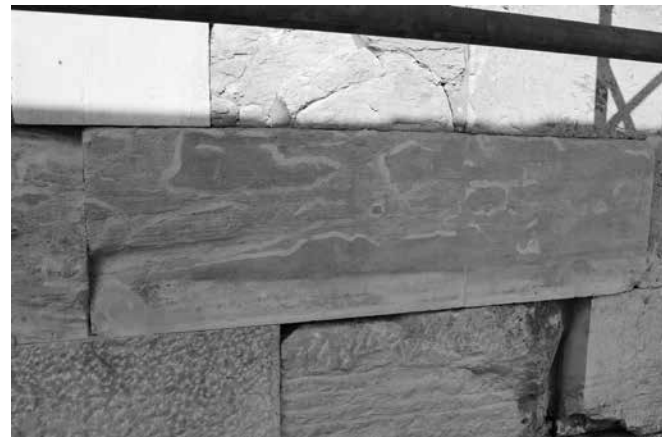
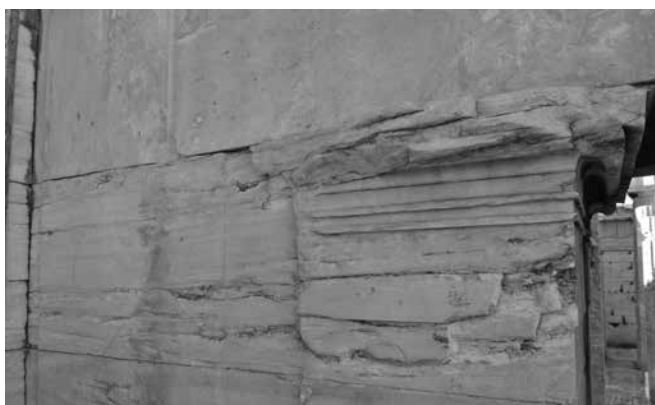
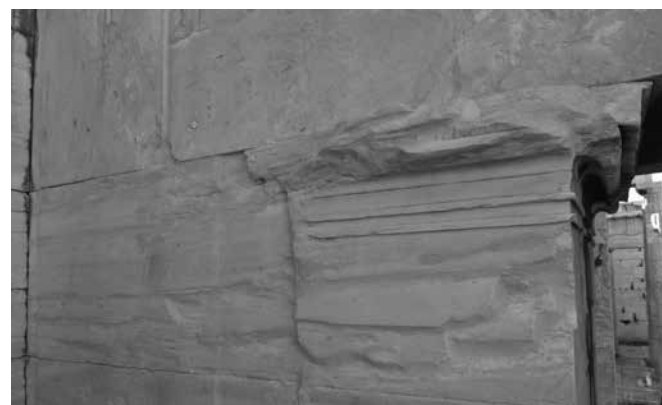
Top, left: The Parthenon: a block from the retaining wall of the west pediment (Δ.TA.I.5) before the conservation works. Top, right: the same block after conservation. Photo A. Panou, 2020. Bottom, left: The Propylaia: a block of the portal wall of the north wing (B.Θ.I.7) before the conservation interventions. Bottom, right: the same block after conservation. Photo P. Vlachouli, 2020

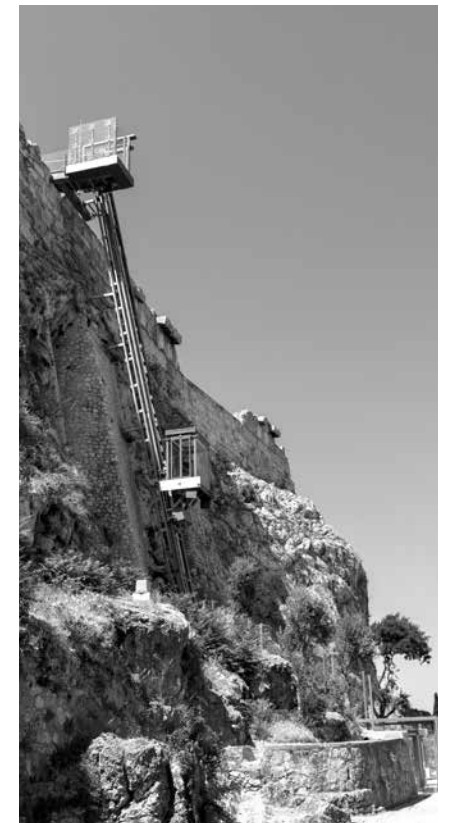
The new elevator for people with disabilities on the north slope of the Acropolis. Photo T. Souvlakis, 2020

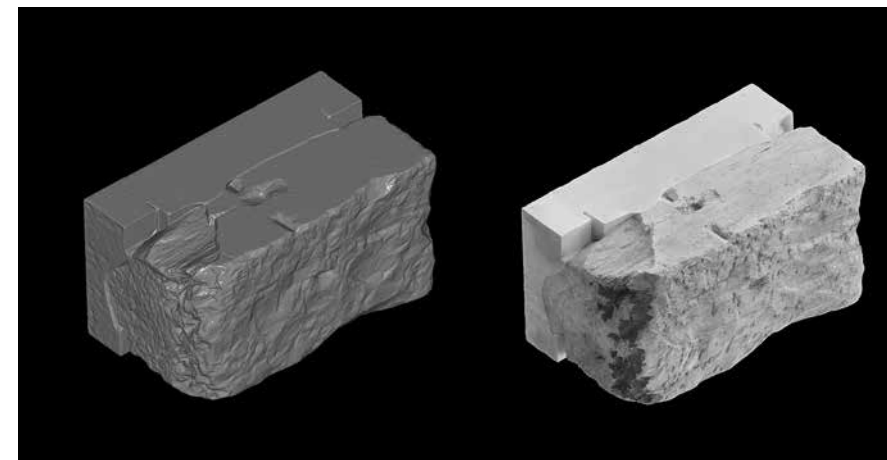
Three-dimensional model of the inner block 2.28 of the north wall of the Parthenon. Photos-Production: S. Kyprissi, 2021

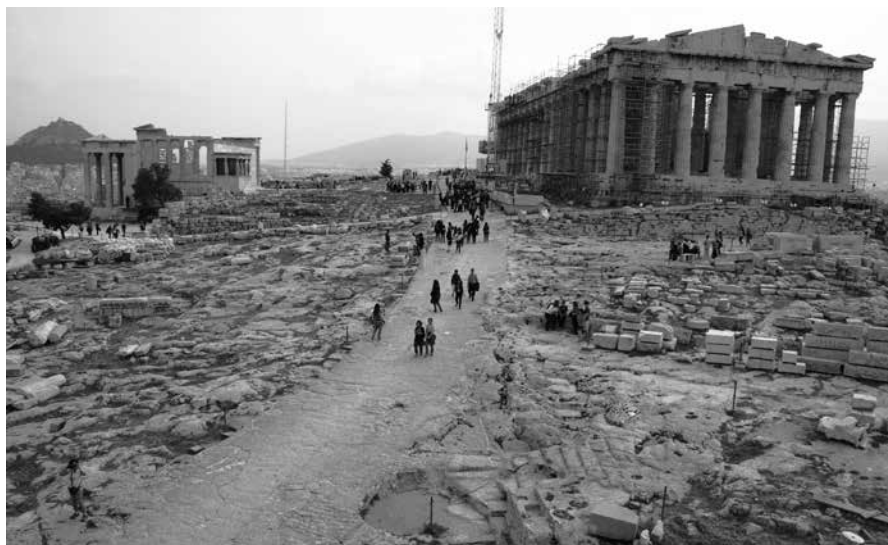
A view of the Panathenaic Way, from the Propylaia towards the Parthenon, before conducting the enhancement works on the walkways. Photo YSMA/ESMA Archive, 2010

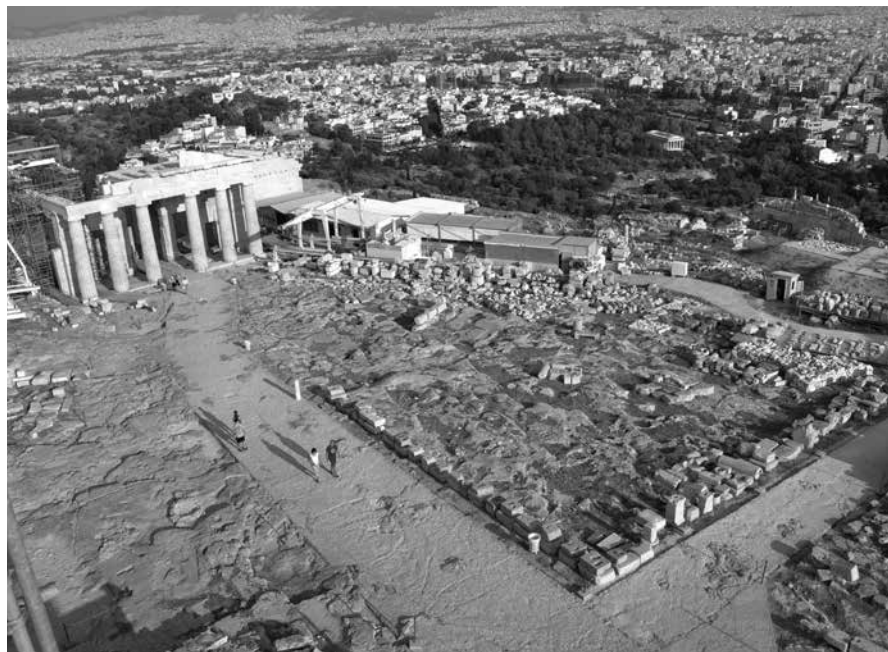
A view of the archaeological site from the NW corner of the Parthenon, before conducting the enhancement works on the walkways. Photo V. Eleftheriou, 2011

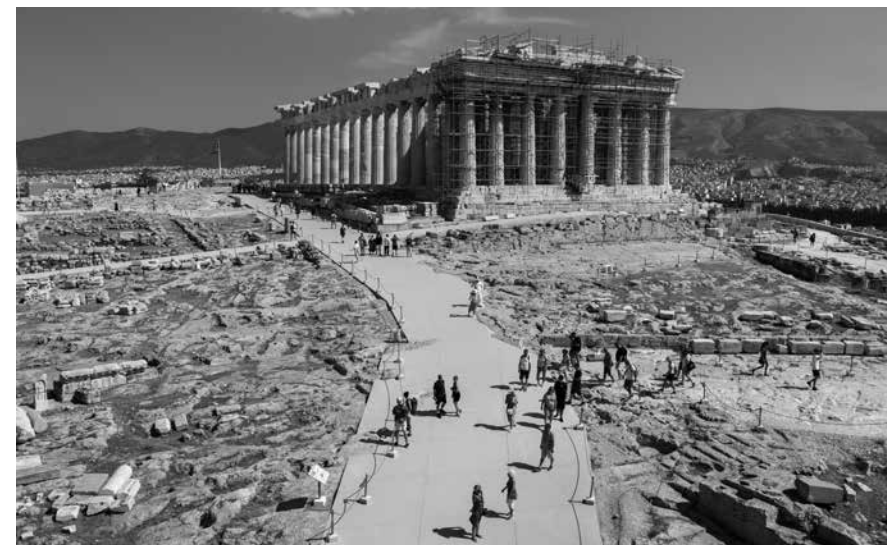
A view of the Panathenaic Way, from the Propylaia towards the Parthenon, after conducting the enhancement works on the walkways. Photo T. Souvlakis, 2021

At first glance, it is obvious that despite the little difference between the previous and the existing situation, the work of redesigning and constructing the new walkways benefited the safe movement of the visitors, enabled people with mobility problems to move around the monuments and contributed to promoting archaeological evidence which is testified by the abundance of carvings on the Acropolis rock and traces of votive monuments such as the Kallimachos monument.

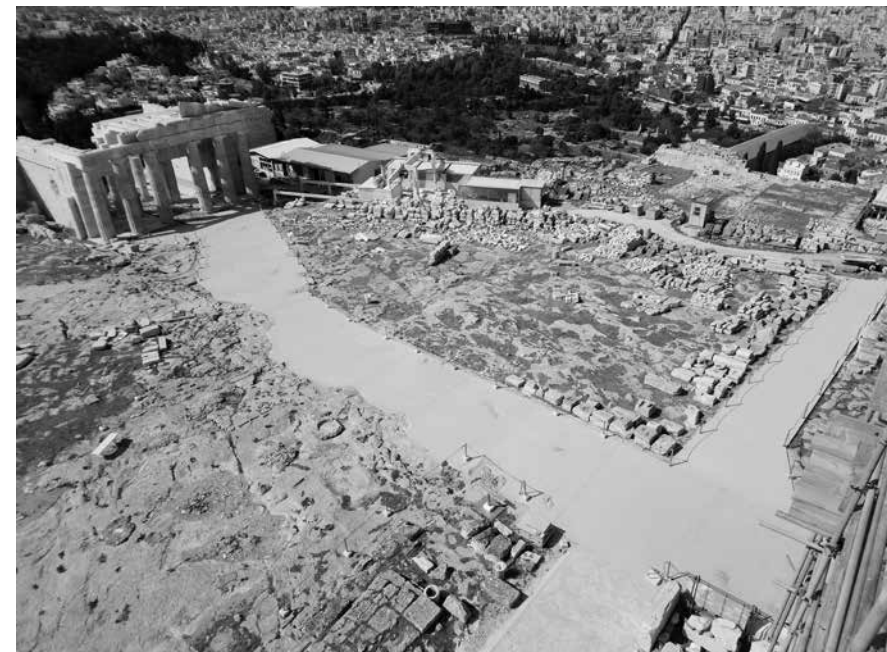
A view of the archaeological site from the NW corner of the Parthenon, after conducting the enhancement works on the walkways. Photo V. Eleftheriou, 2021

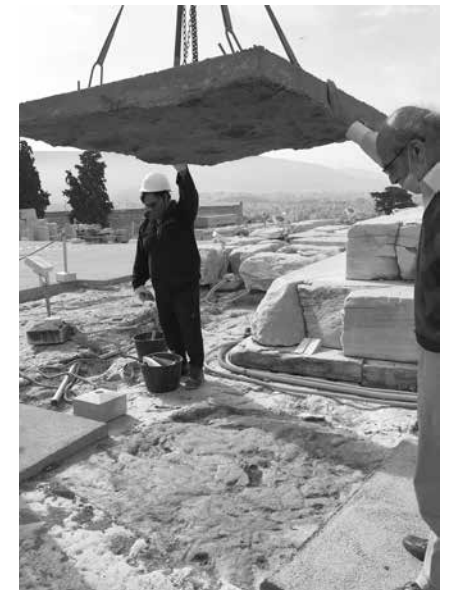
*Removing samples to test out the adhesion of the material on the rock and confirm the intervention reversibility.
Photo T. Souvlakis, 2021*

gravel, filling the cavities of the rock, not only contributed to that separation, but also provided for the height difference in the areas where the thickness of the construction had to be larger than 8cm. In the areas where the paving material had to have less thickness (about 5cm) because of archaeological evidence, light reinforcement was placed to strengthen the adhesion of the material and avoid fractures. The reinforcement, galvanised construction mesh of 5mm, having loops of 15X15 or 5X10, is interrupted in the areas of the joints that had been constructed every 2.5 m. Therefore, if in the future it is decided to remove part or all the paved surfaces, then it is possible to move these separate pieces that weigh about 1.5 tons. This was also confirmed when two samples were removed without causing any damage to the rock on which the samples had been poured.

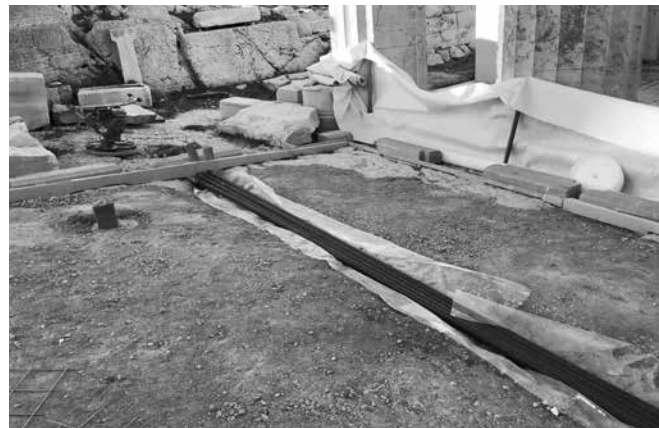
Works of laying the walkways. Top left: covering the rock with gravel and placing pipes for cable routing. Top right: laying concrete on the protective film. Bottom left: laying concrete in an area where metal reinforcement is incorporated. Bottom right: filling concrete to even the contact of the walkways with the natural rock. Photos V. Manidaki, 2020.

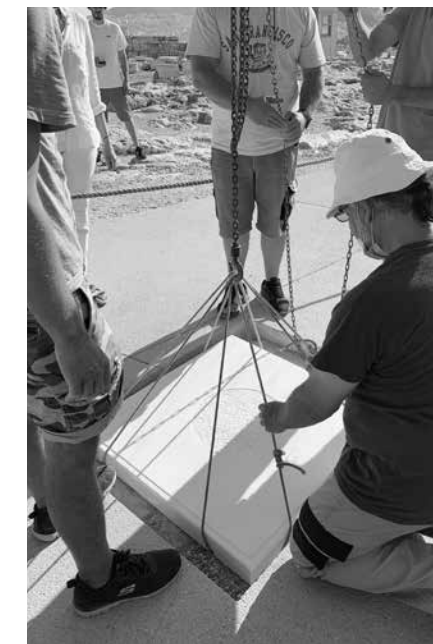
*During the works of placing a marble slab to label the choragic monument of Callimachus.
Photo K. Mamalougas, 2021*

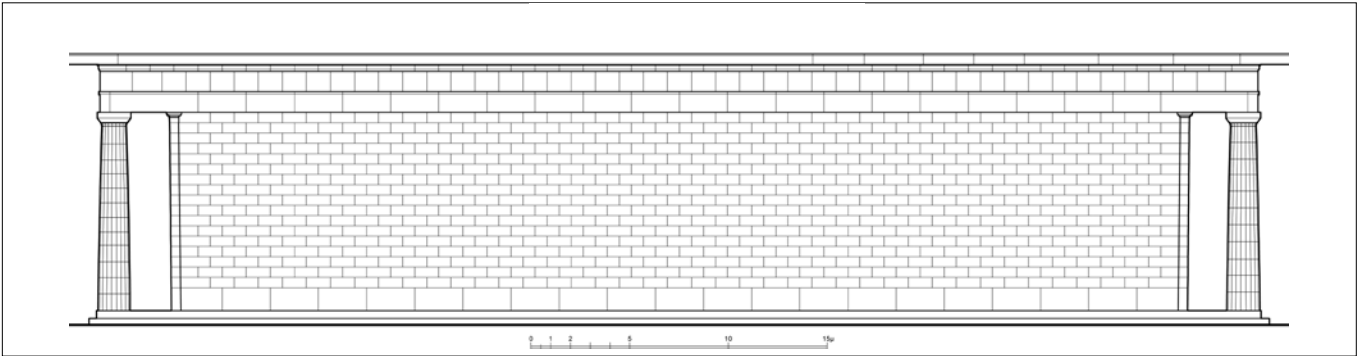
Representation of the exterior elevation of the north wall. Drawing: K. Skaris, 2016

Out of 1,034 blocks of the north wall that existed in the antiquity, 165 remain today in their original position, while on the south wall there remain 156 from a total of 1,033 blocks. The total available material for the long walls of the cella that was found away from their original position includes 854 blocks or large fragments of them. From these blocks 188 have been identified as belonging to certain places of the north wall and 299 of the south wall. In addition, a group of 167 blocks can be placed to corresponding areas of the north wall while 200 blocks remain available to be also placed on relevant areas of the south wall.

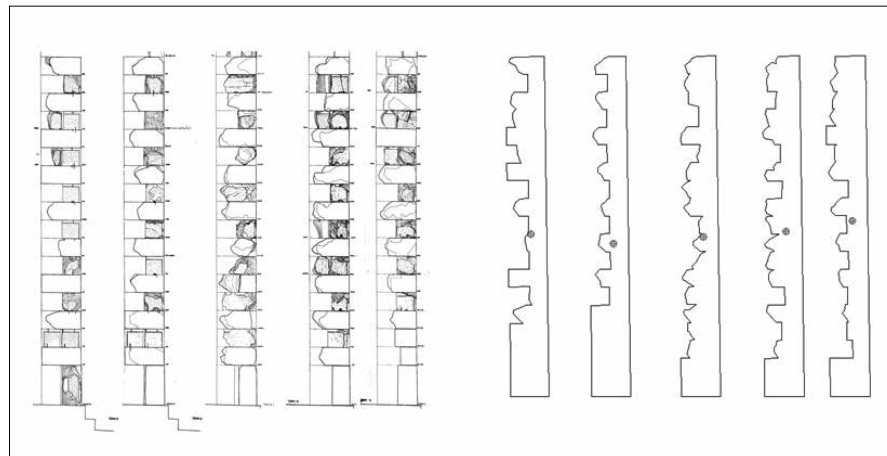
Left: cross-sections of the north wall after the study Toganidis-Matala. Drawing: K. Matala. Right: outline drawings showing the centroid of gravity. Study-drawing: A. Vrouva

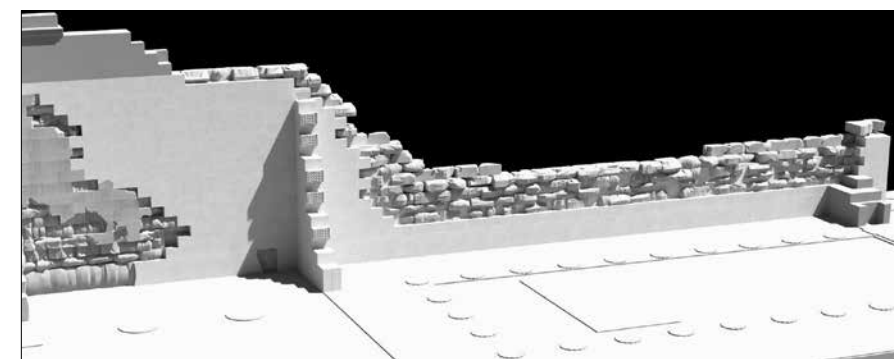
View of the model of the suggested restoration for the interior surface of the cella north wall. Study-production: K. Skaris, 2016

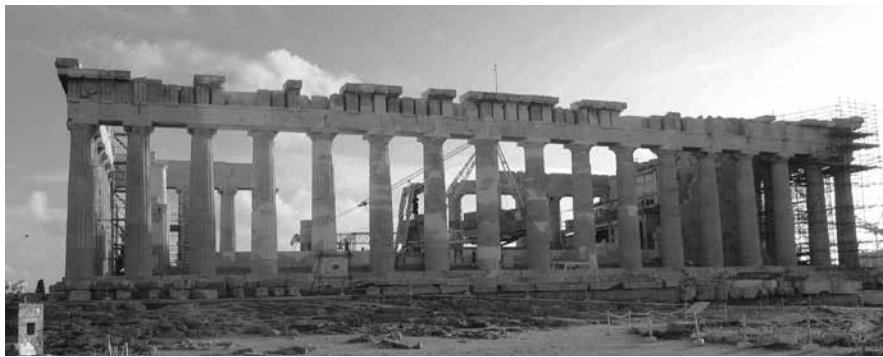
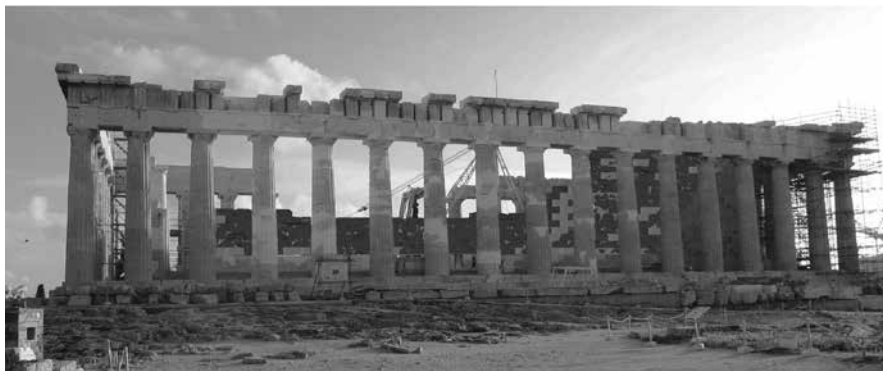
Top: view of the north side of the Parthenon. Bottom: the same picture presenting the suggested restoration for the cella north wall. Study-production: K. Skaris, 2016

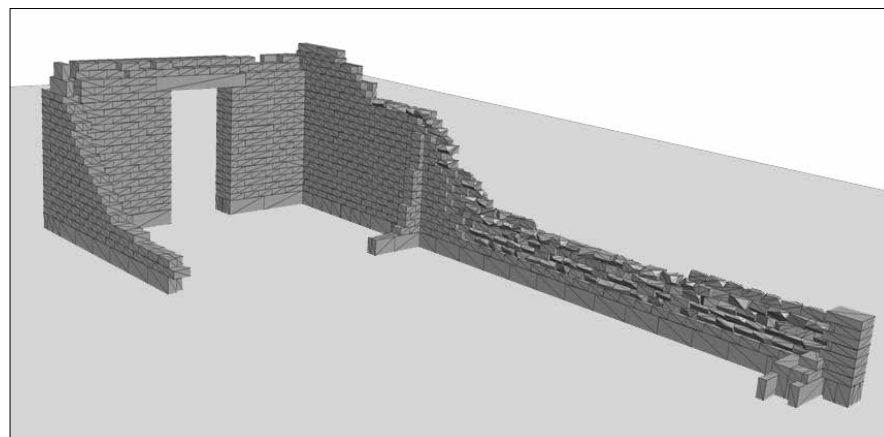
The numerical model used for the analyses of the structural system to be restored. Study-production: A. Vrouva, 2016

In more detail and within the context of the final static study of the works, numerical models of the construction were developed by using data from the research programmes and experiments. In the initial numerical model, the geometric characteristics of the wall were considered simplified and the long walls inclination and connection elements were ignored. Then, the study continued with a numerical model of 1,330 blocks, 150 blocks were examined with their fractures, allowing also for the wall inclination, and 2,878 connection elements. The north wall was examined together with the remaining part of the west and south wall in order to write out an analysis. The final solution incorporated specific seismic scenarios, which were suggested to ESMA by the research programme of the Laboratory of Earthquake Engineering of NTUA (I. Psycharis, 2014).

The dynamic analyses of the models showed that the proposed architectural solution satisfies the demands of the set seismic specifications, without any serious damage, –besides the geometry of the

–up to 25cm. In parallel, the movements along the strong direction of the wall (longitudinal direction) are generally smaller. The contribution of the connection elements lies in the constraint of the width of the maximum and permanent movements, about 50%, whereas when positioned in random places the wall behaviour is closer to a model without any connection. The restoration of the east part where limited supplements are provided behaves adequately as the height of the restoration does not exceed the 6th course. Finally, regarding the stress of the clamping elements, it was observed that only in one out of five seismic excitations examined general failures of the clamps occurred, i.e. exceed their design limit. In this specific case inertia forces dominate.

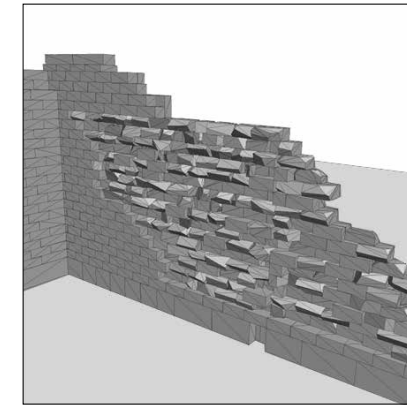
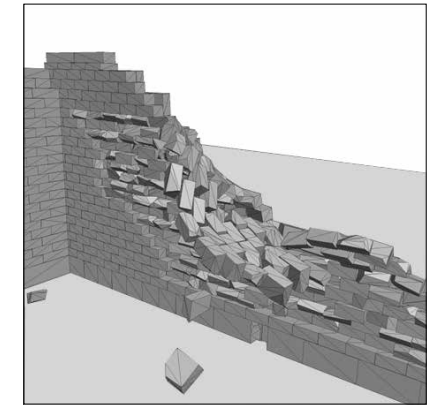
The numerical model of the structural system with the minimum supplements (left) and a snapshot from the moment of its failure (right) during a seismic excitation. Study-production: A. Vrouva

The results of the analyses can be summarised as follows: in the three from the five earthquakes studied and, in the case where the cross wall was not reconstructed a total collapse of part of the north wall between the cross wall and the north wall where the restored wall has considerable height –specifically from the 8th row and above– can be observed. In one of the three cases the connection elements managed to retain the failure. In the case where the numerical model incorporates part of the cross wall's reconstruction, a total collapse of the same part of the wall can be observed in only one of the five seismic excitations considered; and despite the implementation of the connection elements the failure cannot be retained. In order to avoid the collapse, additional supplements should be added to enhance the bedding of the blocks that are to be restored in the middle section between the cross wall and the west portal wall.

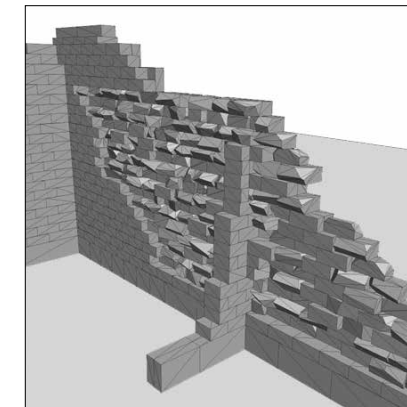
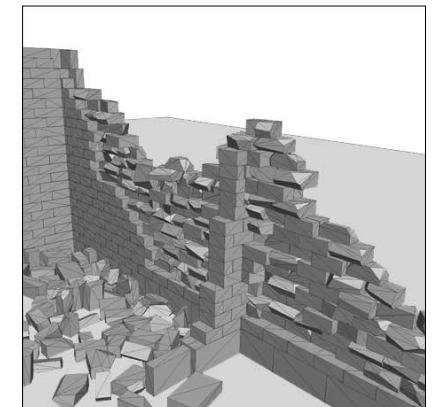
The numerical model of the structural system with the minimum number of supplements and part of the cross wall reconstructed (left) and a snapshot from the moment of its failure (right) during a seismic excitation. Study-production: A. Vrouva, 2016

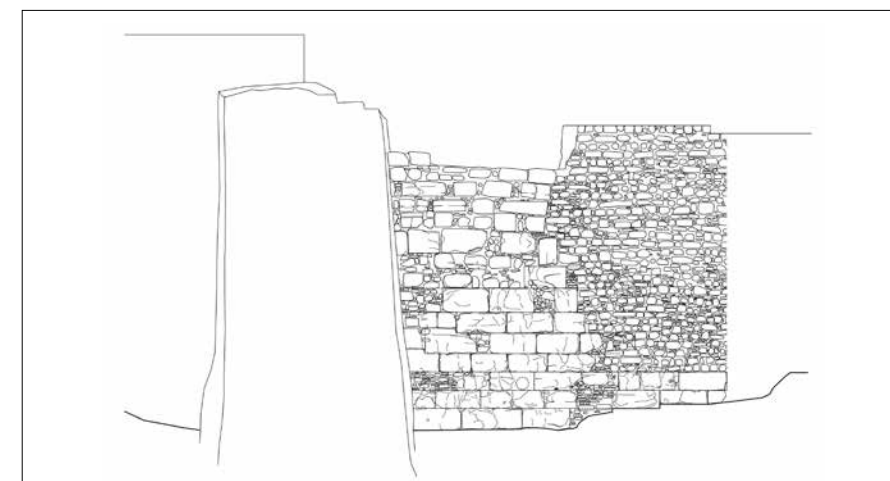
Area B17 of the north wall of the Acropolis. Top: view before the restoration works. Bottom: view after the restoration works. Drawing: K. Mamalougas, 2019. Substratum: orthophoto from the study “Development of GIS on the Acropolis of Athens”, YSMA 2009

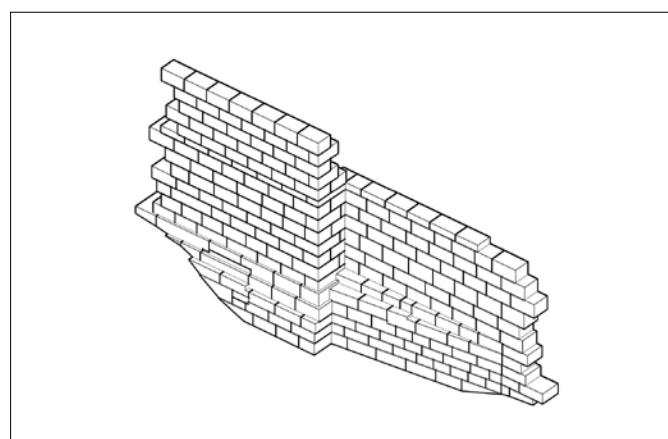
Representation of the classical phase of the area B17. Drawing: K. Mamalougas, 2019

The classical phase: The classical masonry –on which the foundation of the NW building was attached– remains intact to a height of 8 rows in its exterior and of 9 rows in its interior. It is constructed with blocks of Piraeus limestone –harder on the outside and softer

on the inside– built in dry, without any clamps. The blocks on the exterior side are laid with lengths parallel to the face of the wall (stretchers), while the ones of the interior are laid with their shorter ends towards the face of the wall (headers). Although the dimensions of the used blocks show a considerable variation, we could say that the average size of a block is 1.20X0.60X0.45 (h) m. The width of the wall, including the foundation of the NW building, ranges from 1.80 to 3 m. What can be noticed is that the exterior part of the wall inclines towards the interior of the Acropolis, which in its classical phase was achieved through successive small receding of the rows that constructed it (about 2cm per row). Even in this sub-area we can discern small-scale restorations.

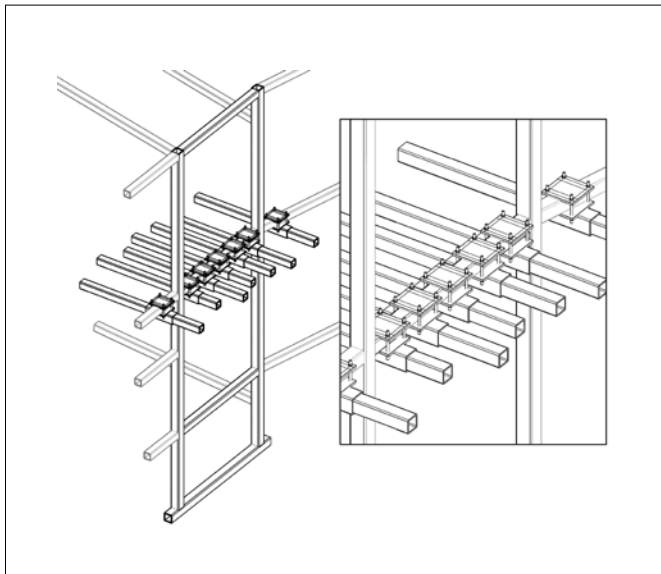
Anchoring/support system. Study: D. Michalopoulou, 2019

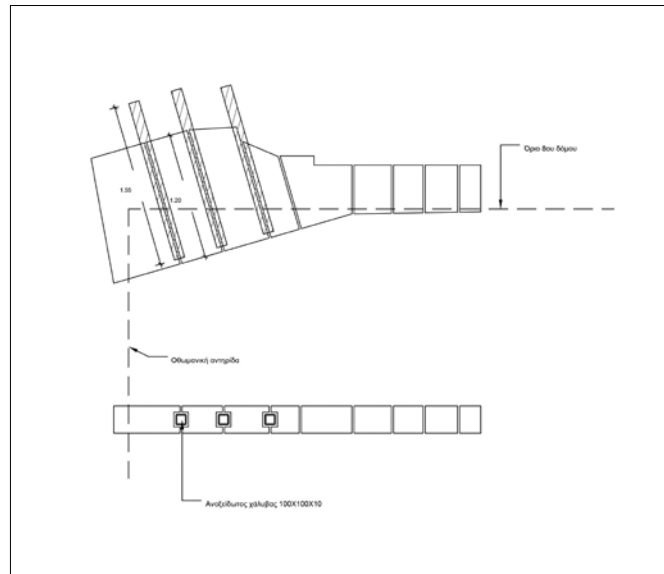
Reinforcement with metal beams. Study: D. Michalopoulou, 2019

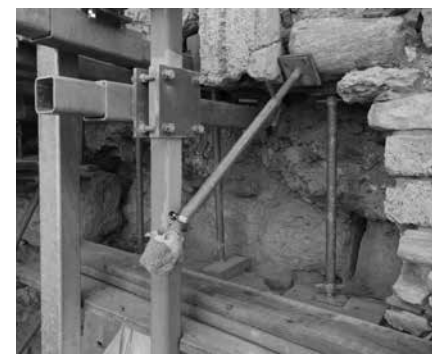
Temporary shoring of the masonry during the dismantling period.
Photo K. Mamalougas, 2019

It was initially suggested that the original form of the wall in all the height of the area covered by “Restoration A” should be restored. Finally, though, it was decided to preserve the largest part of what was already restored and to restore the classical phase up to the 8th row. As a consequence, the works had to be conducted in the middle of the height of the wall at a depth of about 1.50 m from the exterior surface, whereas the uppermost part of the wall would remain intact. This option demanded the study and construction of a metal system of buttressing-shoring, which stabilised the masonry above

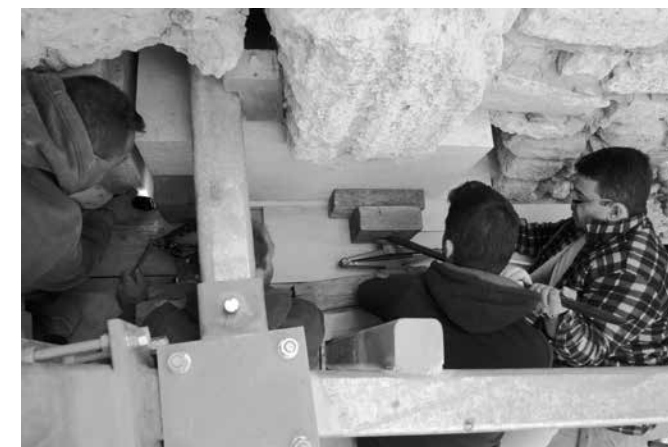
Placing a new block in the area B17.
Photo K. Mamalougas, 2019

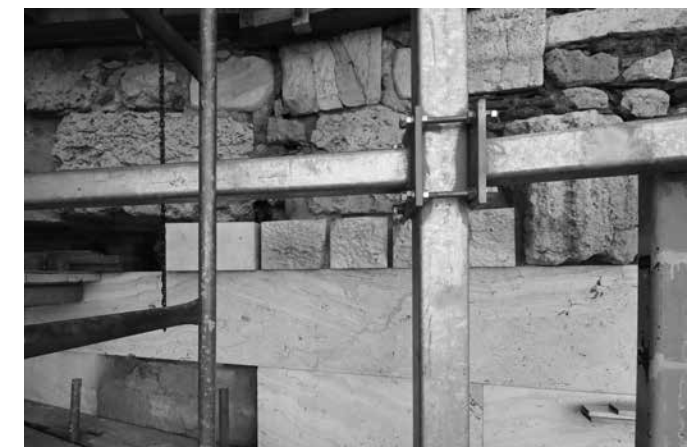
The west edge of the intervention area after placing new blocks
Photo K. Mamalougas, 2019

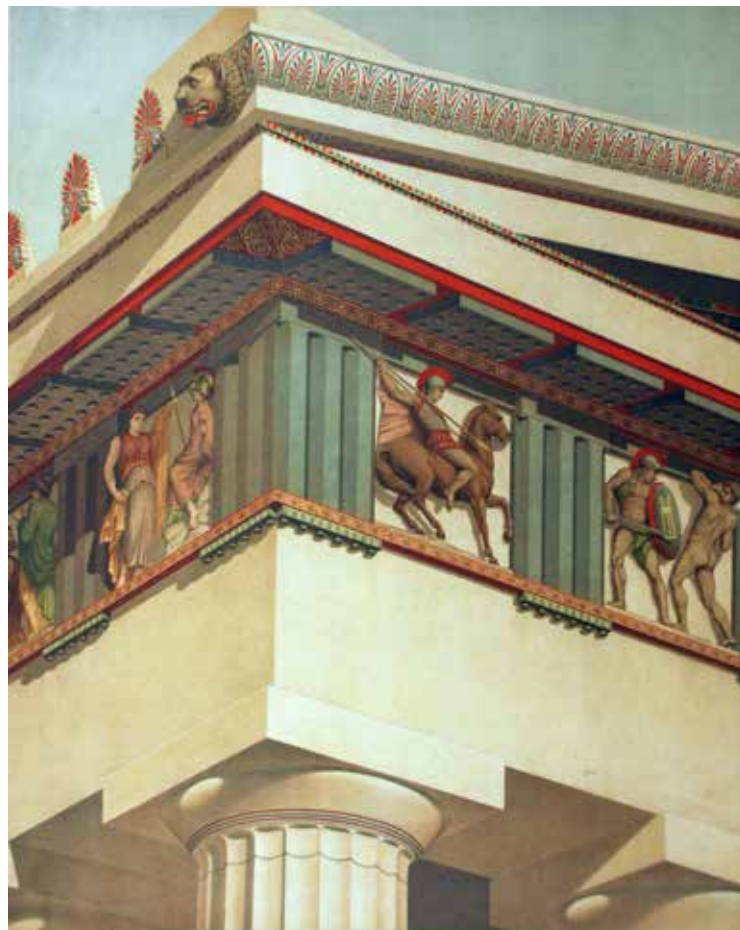
A representation of the Parthenon entablature according to Julius Springer. In colour in the initial publication.

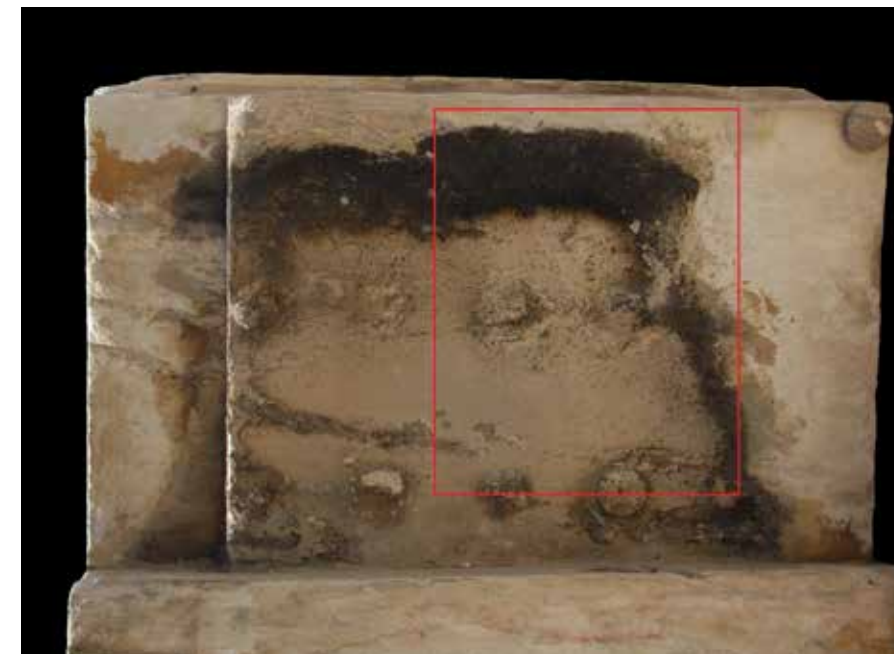
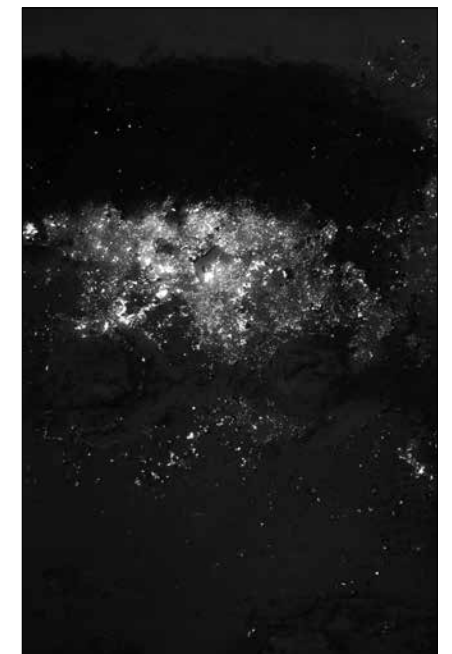
The 4th west cornice block. Left: View of the mutulae and the viae. Black crusts and orange-brown patina layers. Right: Area defined inside the frame in the adjacent photo. Intense luminescence indicating the existence of Egyptian blue.

1. Imaging diagnostic techniques (in situ evaluation without sampling) - Phase B. These techniques are the following:
 - Raking light imaging, in order to determine the existence of the incising and tools traces in marble surfaces.
 - In-situ optical microscopy (magnification: x30, x50, x120).
 - Visible Induced Luminescence (VIL). It is the main technique to trace the Egyptian blue.

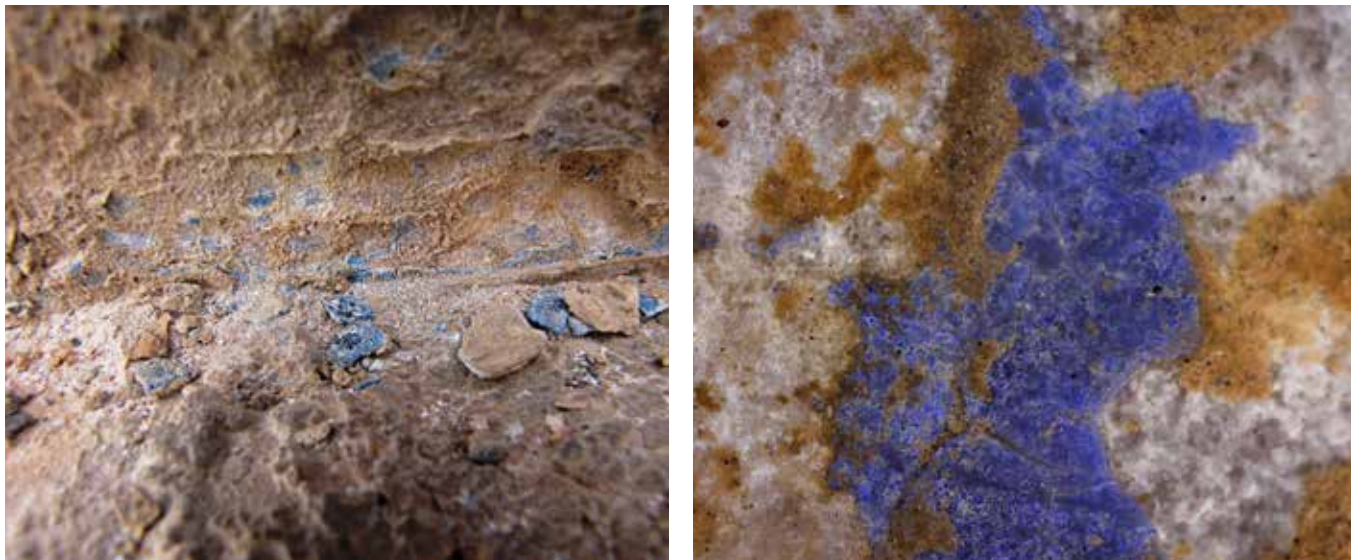
The 4th west cornice block. Left: north vertical side of the mutulae. Intense blue colour under the crust. Right: a photo from a portable optical microscope (x50) of the blue colour in the adjacent photo.

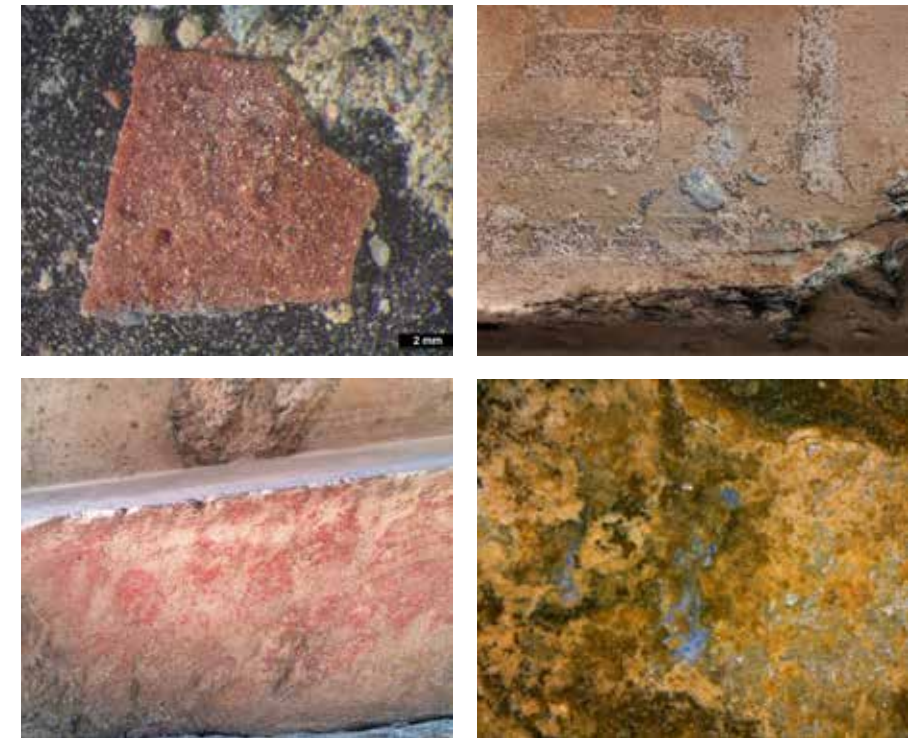
Cornice blocks of the west side of the Parthenon. Top left: The 4th west cornice block: red pigment from the via. Photo from the stereomicroscope. Top right: The 21st west cornice block: the meander grid on the taenia. Bottom left: The 11th west cornice block: a red pigment layer at the bottom of the taenia. Bottom, right: The 14th cornice block: blue colour on the meander under a layer of orange-brown patina.

2. The mutules of the cornice blocks were painted with Egyptian blue. The viae were

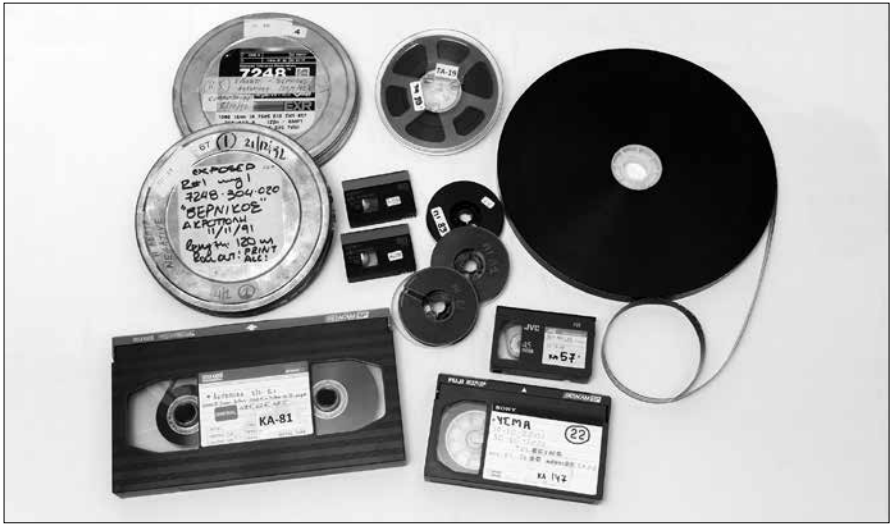
Examples from the analog audiovisual archive (motion picture film 16mm, 35mm and super 8mm, betacam and mini dv tapes, audio magnetic tapes)
