The Acropolis Restoration News

19-20 • February 2023

V. Eleftheriou - 2019-2020, The progress of the restoration works on the Acropolis

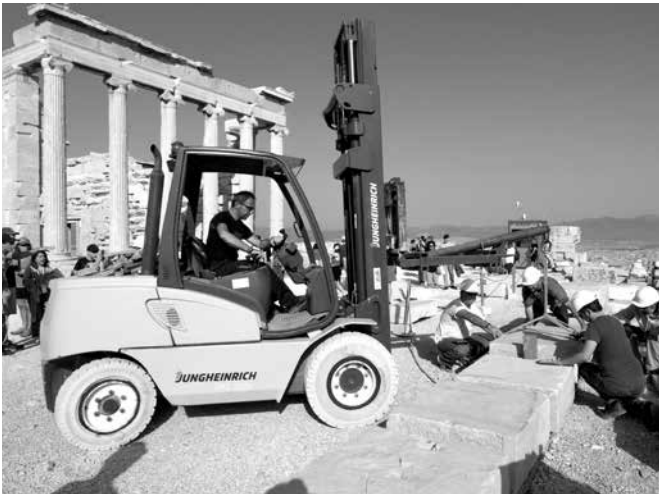
The forklift machine JUNGHEINRICH DFG550s
Photo G. Kehagias, 2019

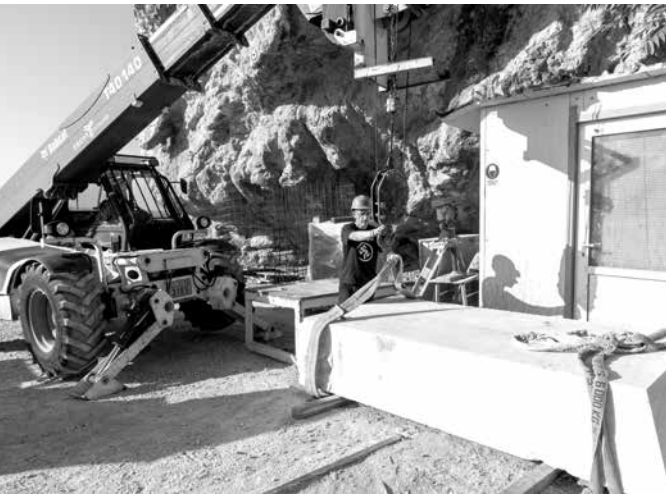
The forklift machine BOBCAT T40140
Photo G. Kehagias, 2019

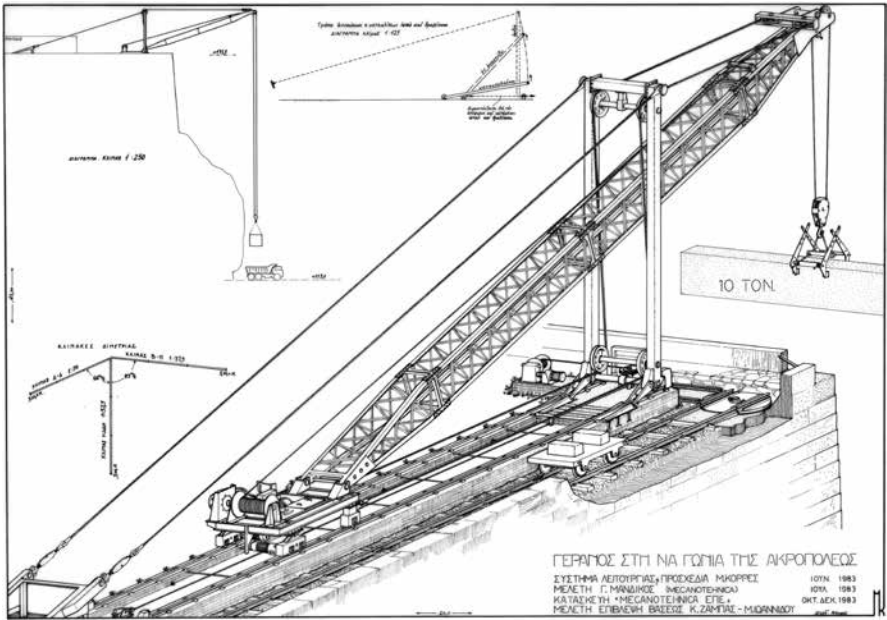
The crane at the SE corner of the Acropolis. Drawing: M. Korres, 1983

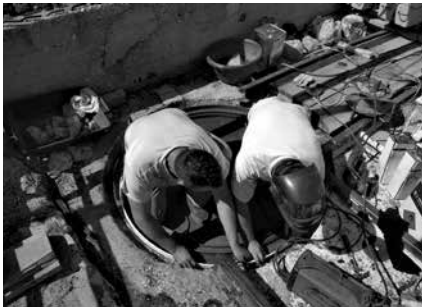
Corrective maintenance works on the rotor mechanism. Photo G. Kehagias, 2019

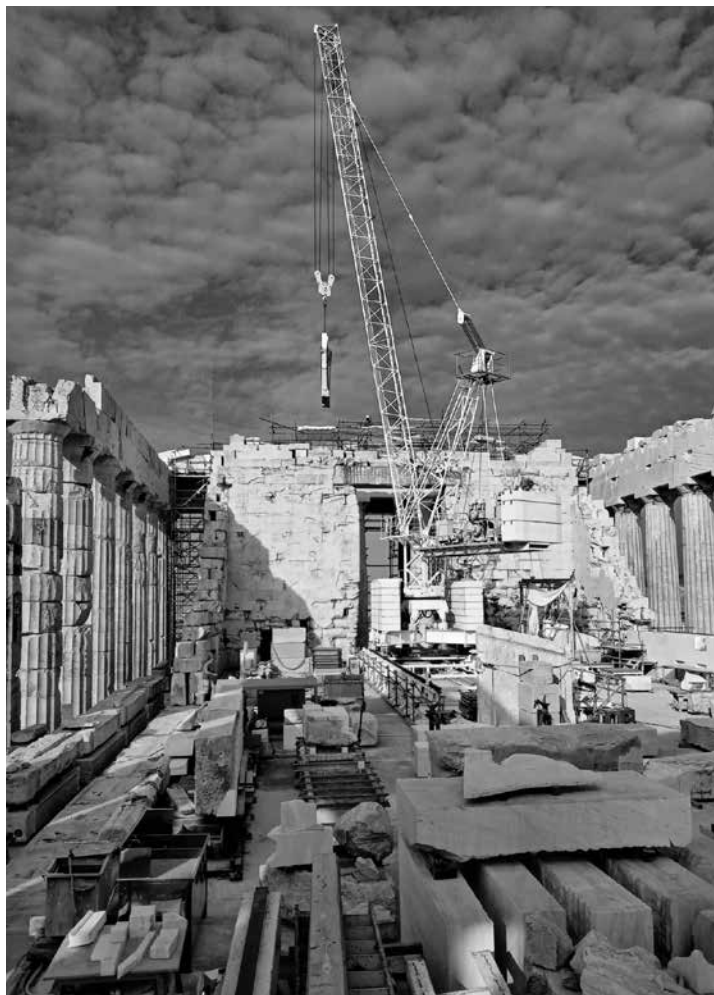
The crane POTAİN MR90 at the Parthenon. Photo G. Kehagias, 2020

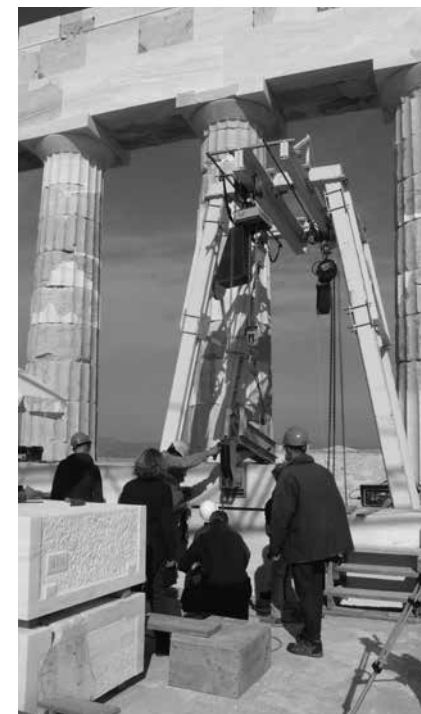
The bridge crane inside the Parthenon cella

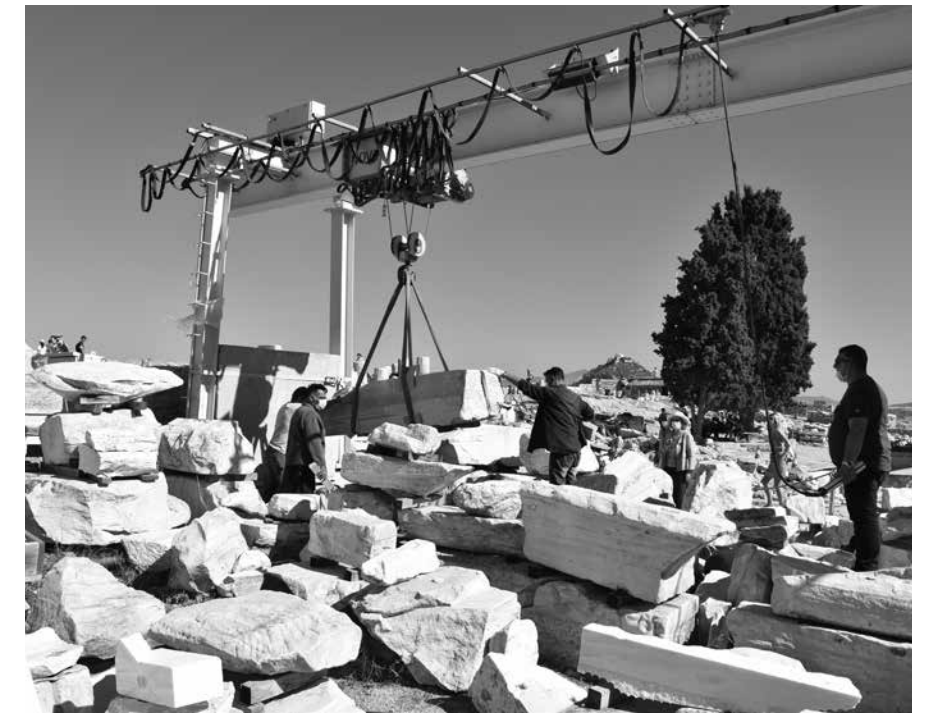
The bridge crane at the Parthenon worksite
