V. Eleftheriou – 2021-2022, The progress of the restoration works on the Acropolis

A. Vrouva – Designing the special clamp system of the Parthenon's west pediment

V. Manidaki, K. Skaris – The use of digital technology to produce new marble additions in restoration works on the Acropolis

D. Michalopoulou, K. Karanasos, K. Frantzikinaki – Monument of Agrippa: preservation state and restoration works

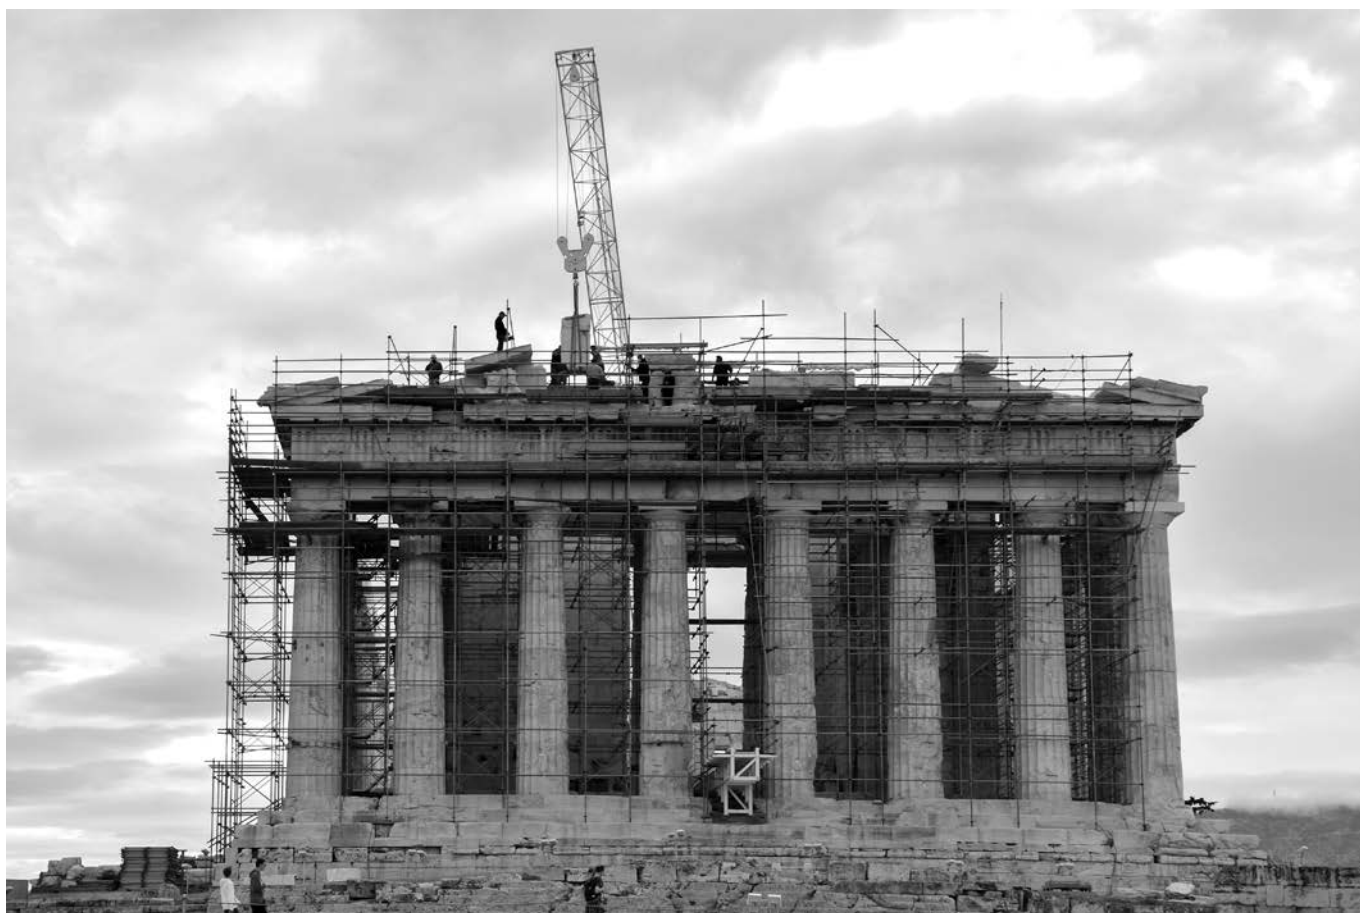
Trial positioning of an orthostate block in the Parthenon's west pediment. Photo K. Karanasos, 2021

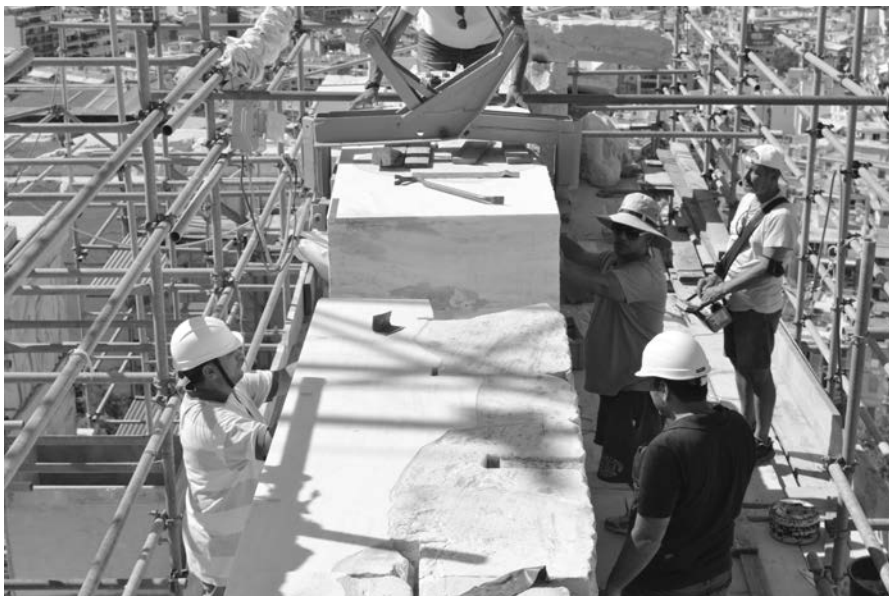
Trial positioning of a stone block of the backing wall of the Parthenon's west pediment. Photo K. Skaris, 2022.

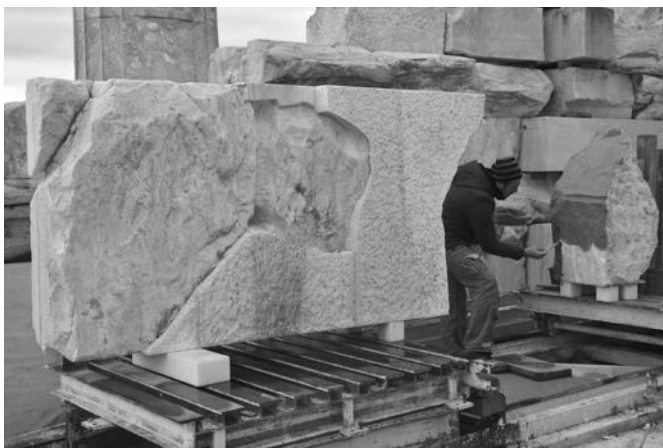
Elaborating a fragment for the orthostate of the south wall of the Parthenon cella. Photo R. Christodouloupoulou, 2022

The north wall of the cella is being restored at the level of the 2nd course, whereas work has progressed up to the 9th block from the east. In parallel with the application studies on the structural restoration of architectural members and their assembly method, the study on the attribution of the ancient stones in the east part of the north wall’s 2nd course was updated. In 2022, works for the restoration of the partition wall separating the cella from the opisthodomos, which will be entirely built of new marble, commenced. Financed by the Recovery Facility, the restoration of the toichobate of the south wall of the Parthenon cella was launched, following the updating of the study on the restoration of the toichobate and the orthostate of the cella’s south wall, by L. Lambrinou.

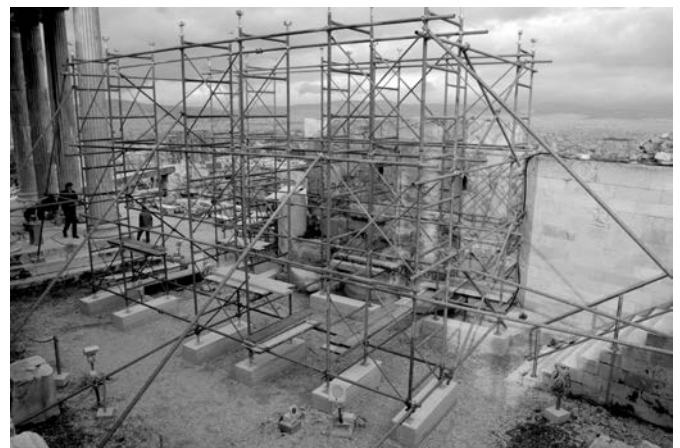
Setting up a scaffolding for the commencement of works in the B12 area of the Acropolis north wall. Photo V. Eleftheriou, 2022

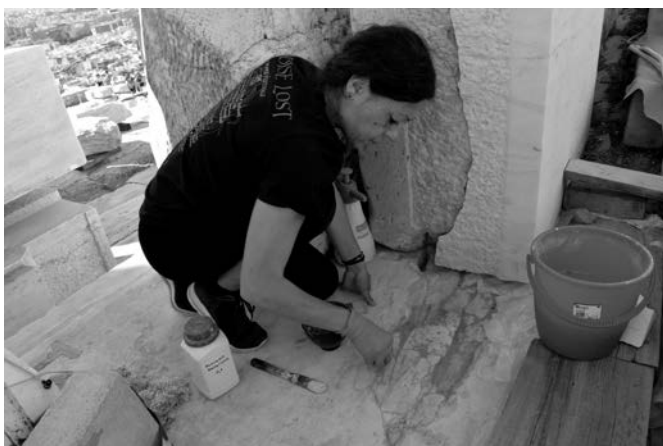
Conservation of the toichobate blocks of the south wall of the Parthenon cella. Photo S. Gabrielidou, 2022

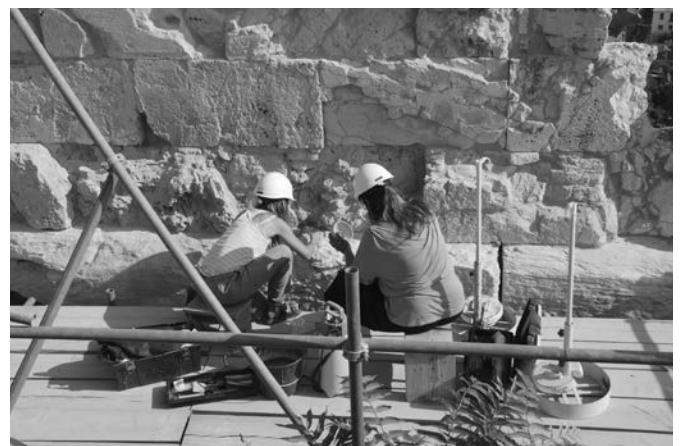
Conservation works on the north Acropolis wall, B12 area. Photo A. Tsimereki, 2021

In the area B17 of the north wall, where filling with new stone blocks had been completed in accordance with the approved study, the following works were performed: filling of lacunae within the wall using compatible mortar in places that were inaccessible prior to the removal of the metal support-buttressing system; filling of lacunae found in the later stonework in the upper part of the wall's inner face and also on a surface around 15m² in area in the west face of the adjoining tower-shaped buttress that was not included in the original study. Other works involved dismantling of the metal support-buttressing system of the wall and part of the bearing scaffolding by means of a bridge crane; modification of the scaffolding for the conservation of the ancient stones of the lower courses and application of injected mortar to the interface between the rock and the ancient bearing stones of the wall.

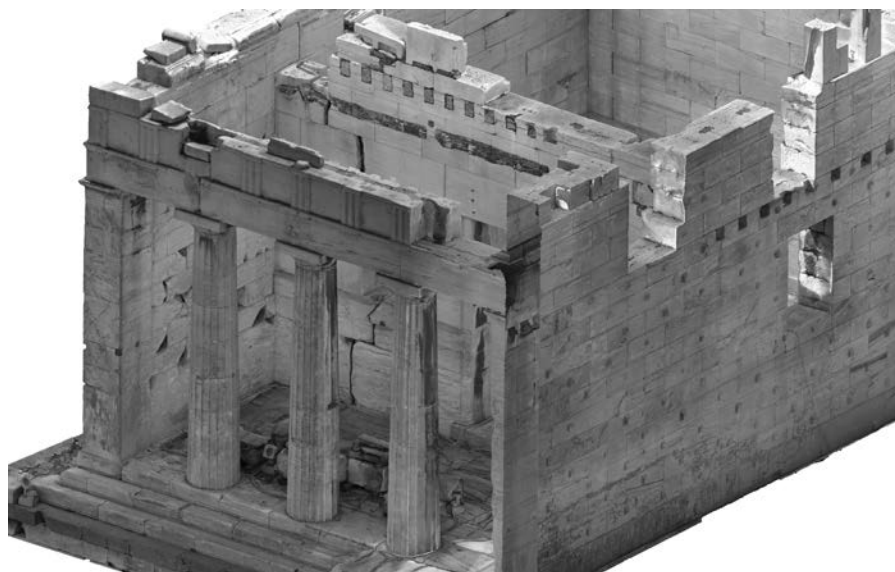
*Photo-textured three-dimensional model of the north wing of the Propylaea.
Study: "Production of three-dimensional model of the Propylaea north wing", 2021*

In 2021-2022, the Service produced a wide range of photogrammetric surveys and three-dimensional images in support of all works that were underway. Responsible for the photogrammetric documentation is the surveying engineer D. Mavromati, whereas in the Office also works the surveying engineer S. Kyparissi. During the period in question, the “Study of topographic and photogrammetric surveying on the Parthenon” continued through the collaboration of ELPHO Ltd. – FOTOPO

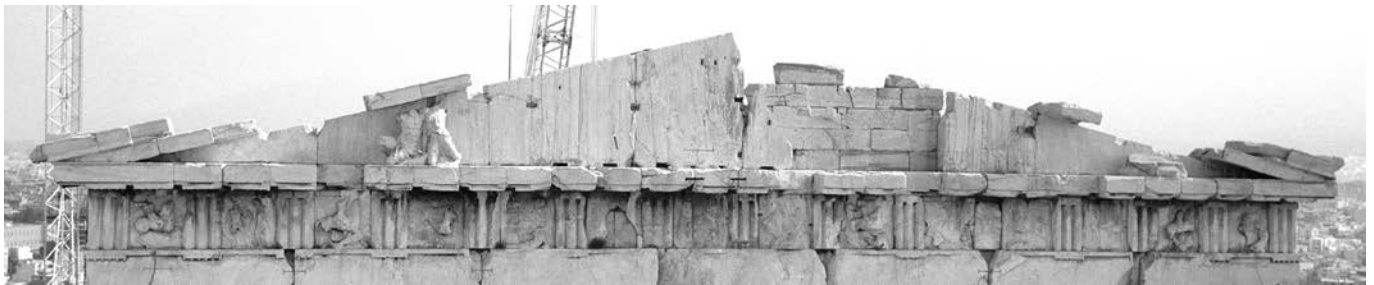
The Parthenon's west pediment. Photo S. Gesafidis

The most severe damage mainly resulted from the fire of the 2nd century AD, affecting the backing wall blocks. The fire caused serious thermal cracks within the backing wall. Although the east face of the stone blocks seemed intact, a few centimetres beneath their surface, a multiple fracture network was noticed reaching around the midpoint of each block's thickness. The failure mechanism was also confirmed by experiments conducted on the worksite by the architect K. Skaris. Given that the load-bearing capacity of the thermally affected marble is reduced and the anchorage areas of the transverse clamps are fractured, the restoration planning had to take account of tight constraints. It was decided to restore most of the stone blocks in situ –without dismantling, as they were undisturbed since the original construction– by using

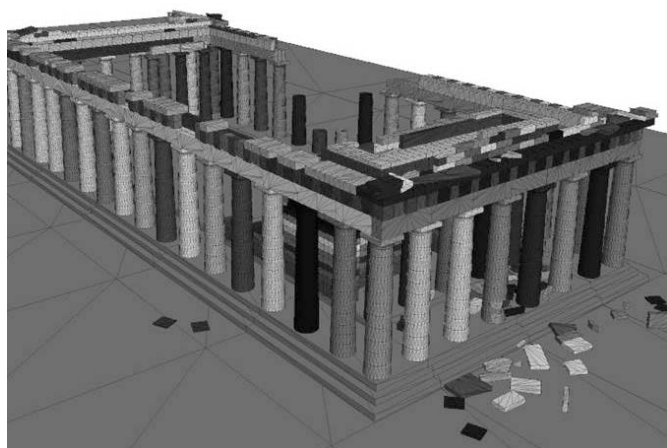
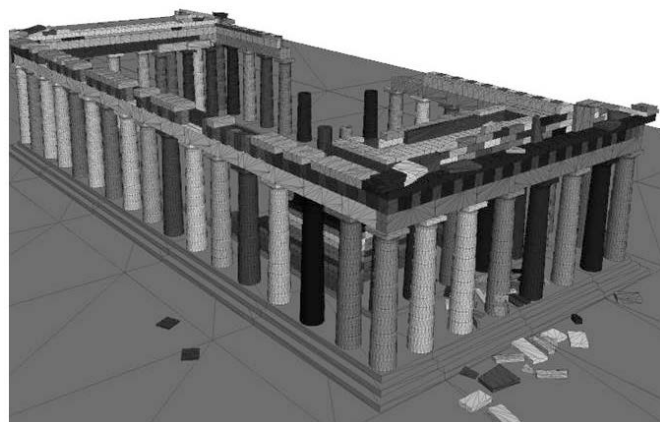
Numerical analysis results on the freestanding orthostates. Left: Bagnoli-Irpino earthquake - Collapse of the tympanum's central section. Right: Athens' earthquake - Collapse of the tympanum's central section.

In order to assess earthquake hazard and the forces that would be exerted on the joining elements, the structure was numerically simulated using the Discrete Element Method (DEM). According to this method, the stone blocks were modelled as rigid elements, and all deformations took place on the structure's joints, while the clamps were modelled as non-linear springs. For the simulation of the joints and the connectors, suitable parameter values were adopted, based on previous experimental studies carried out by the Laboratories for Earthquake Engineering, Reinforced Concrete, and Testing and Materials of the National Technical University of Athens (NTUA).

It was analytically proved that the connectors were critical for the tympanum's behaviour and for preventing a possible fall of its central section. In the case of freestanding orthostates, lacking connectors, numerical analysis predicted significant damages caused by the collapse of the stone blocks of the orthostates, thereby demonstrating the necessity to redesign these clamps. In addition, this analysis specified the design force for the special clamps that equals around 7 tonnes.

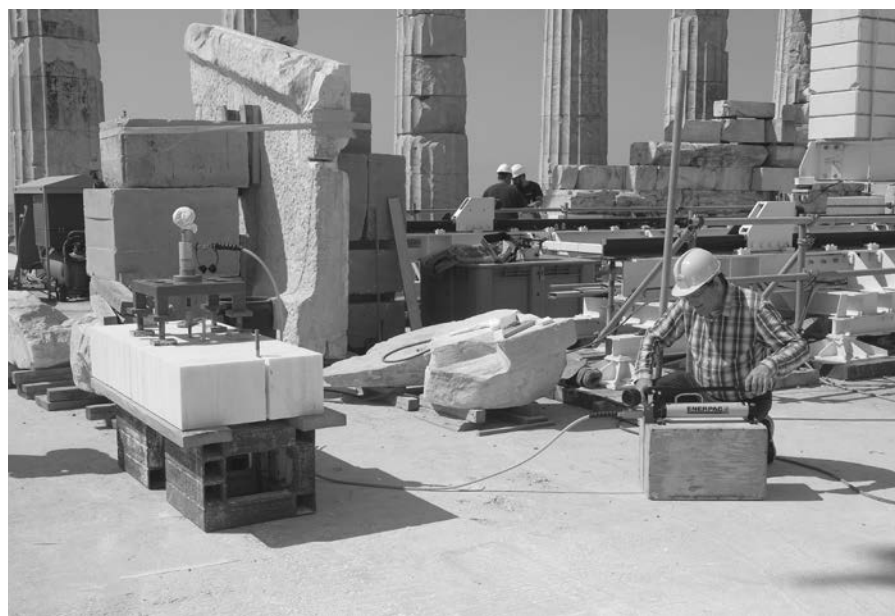
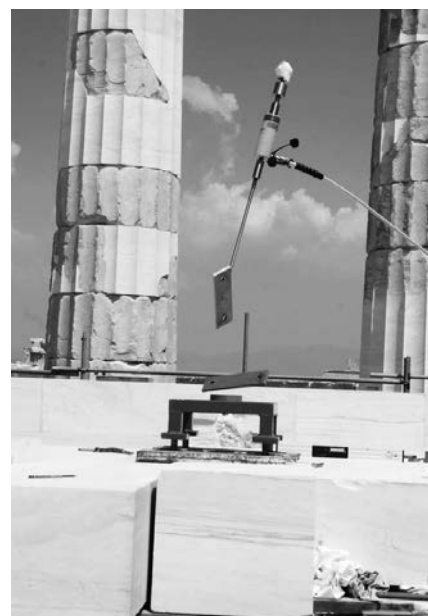
Snapshots from the testing procedure: on the right the moment of failure of the anchoring system is captured.

ly designed nut was tested demonstrating that, on the whole, the anchorage system was reliable, since only the intended part systematically failed within the desired failure load forces.

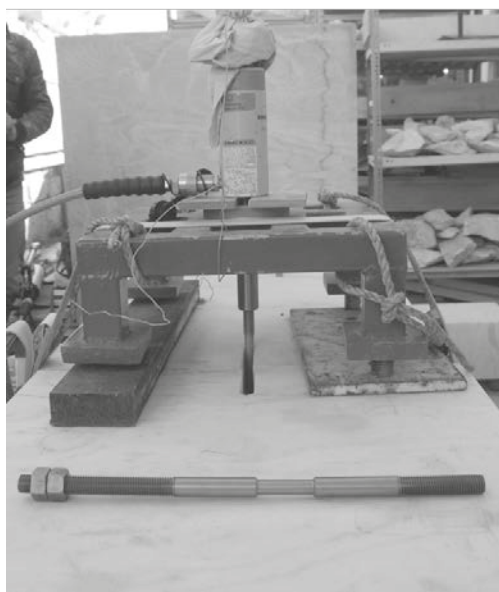
Left: testing the composite specimen. Right: the specimens after the completion of testing

tested. Five specimens were prepared for testing in order to ensure that the part anchored to the orthostate blocks would not fail before the connection's horizontal element, which was to be fixed into the stone blocks of the backing wall. The test results showed that the anchorage system was reliable, since it was the horizontal part that systematically failed, the fracture values of which were larger than the desired design load that reached 8.5 tonnes.

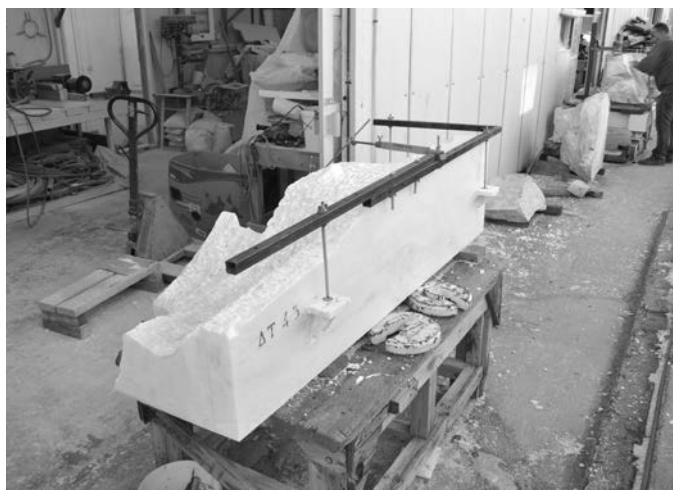
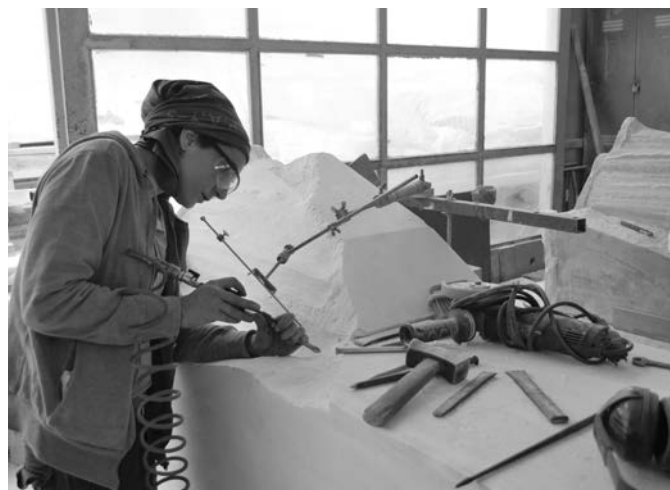
The traditional method of creating new marble additions with the use of a pointing device. Photos K. Skaris, 2020

The pointing device, a mechanism used by artists in the precise copying of sculptural reliefs, is similarly employed by technicians to copy the exact fractured surfaces of architectural members during restoration works. This is the same process used by sculptors to transfer desired shapes from their preliminary plaster models to the raw marble.

In the case of ancient broken architectural members, the fractured surface where the bonding is to be carried out is first prepared by identifying the existence of friable, weathered areas, which are cleaned if necessary. Then, a decision must be made how the new addition will be adhered, with consideration given to the specific geometrical characteristics of the ancient member's fractured surface. To achieve proper bonding, it is necessary to define the axis along which the new addition will move until it completely binds to the ancient fracture. Next, areas of the original marble typically termed “dark areas” or “skoura” by the technicians, which protrude and obstruct the movement of a new addition as it is fitted to an ancient fragment, are identified. Clay is then applied to these “skoura” and so during the copying of the

ancient, fractured surface these marked areas are disregarded. In general, the outline of a new addition is precisely drawn on its recipient ancient fragment in agreement with a previously prepared architectural study. Also, when marble additions are initially prepared, the overall dimensions of a new marble piece are left larger than necessary, in order to allow for a margin of error during the precise final carving process (apergon).

After these initial steps, a cast is made of the ancient member's fractured surface. Plaster is applied to produce a mould, which is then copied onto the marble with the use of the pointing device. This technique has been continuously used over the past 50 years in the restoration works of the Acropolis, where young apprentice-technicians employed on the worksites are trained by older, more experienced master craftsmen.

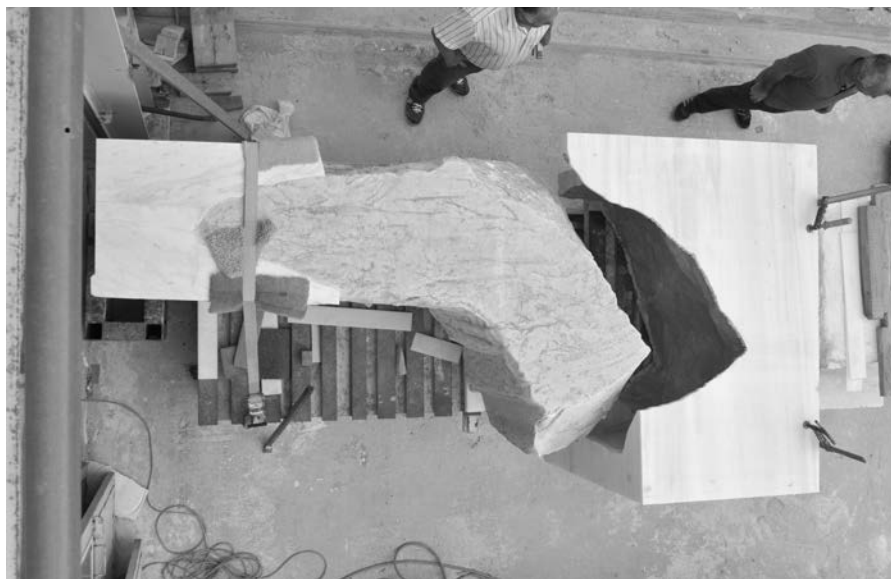
Adjusting a new marble addition for the Parthenon's orthostate, northeast parastasis. The addition was created in CNC with digital scanning of the mould. The "mixed method." Photo V. Manidaki, 2014

In some cases, since the first decade of the 21st century, and in parallel with the "handmade" production of new marble fillings in the Acropolis works, a secondary process has also been used to create new additions. This alternative process amounts to an automated treatment of marble blocks placed in carving machines that employ digital technology (CNC) – a service provided under contract by the Venus Marble

Group. Plaster casts are also used during this process –but the marble additions are machine-carved. This method is comparable to the traditional approach, as copying with the use of a manually operated pantograph has been replaced with the use of a machine pantograph (CNC). The greatest difference, however, lies in the need to digitally scan the casts and to create digital models. For the sake of distinction, it is proposed that this procedure be called the "mixed method".

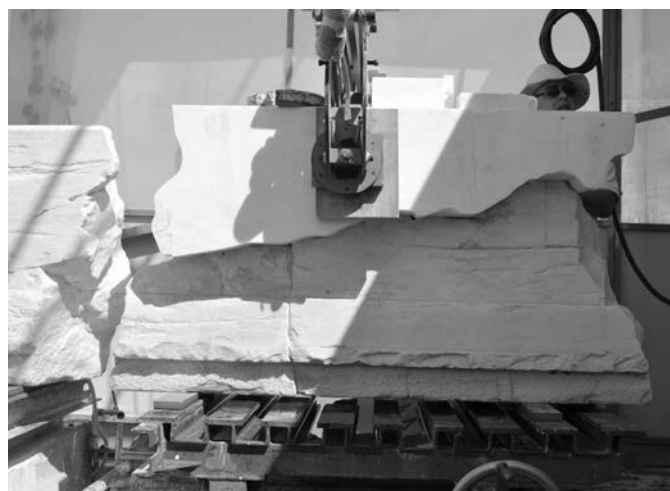
Left: a mould for a new addition for the frieze on the south wing of the Propylaea. Right: a trial placement of the new marble addition created in CNC with digital scanning of the mould. The "mixed method." Photo V. Manidaki, 2014

Experience with this mechanized, digital method, however, has shown that although such production of large new additions is faster and benefits the process, there is still the need to conduct trial fittings and to apply further treatment by hand to achieve the best possible bonding of new additions. In the digital process, some small distortions in large moulds are inevitable and negatively affect the precision of the method. This problem is intensified because during the process a further copy con-

sequently has to be made –that is, one generated with digital scanning of the mould– in order to accurately create the new addition. Failures of a more serious nature, furthermore, sometimes occur in cases of large moulds with more complicated surfaces. As a result, new additions to ancient blocks have to be repeatedly readjusted, thus ultimately allowing little significant reduction in the time required to complete the work.

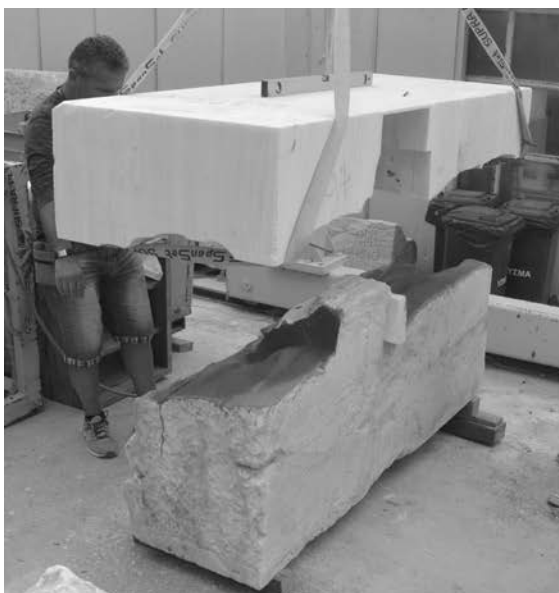
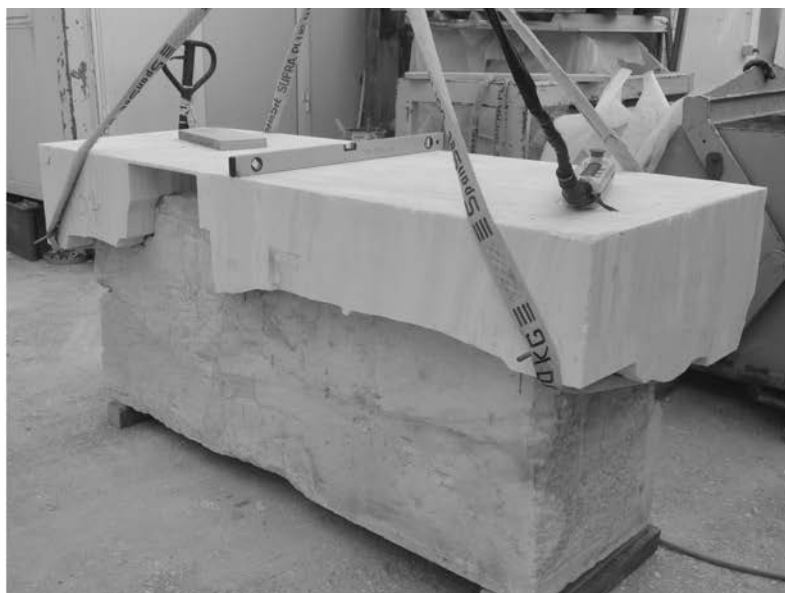
Adjustment of the new marble addition on the ancient block Δ.TA4.6. Photos V. Manidaki, 2022

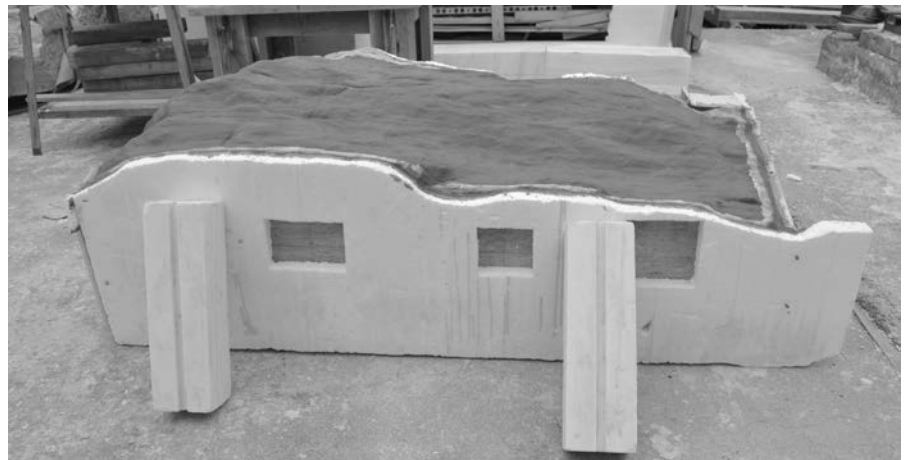
Creation of a perimeter zone on block Δ.TA5.5 to mark the edges of the new addition. Photo K. Skaris, 2023

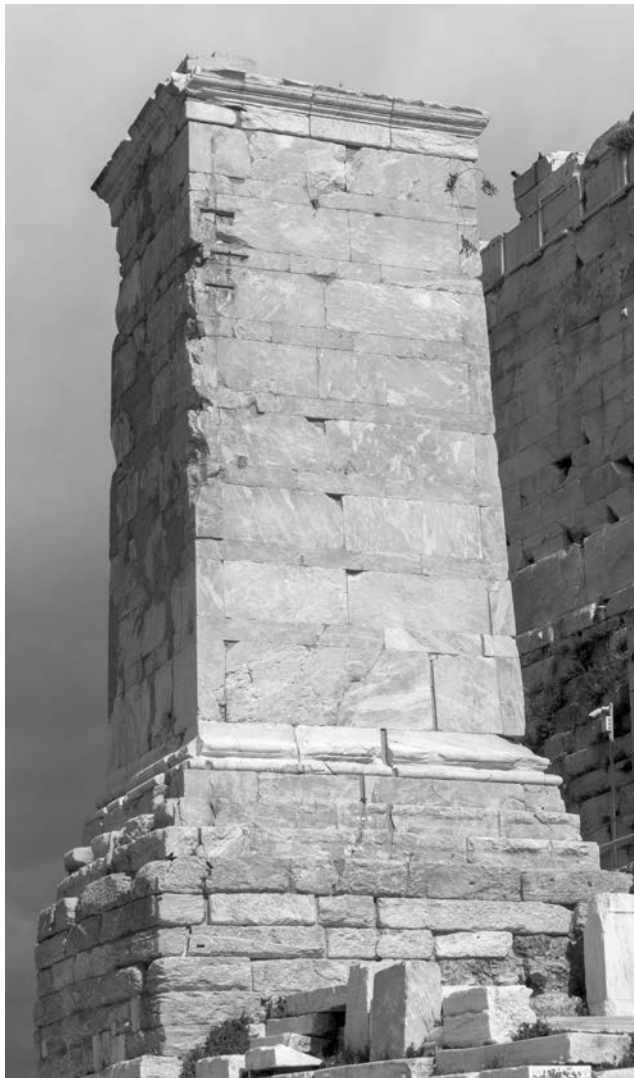
*View of the monument of Agrippa from the SW.
Photo T. Souvlakis, 2021*

the monument's invisible parts, as can be seen today on its south side. The monument consists of the stereobate, a three-stepped crepis, an Attic-Ionic base, a slightly tapering shaft built in the *opus pseudo-isodomum* system, and a protruding crown upon which the plinth's blocks were placed. The Pedestal of Agrippa, including the crepis, is around 9.50m high and rests on a foun-

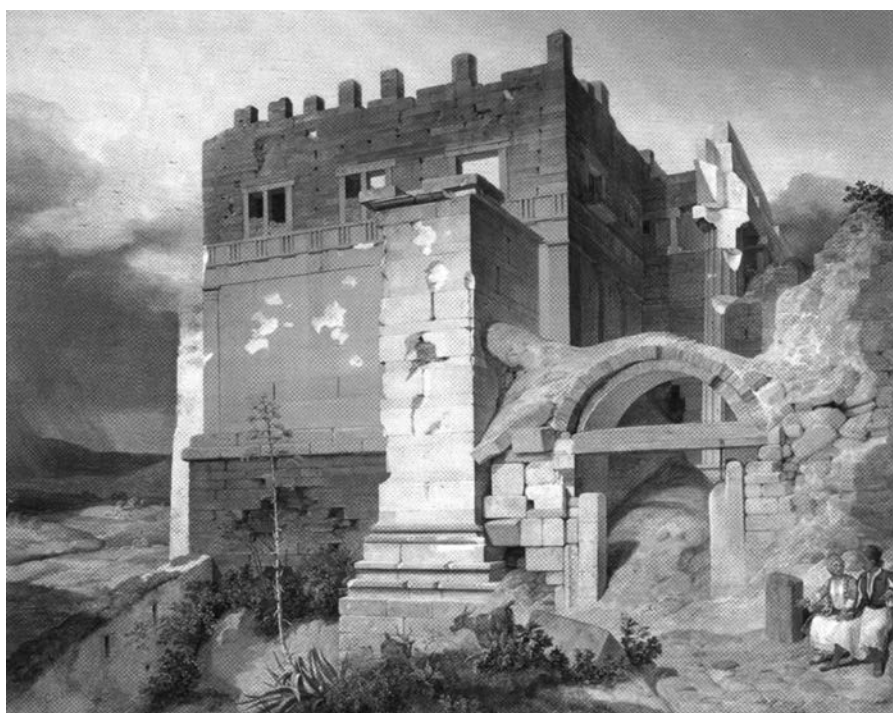
View of the monument of Agrippa from the W before it was completely freed from the later structures (Karl Wilhelm von Heideck, 1835)

In the aforementioned recording it was ascertained that the west side's stone surface was more seriously damaged compared to the other sides. The impact of cannonballs had created lacunae in the Hymettian stone blocks, which during past interventions were filled –as already mentioned– with concrete, and caused severe disintegration of its surface.

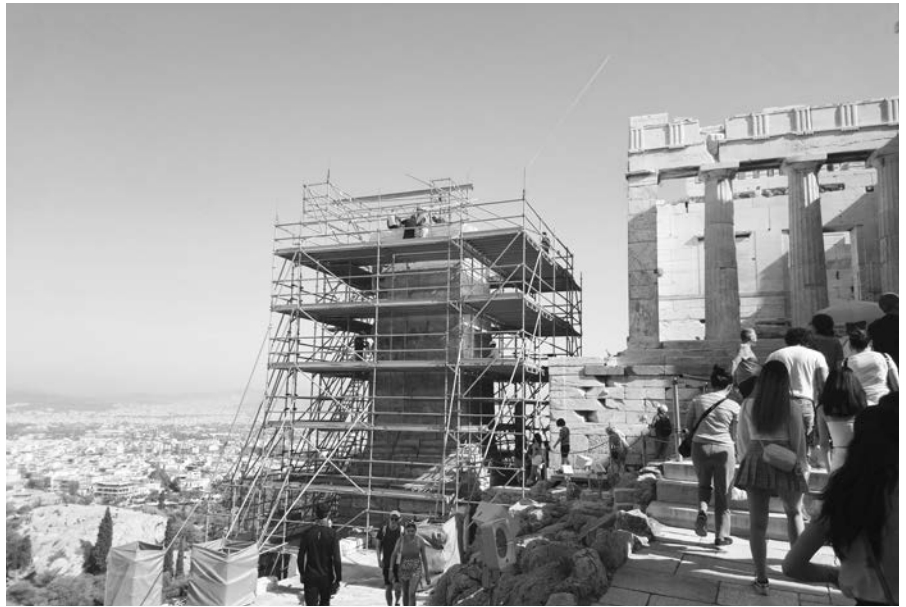
*View from the S after the scaffolding was mounted to the crown of the Pedestal.
Photo V. Eleftheriou, 2022*

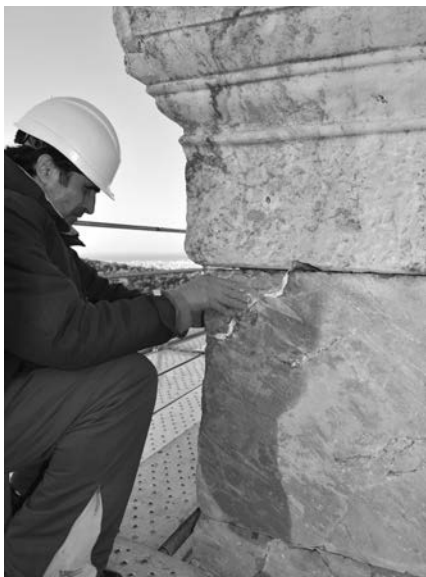
View from the E during works for the reattachment of a fragment of the monument's shaft. Photo P. Vlachouli, 2022

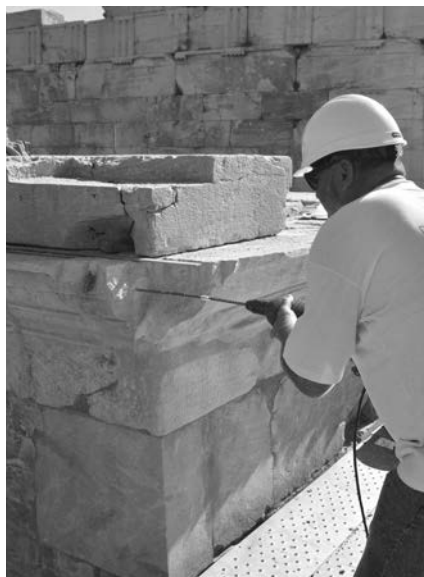
View from the SW during the consolidation of a stone of the monument's crown. Photo K. Karanasos, 2022

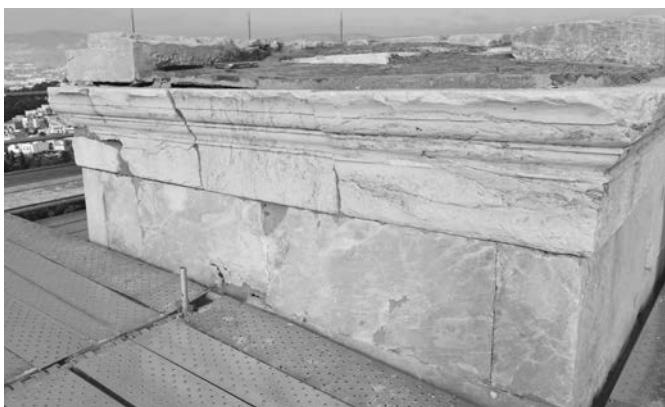
View from the S of the monument's superstructure before conservation. Photo K. Frantzikinaki, 2022

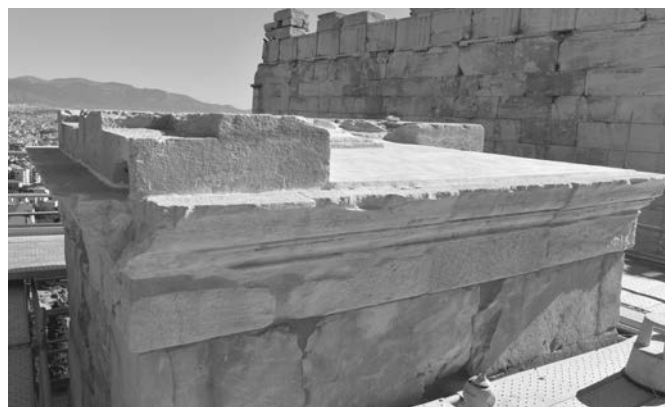
View from the S of the monument's superstructure after conservation and the restoration of the crown's waterproofing. Photo K. Frantzikinaki, 2022

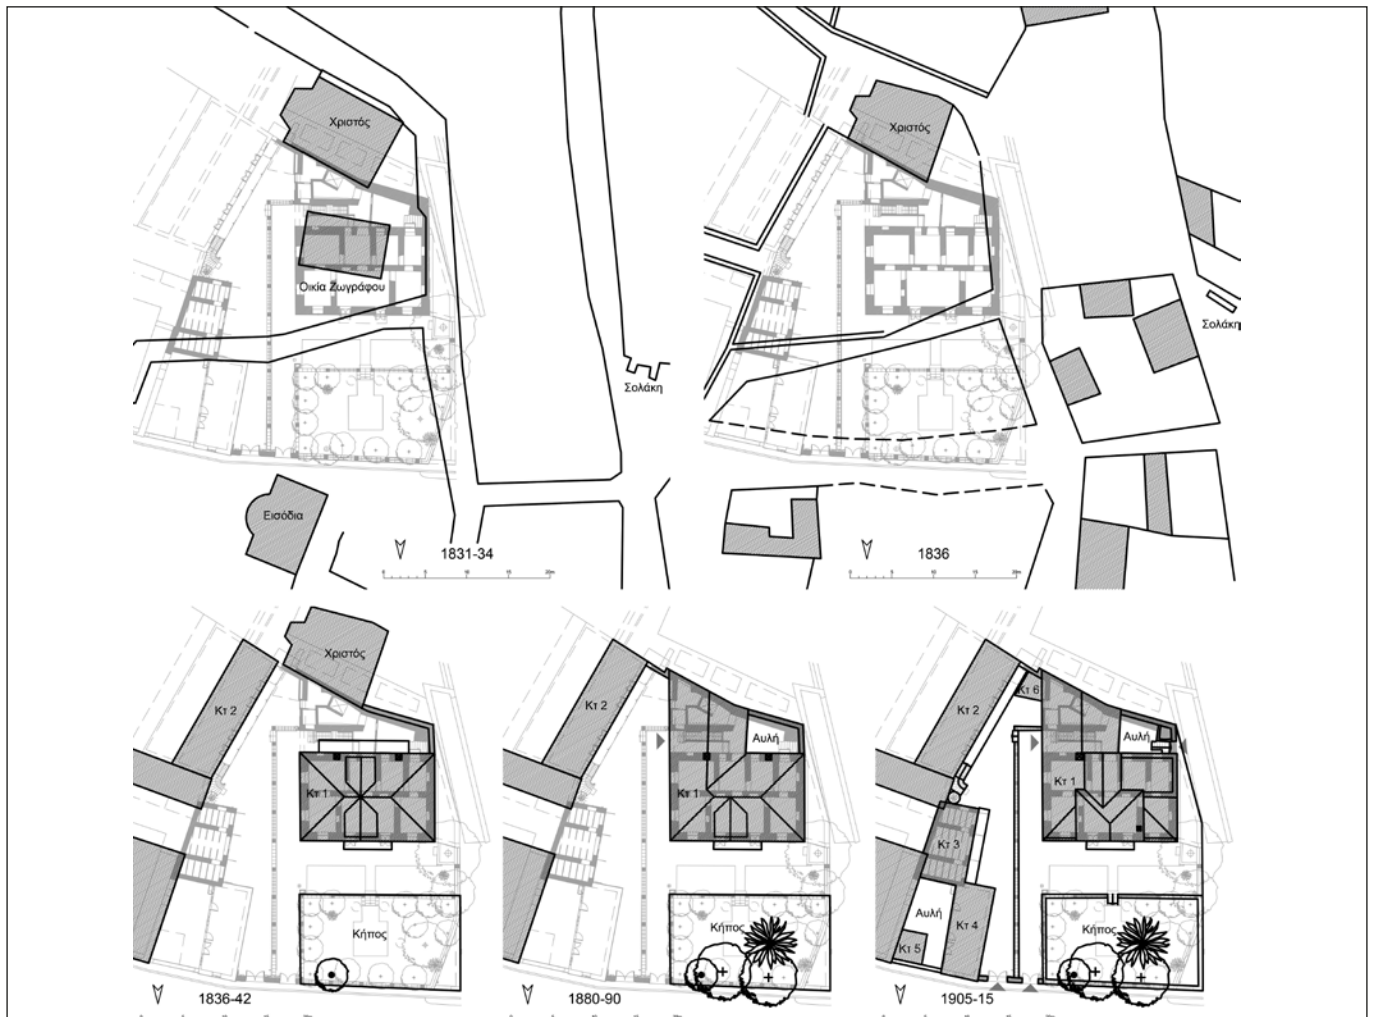
The main building phases of the listed building at 13, Polygnotou Street. Study-Drawing: K. Skaris, 2020
