2ND INTERNATIONAL MEETING
FOR THE RESTORATION
OF THE ACROPOLIS MONUMENTS
PARTHENON

ATHENS, 12-14 SEPTEMBER 1983

PROCEEDINGS

POLLUTION ATMOSPHERIQUE ET CORROSION DE LA SURFACE DU MARBRE DU PARTHÉNON. OBSERVATIONS ET PROPOSITIONS

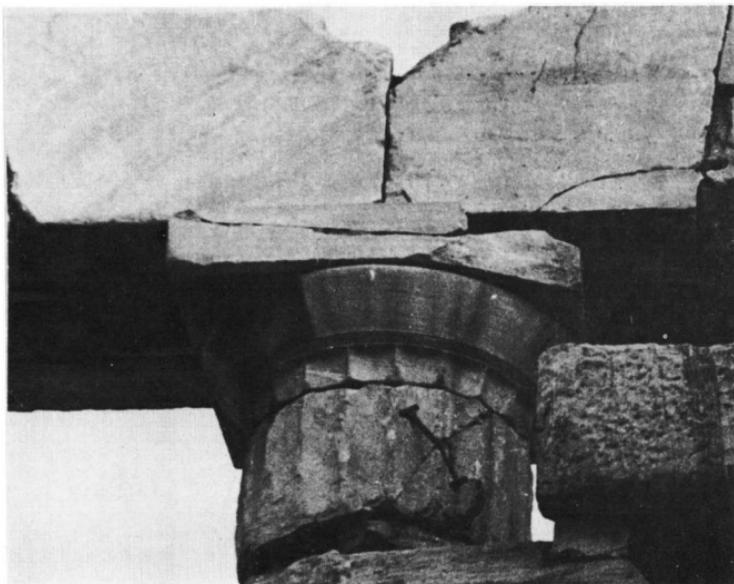
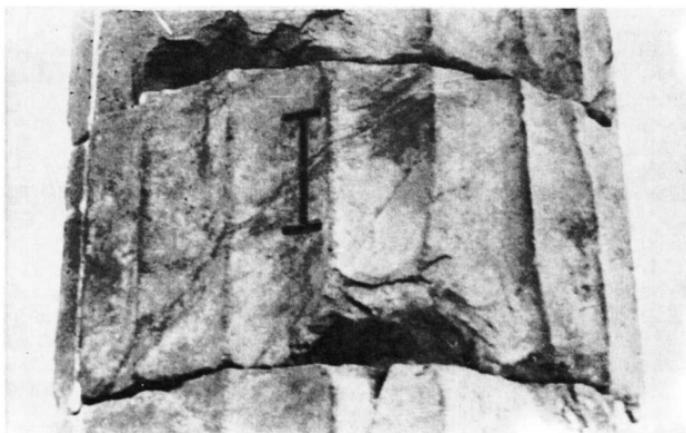
Fig. 4, 5. Fissures et ruptures du marbre provoquées par le gonflement des goujons métalliques.

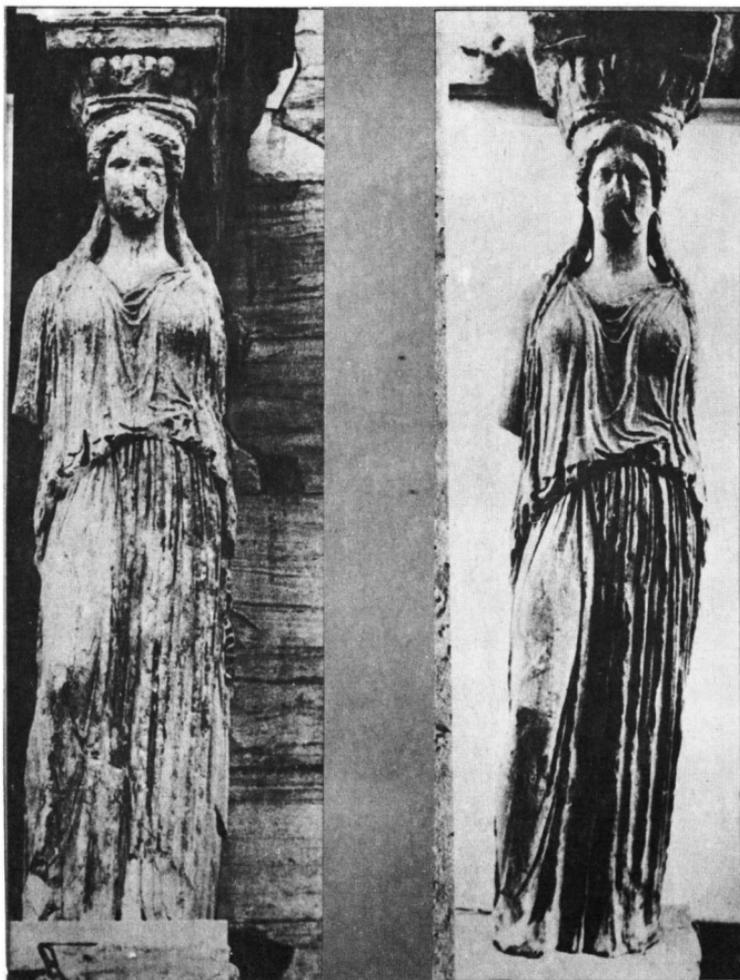
Fig. 12. Comparaison de l'état de détérioration de la même caryatide entre 1955 et 1965.

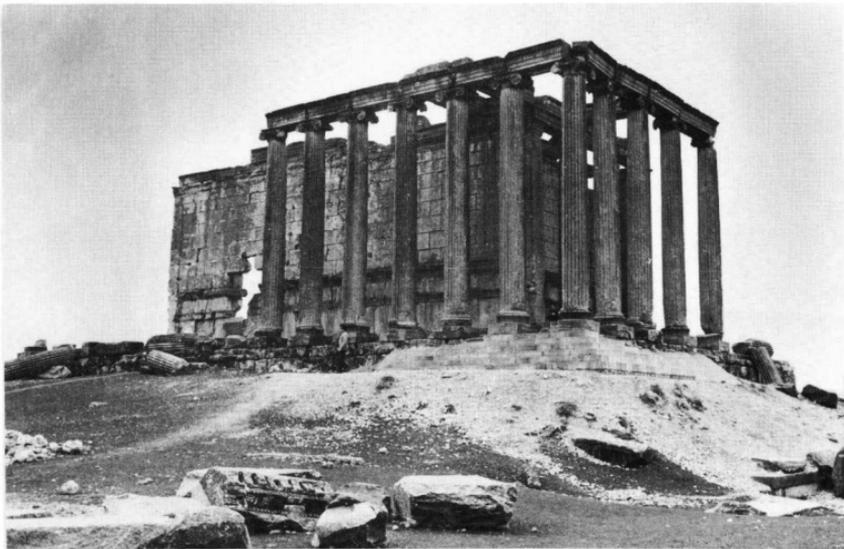
Plate 2. Same view as in Plate 1, shortly after the 1970 earthquake. Notice in Plate 1 the three columns that collapsed had already lost half of the lowest drums which had been repaired.

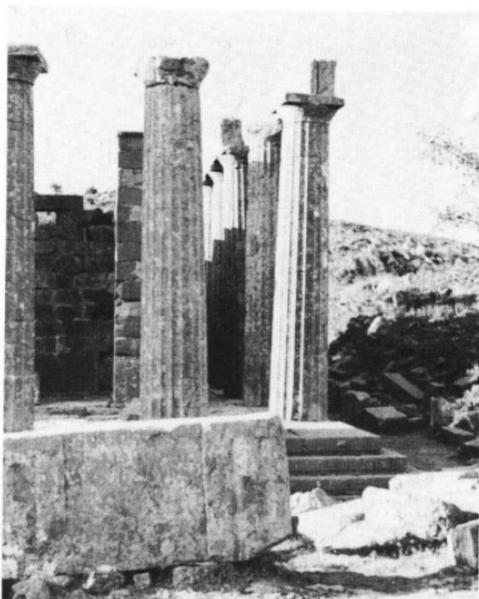
Plate 4. Leaning columns and damaged lintel of the temple of Apollo at Bassai after the earthquake of March 1965.

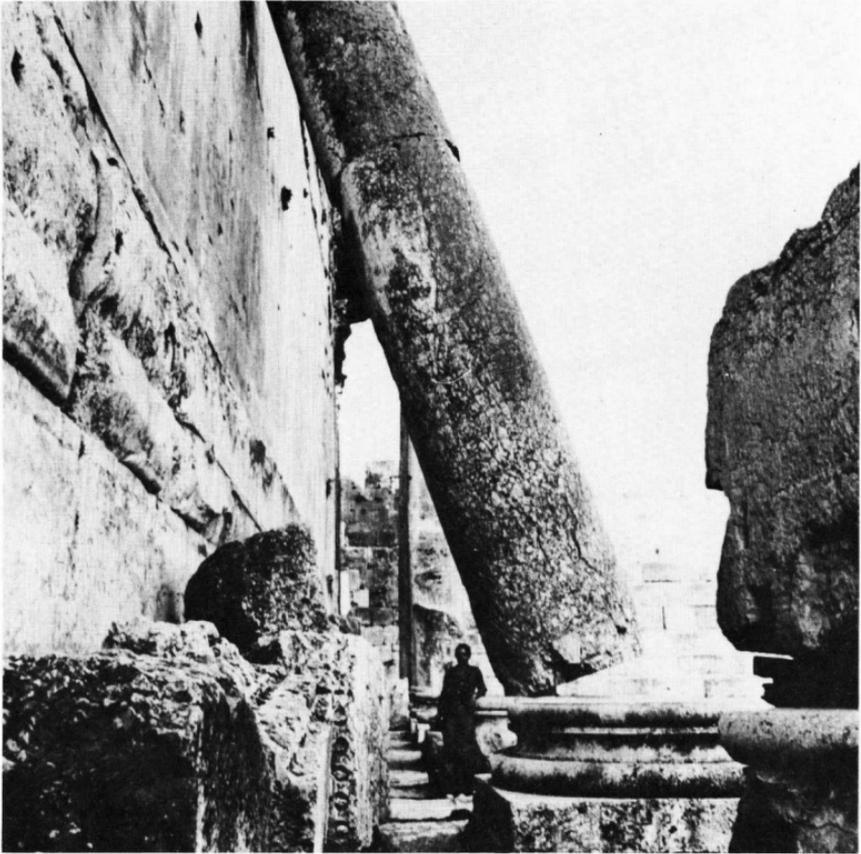
Plate 6. One of the columns of the temple of Bacchus at Baalbek leaning against the cella wall. Notice that inspite of the concentration of stresses at its contact with the base, the drum did not crush nor the upper drum slide at its contact with the lower drum.
