THE ACROPOLIS AT ATHENS

CONSERVATION
RESTORATION
AND RESEARCH
1975-1983

MINISTRY OF CULTURE
COMMITTEE FOR THE PRESERVATION
OF THE ACROPOLIS MONUMENTS

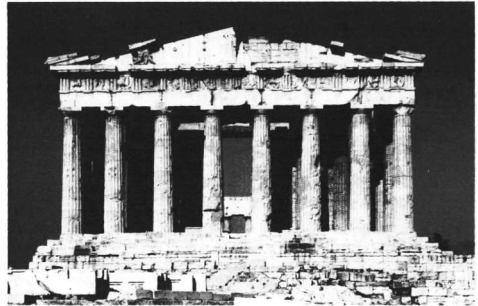
Today all critical assessment of Balanos' work stresses the unlimited use of iron which rusted and swelled in a

very short time as the atmospheric conditions deteriorated, thereby shattering the marble and inflicting terrible damage. In using iron to fasten blocks or fragments together Balanos should indeed have paid more attention to the damage in the Caryatid Porch caused by Paccard's use of iron components, which Balanos had had to replace with brass, and he should have listened to those voices (a small minority) who opposed the use of iron. The criticisms of Balanos' work are justified in this respect.

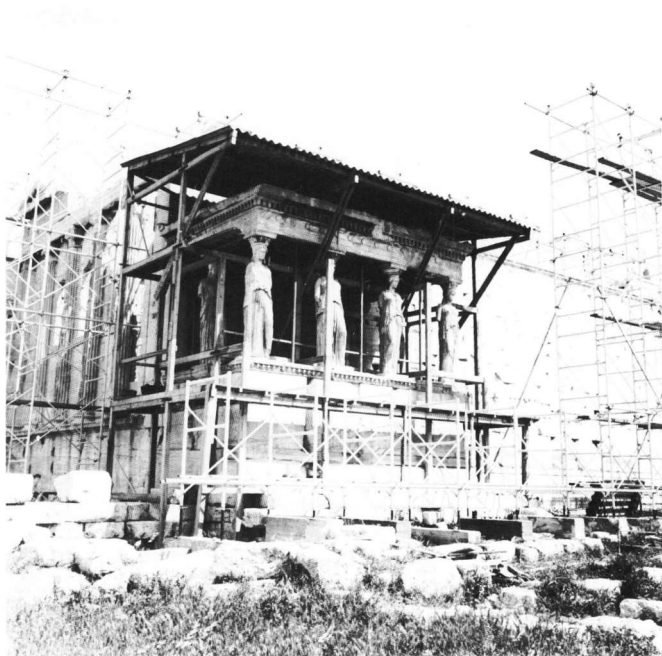
VI.1a

- 1a. Erechtheion**
Temporary wooden covering to protect the Caryatids (1976)
 - b. Parthenon**
Temporary wooden covering to protect the west frieze in situ (1976-1977)
 - c. Parthenon, west facade**
Removing the figures of Cecrops and his daughter from the pediment (1977). Preparations for transport.
 - d. Parthenon, west facade**
Scaffolding erected for removal of the Cecrops group from the pediment.
- 2 a. Propylaia, East Porch**
The ceiling before and after installation of underpinning (1983).
 - b. Propylaia**
Covering the central passage with a protective boardwalk (1978)
 - c. Parthenon**
 - 1. The northeast corner after the earthquakes of February 24th and 25th, 1981
 - 2. Temporary measures for protecting the northeast corner (1981)

Temporary remedies have been applied in respect to urgent static problems. Metal braces are temporarily propping and securing the southeast corner of the Parthenon and a part of the cornice in the opisthodomos, two sections which have been threatening to collapse ever since the earthquake of February 1981. In 1983 the Propylaea received a temporary system of supports until the definitive operation on the ceiling coffers of the East Porch and Ionic passageway shall have been completed. These preventive measures are immediately reversible, the materials are resistant for long periods in the open air and efforts are made to keep the first-aid operations as inconspicuous as possible so as not to spoil the view of the buildings.
