## The Acropolis of Athens : The Restoration Project

The Acropolis of Athens  
The Restoration Project

希腊共和国文化部 • 卫城修复工程部  
HELLENIC MINISTRY OF CULTURE • THE ACROPOLIS RESTORATION SERVICE

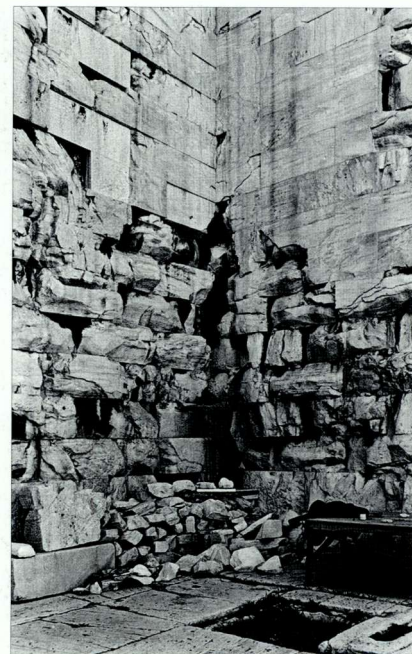
3. (帕特农神庙内殿西北角内部的)大理石因受热不均而破裂
3. Thermal fracturing of the marble (interior of the northwest corner of the Parthenon cella).

- 2-3. 帕特农神庙内殿墙壁因受热不均而开裂。
- 2-3. Thermal fracturing in the cella walls of the Parthenon.

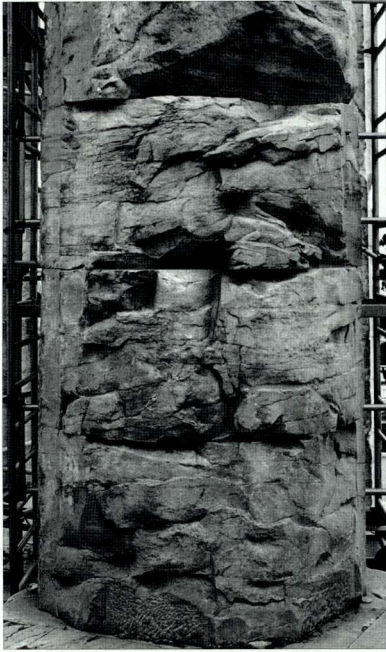
4. 帕特农神庙前殿的一个石柱因受热不均而破裂  
4. Column in the Parthenon pronaos showing thermal fracturing.

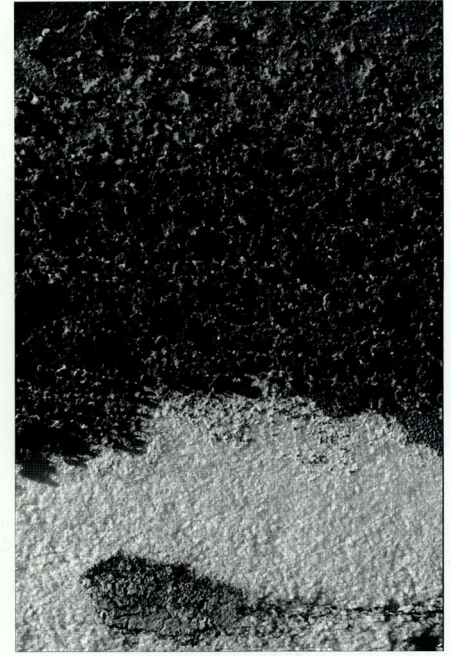
6. 帕特农神庙楣梁下方的大理石水晶面已失去粘着力，并受碳化作用和灰尘的影响，形成了一个黑痂。  
6. Detail of the lower surface of a Parthenon architrave where the marble crystals have lost their cohesion and a dark crust has been formed, caused by carbonization and dust.

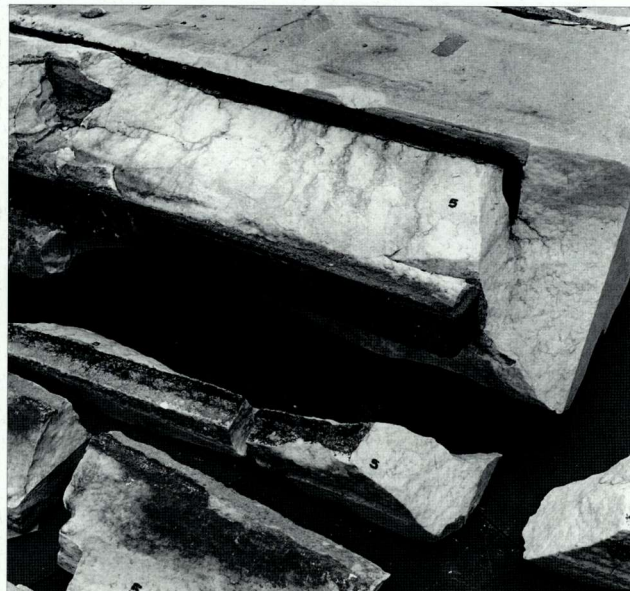
8. 早期修复时使用的铁夹生锈膨胀，导致神庙上楣柱破裂。  
8. Fracturing of the cornice caused by the swelling of rusted iron clamps introduced in earlier restoration.

The first is the rusting of the iron components used extensively in previous restorations. These comprised beams, clamps, dowels and supports that had been set into the ancient marble. During the process of oxidation, the iron components expanded, thus cracking the marble. In some cases, parts of the monuments were in immediate danger of falling off.

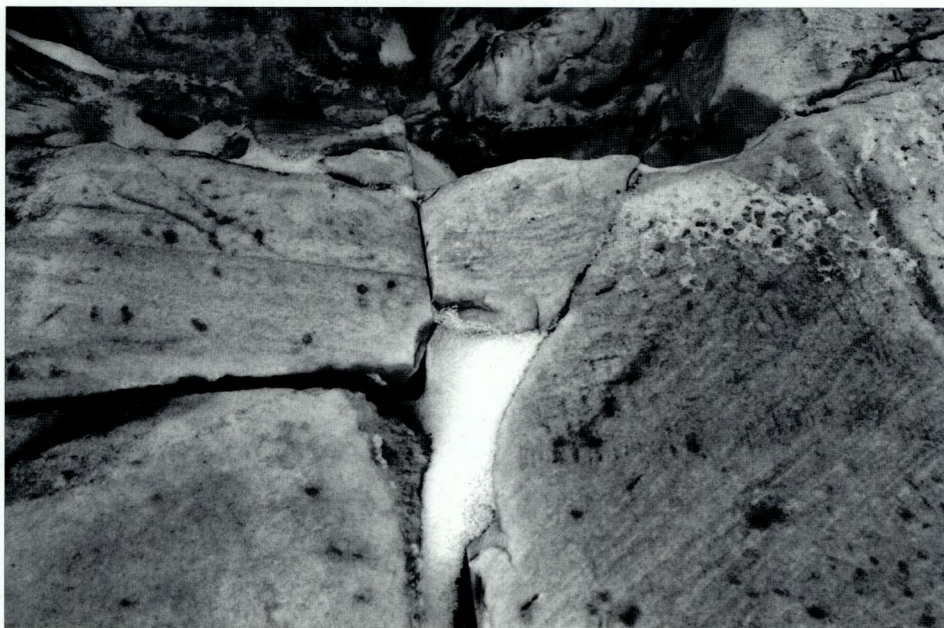
13. 冰冻导致裂缝加宽。  
13. Crack widened by freezing.

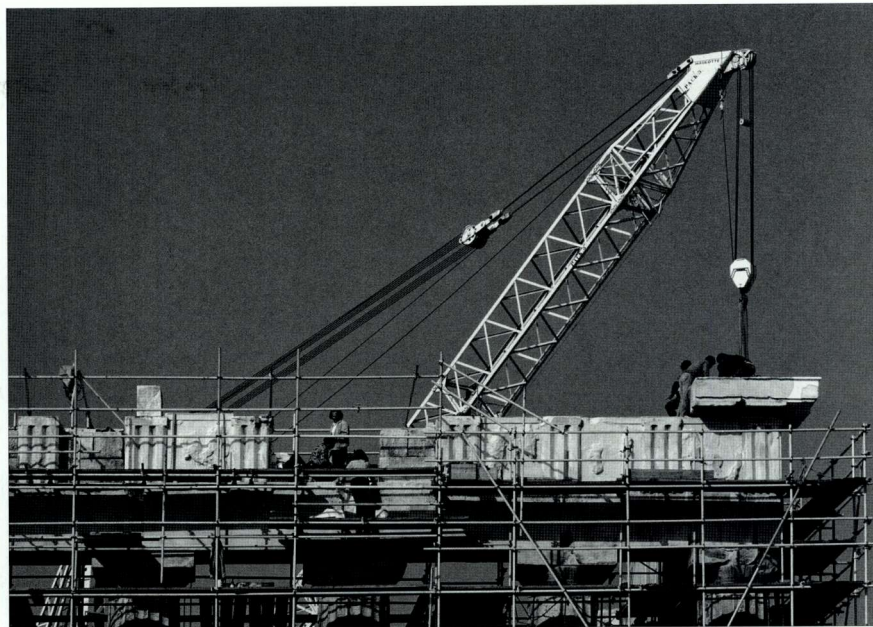
28. 帕特农神庙。正在复位过程中的东端上楣柱（1990年）。  
28. Parthenon. During the re-setting of the cornice of the east end (1990).

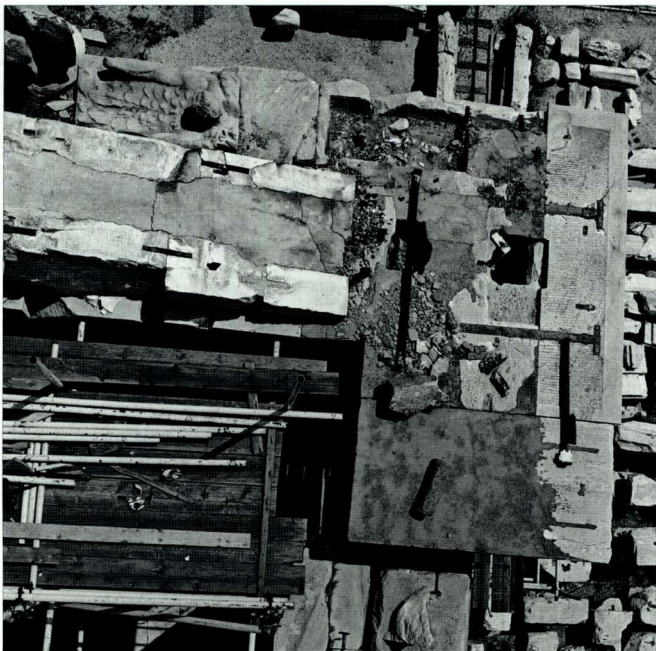
31. 帕特农神庙。在拆除过程中的神庙东南角。水平上楣柱和生锈的铁制加固件清晰可见（1988年）。

31. Parthenon. The southeast corner during dismantling. Visible are the corner horizontal cornice and the rusted iron reinforcements (1988).

Removal of the oxidised iron components of earlier restorations implies dismantling of the architectural members and their re-setting, using new, non-corrosive clamps and dowels. The members that have cracked, either through expansion of the rusting iron pieces or because of earlier damage, are mended and, where necessary, supplemented with new marble. Moving the architectural members has also provided the possibility of joining them exactly, as they were in their original positions, and of carrying out surface conservation.

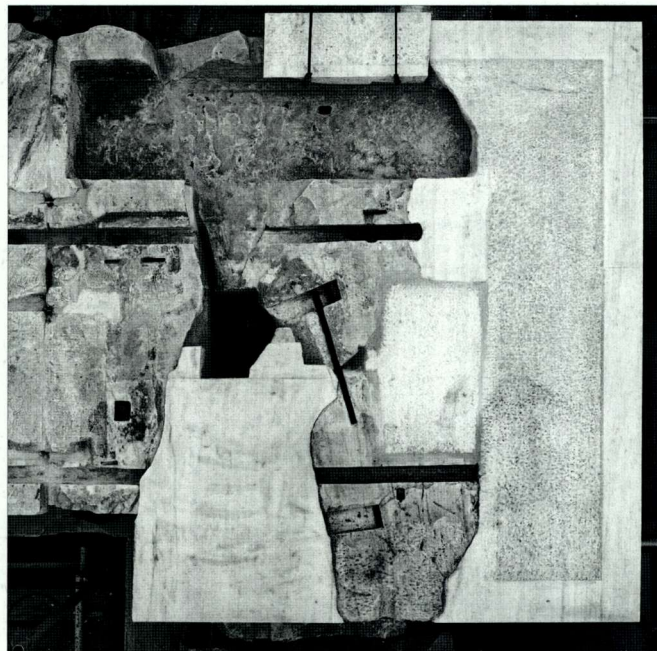
32. 帕特农神庙。复位后神庙东南角上的水平上楣柱（1992年）。

32. Parthenon. The horizontal cornice of the southeast corner after resetting in place (1992).

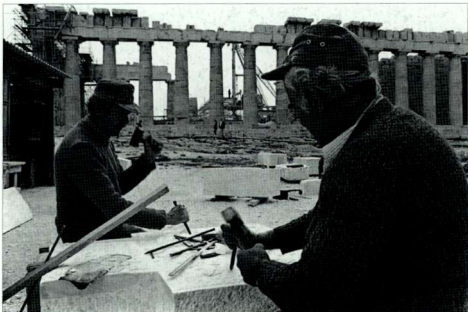
39. 切割伊瑞克提翁神庙的辅助性建筑构件（1985年）。  
39. Cutting supplementary architectural members for the Erechtheion (1985).

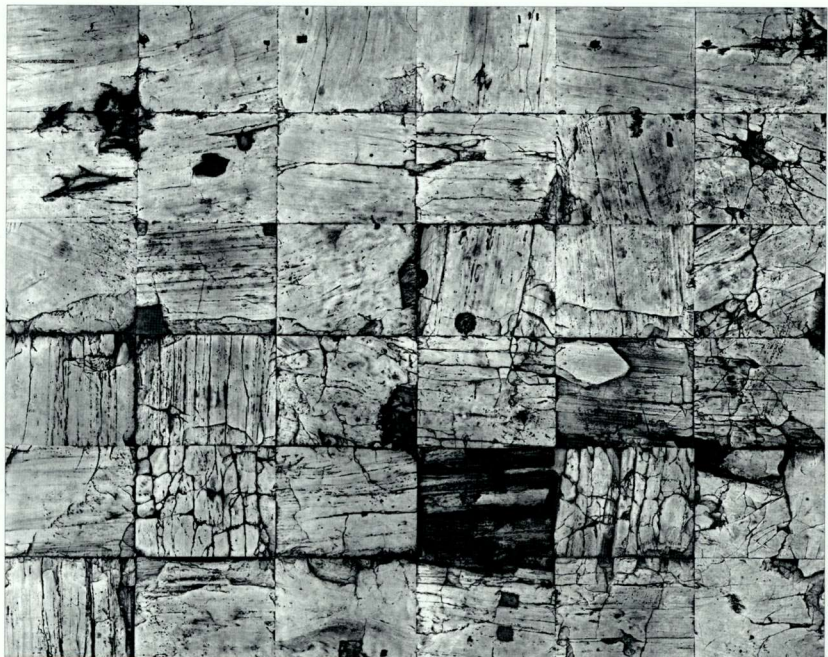
45. 帕特农神庙部分内殿的照片还原情况，在照片中18对板饰均未发生变形。

45. Photographic reconstruction of part of the Parthenon cella floor showing eighteen pairs of plaques, without optical distortion.

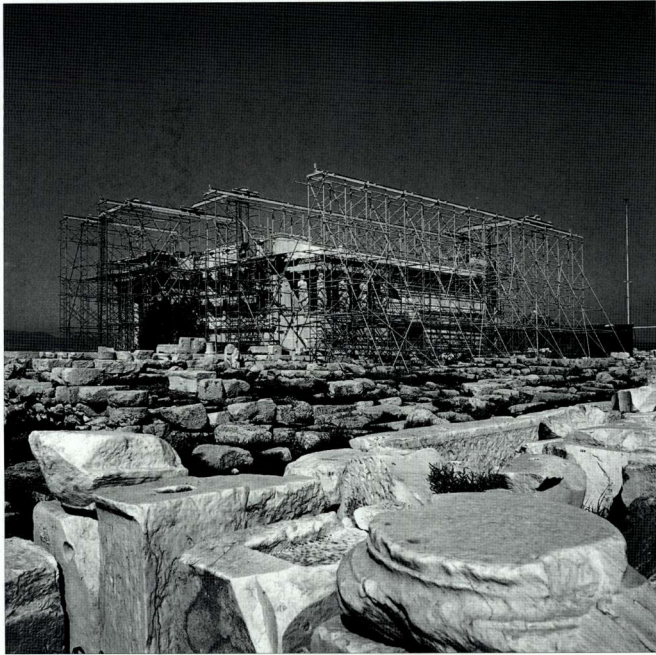
61. 从西南部所看到的，修复期间脚手架和桥式起重机随处可见的伊瑞克提翁神庙情景（1986年）。

61. Southwest view, with scaffolding and bridge cranes during the intervention (1986).

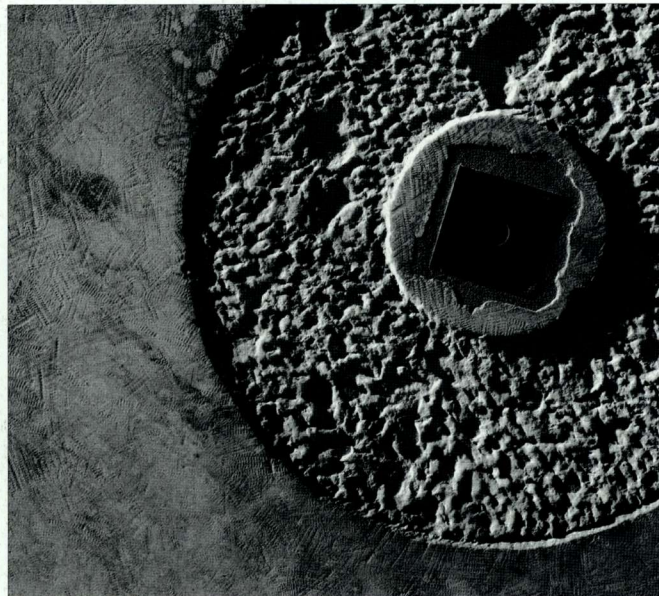
87. 平放着的柱子表面细部，显示有环行的凸起石缘和新的木榫（2002年）。

87. Detail of the resting surface of a column showing the circular anathyrosis and new empolion (2002).

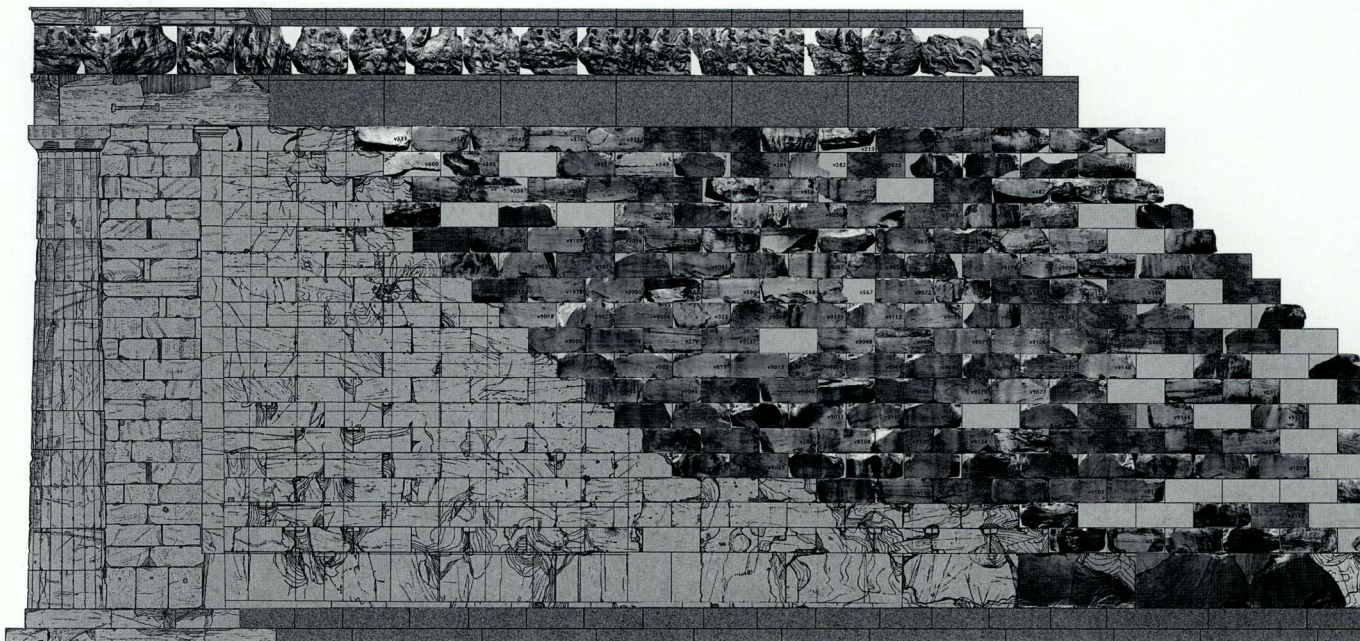
对帕特农神庙内殿南墙进行的修复（图片合成：马夫罗马提斯、帕拉斯奇）。

The proposed restoration of the south wall of the Parthenon cella (Photographic re-synthesis: S. Mavrommatis – C. Paraschi)
