**Conservation of the Surface  
of the  
Acropolis Monuments**

**Committee for the Preservation of the Acropolis Monuments**

**CONSERVATION OF THE SURFACE  
OF THE ACROPOLIS MONUMENTS**

**ATHENS 1994**

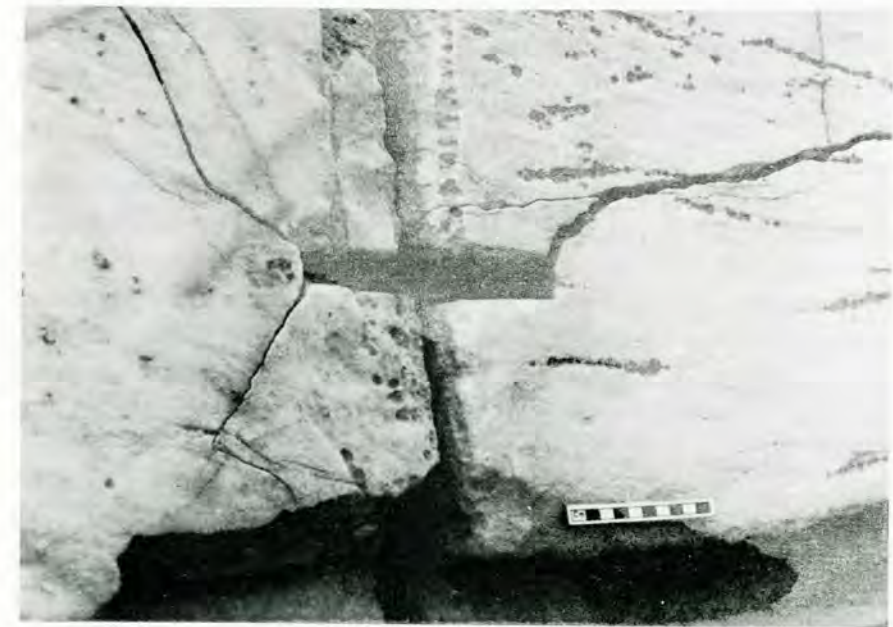
Fig. 1. Cracking of marble due to expansion of the steel junctions.

Metals expand during corrosion. This is caused both by the fact that the molecular volume of the corrosion products in the atmosphere, usually oxides, is greater than that of the metals and by the fact that these products are created on the surface of the metal toward the environment. If the metals are embedded in concrete or marble, strong forces develop during their expansion which cause these materials to crack (Fig. 1-3). The ancient

Greeks understood the phenomenon, which was why they embedded the steel elements used on the Acropolis and other monuments in lead. This method has proven to have been particularly effective, because only 20% of the ancient junctions have cracked the marble, and in these cases the cause was usually poor workmanship and/or the localised dissolution of the lead by the weak nitric acid solution in acid rain; whereas 90% of the junctions installed during the restorations by Pittakis (1837-1843) (bare steel with tips embedded in lead) and Balanos (1898-1940) (steel in concrete) have cracked the marble and continued doing so as the corrosion progressed.

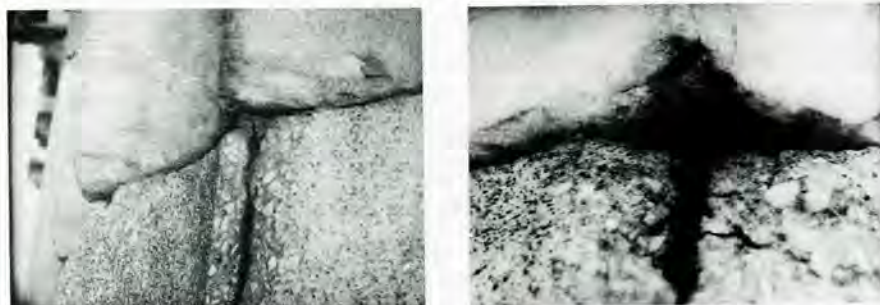
**Fig. 2, 3.** Successive steps in the cracking of concrete and marble owing to corrosion of the steel reinforcement. Detail from Balanos' restoration of a column on the Parthenon.

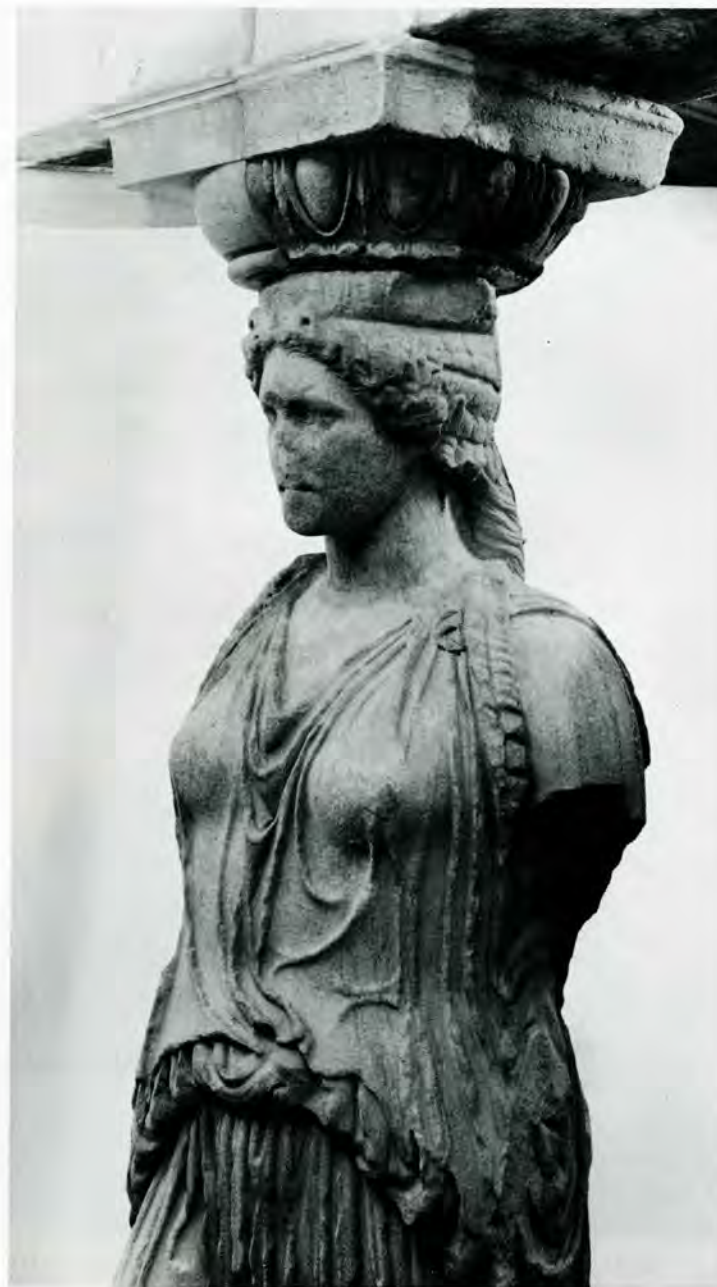
**Fig. 4a.** View of a Caryatid showing the acid attack by acid rain on the front.

The second and third reactions—which essentially describe the attack on marble by sulphuric acid ( $\text{SO}_2$  oxidises into  $\text{SO}_3$  catalytically and, when mixed with rainwater, becomes  $\text{H}_2\text{SO}_4$ ), and by  $\text{HNO}_3$ —are the most destructive. Obviously this reaction is due solely to atmospheric pollution by  $\text{SO}_x$  and  $\text{NO}_x$ , pollutants whose presence has increased significantly in all countries, including Greece, especially after its rapid industrialisation between 1955 and 1965. It is a very fast reaction which takes place only in the presence of rainwater. The mechanisms of these reactions are known. The combination of the three is called “acid attack” and, as has already been pointed out, is caused by “acid rain”. This dissolution process is of course selective, as is usually the case with heterogeneous reactions; it primarily attacks macroscopic and microscopic active centres, i.e. high reliefs, active paths and the grain boundaries of the marble crystals. This type of attack causes high reliefs, such as details on statues and sculpted ornamentation, to dissolve: it causes marble to crack and spall and causes parts to break off because the cohesion of the grains is loosened. This type of attack is shown in the picture (Fig. 4a) of a Caryatid.

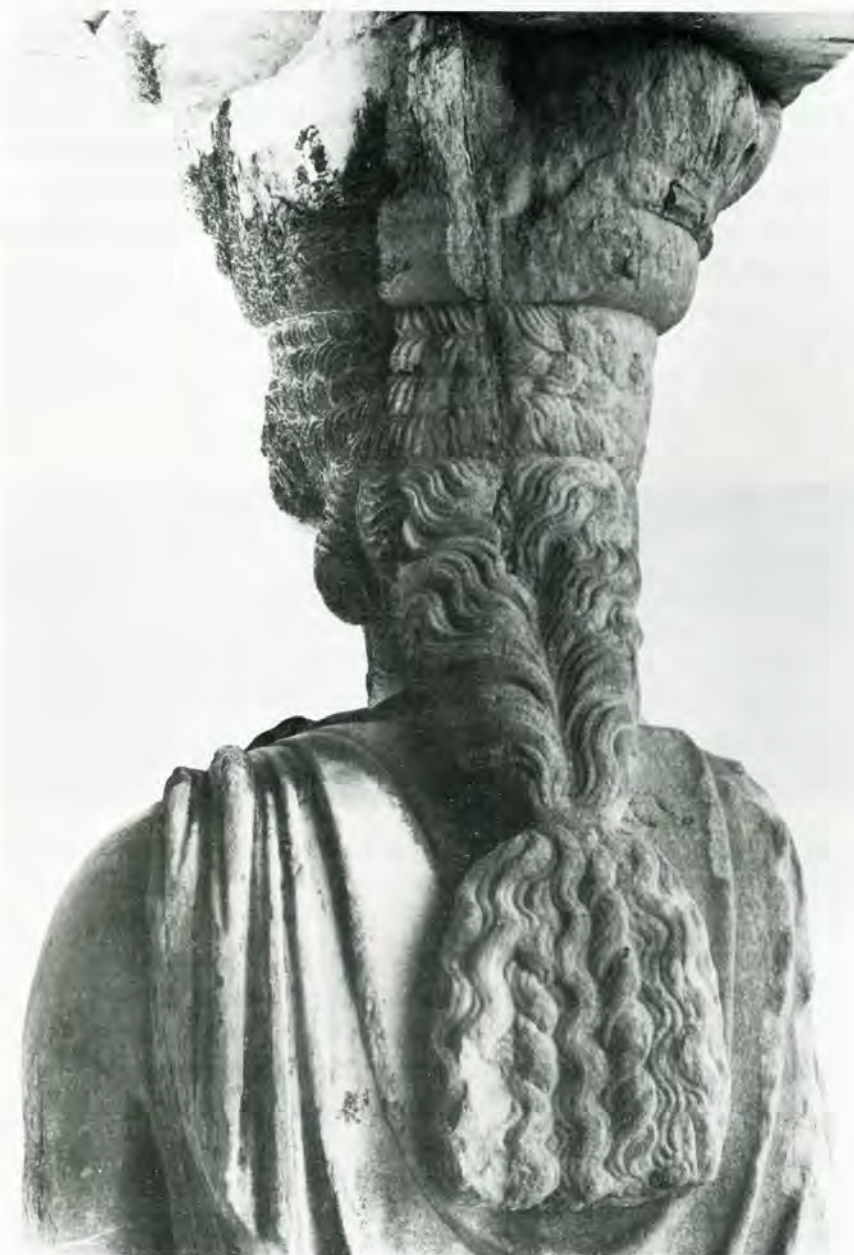
**Fig. 4b.** Sulphation on the back of a Caryatid. Rear surface protected from rainwater.

During the measurements, it was ascertained for the first time in the world (21), that details of the statues are preserved on the gypsum surface (Fig. 4b). If the gypsum was more than a few mm thick, those details would be lost from the surface of the marble (Fig. 6). Consequently, the gypsum films must be stabilised and not destroyed, in order to avoid the definitive loss of details on statues and sculpted ornamentation.

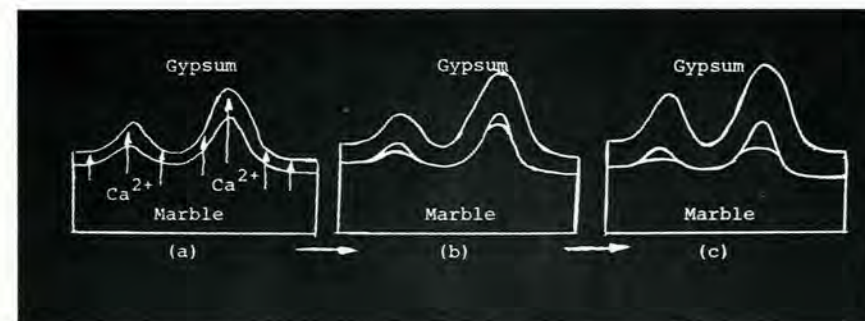
**Fig. 6.** (a) Preservation (with the high relief slightly deformed) of the surface details on the gypsum film due to the sulphation mechanism (diffusion of calcium ions, p. 27), (b), (c) increase in the thickness of the gypsum and creation of cavities under high reliefs caused by the more rapid diffusion of calcium ions; disappearance of details from the marble and from the surface of the gypsum after a certain thickness.

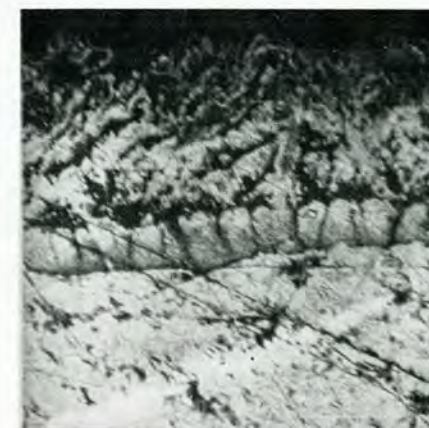
Fig. 7.  $\text{CaCO}_3$  crystals from the conversion of gypsum.

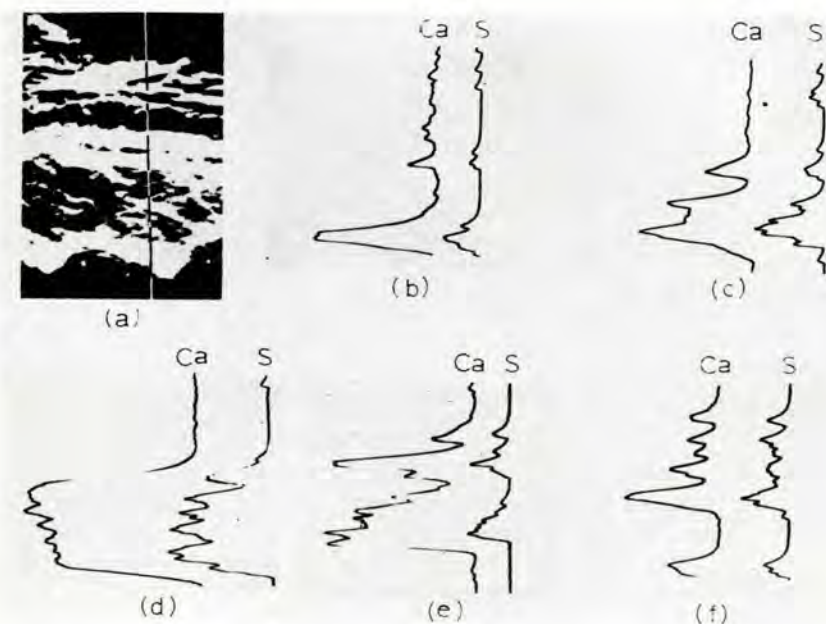
**Fig. 10.** (a) Photograph taken by scanning electron microscope (magnified  $\times 150$ ) of the cross-section of a "protective" polymer on marble; this "protective" coating is  $200 \mu\text{m}$  thick. (b) to (f) show the profile of the Ca and S concentration measured by EPMA on the cross-section of the "protective" coating after exposure to an atmosphere of 50%  $\text{SO}_2$  + 50% air saturated with water vapour, (b) two days later, (c) six days later, (d) 7 days later, (e) 13 days later, (f) 20 days later.

b) The diffusion of  $\text{Ca}^{2+}$  ions was demonstrated by EPMA using a cross-section after the marble had been coated with a polymer (Fig. 10).

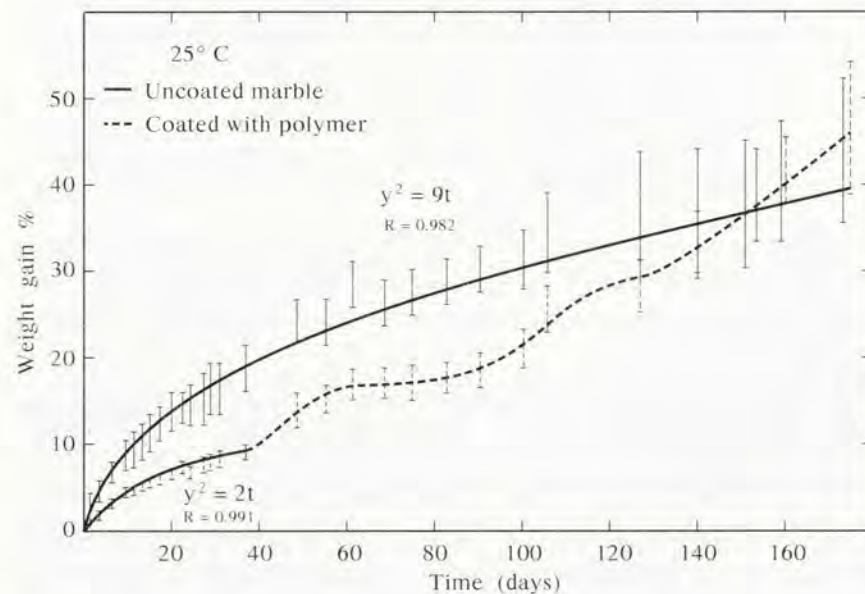
**Fig. 12.** Effect of high concentration of sulphur dioxide, oxygen and water vapour on bare marble (unbroken line) and on marble covered with polymer (broken line). We can see the successive cracking of the coating and acceleration of sulphation.

b) The cracking of all "protective coatings" which were not designed according to the mechanism in order to retard the  $\text{Ca}^{2+}$  diffusion (Fig. 12, 13).

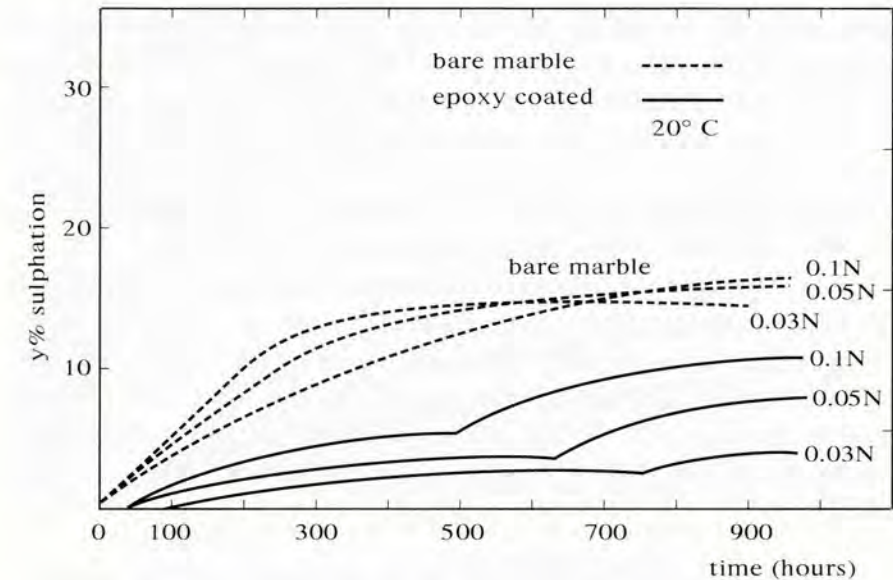
**Fig. 13.** Percentage sulphation of bare marble and marble covered with epoxy at 20°C, for various concentrations of sulphuric acid.

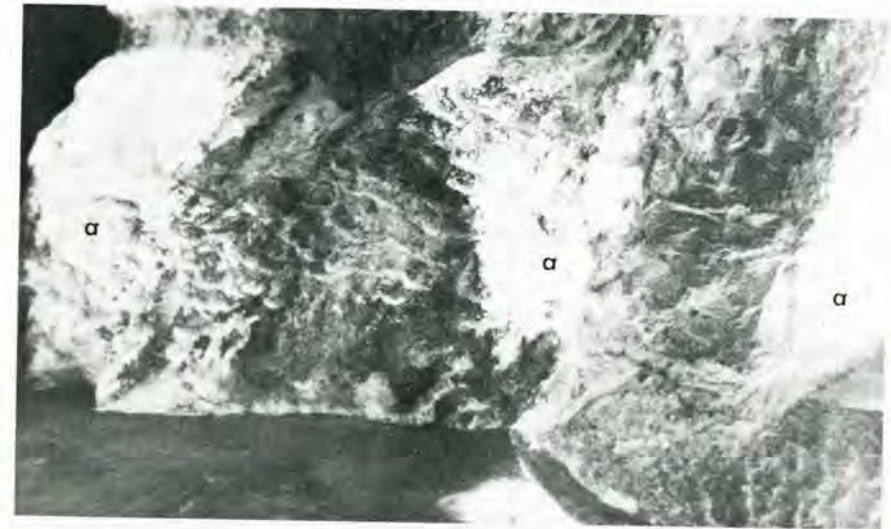
Fig. 17. At points (a) treatment (spraying) was undertaken with a solution of  $\text{K}_2\text{CO}_3$  saturated with  $\text{CaCO}_3$ .

It was also confirmed that the sulphation inversion process simultaneously cleans the surface (Fig. 17), since the molecular volume of the calcite is smaller than that of the gypsum, and the suspended particles which have settled are loosened and removed (51). (See also A.II.3, 4).

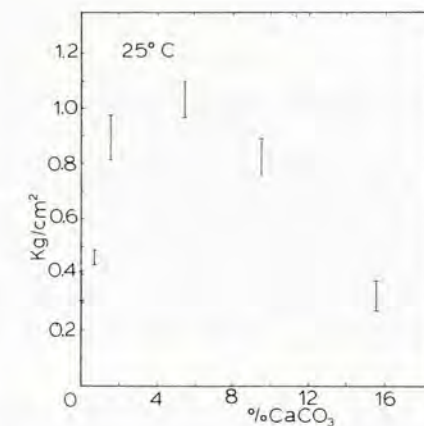
Fig. 20.  $\text{Kg/cm}^2$  for the detachment of marble pieces (which were bonded with lime) as a function of the initial content of  $\text{CaCO}_3$  in the lime (for a conversion  $\text{CaO} \xrightarrow{\text{H}_2\text{O}} \text{Ca(OH)}_2 \xrightarrow{\text{CO}_2} \text{CaCO}_3 > 90\%$ ).

$25\% \text{CO}_2$ , in an artificial environment, which can be achieved both in the conservation laboratory and *in situ*. Finally the  $\text{CaCO}_3$  content in  $\text{Ca(OH)}_2$  (auto-catalysis) offers maximum resistance when  $\text{CaCO}_3$  is 6% of the solid lime (Fig. 20).

This method (addition of  $\text{CaCO}_3$ ) is already in use on the Acropolis monuments (Fig. 20) and in the museum ( $\text{CaCO}_3$  and  $\text{CO}_2$ ). Sometimes white cement is added to the lime to improve its mechanical properties, especially because if the  $\text{CaCO}_3$  is converted to  $\text{CaSO}_4 \cdot 2\text{H}_2\text{O}$ , over a long period, the parts which were attached will stay in place and will not fall off.

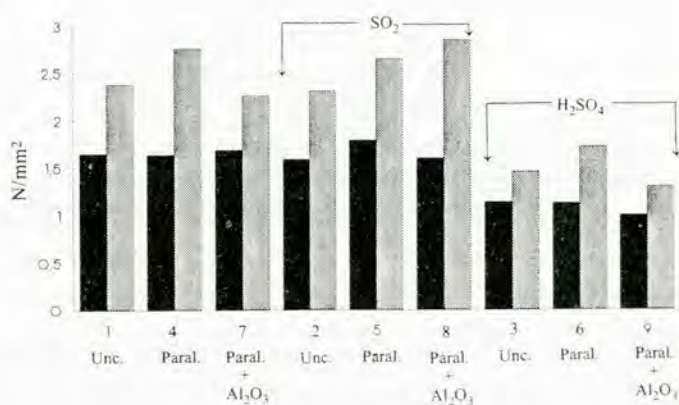
Fig. 22. Histogram of the load to failure—pretreatment.

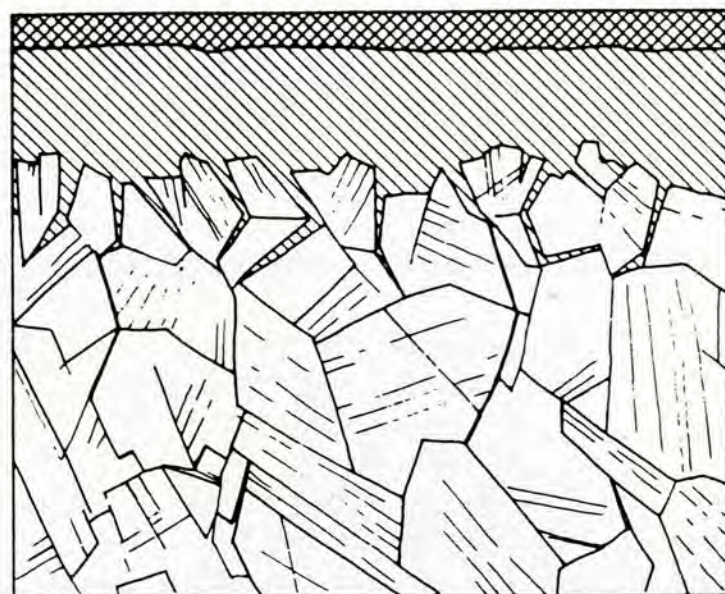
**Fig. 23.** *Cross-section of sulphated, stained marble.*

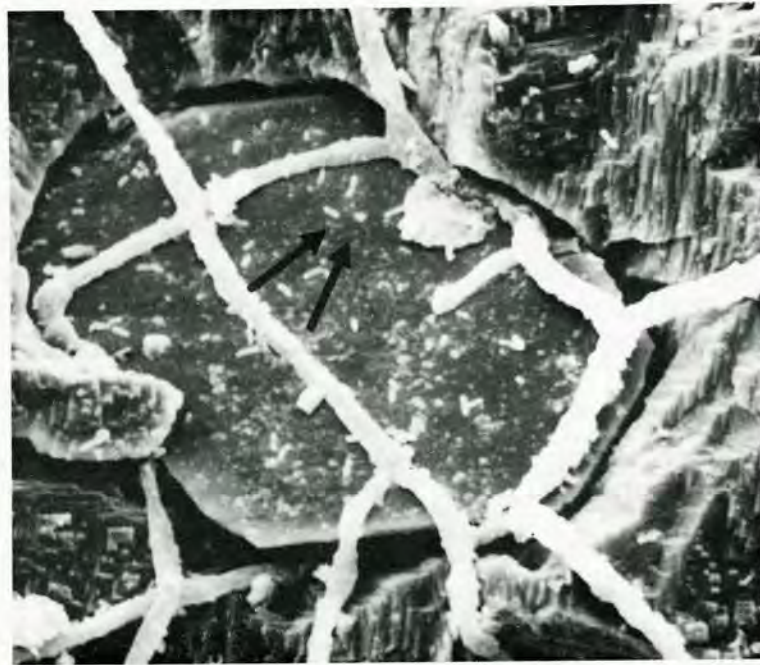
**Fig. 24.** *Biological attack. Fungi penetrating under a marble grain and detaching it. Parthenon. (Scanning electron micrograph, Krumbein).*

It was found that the contribution of the biological factor to the physico-chemical decay of the marble was significant. The epilithic and chasmolithic microflora on the Acropolis marble play a large part in tinting the Pentelic marble, which was initially white. This colour alteration is mainly due to the pigments of the microorganisms and less so to the inorganic particles (soot) deposited on the marble. Secretions of organic acids and other corrosive substances by some microorganisms cause the calcium carbonate to dissolve and exacerbate the existing situation. In addition, most of the microflora provoke damage through various mechanisms by exerting minute pressures on the marble, extending the network of tiny cracks and creating microscopic cavities (Fig. 24, 25).

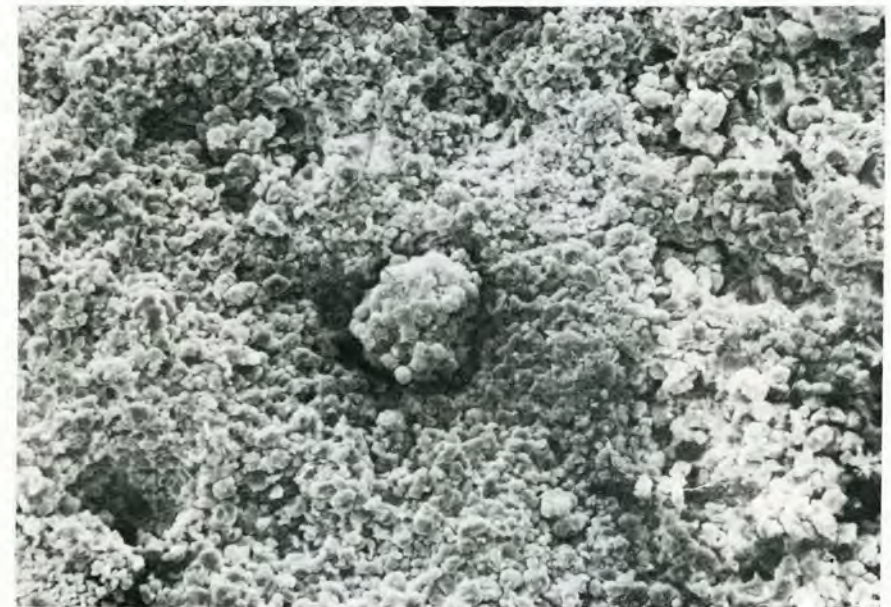
**Fig. 25.** *Biological attack. Marble "pitting" by black yeasts. The yeasts have a shape similar to Pentelic marble crystals and penetrate deep, sometimes also by hyphae formation. Theatre of Dionysus. (Scanning electron micrograph, Krumbein).*

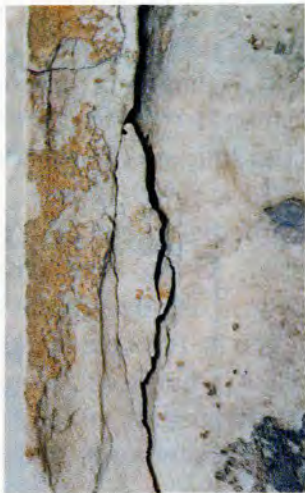
**Fig. 27.** *Delamination.*  
Detail from a Parthenon column.

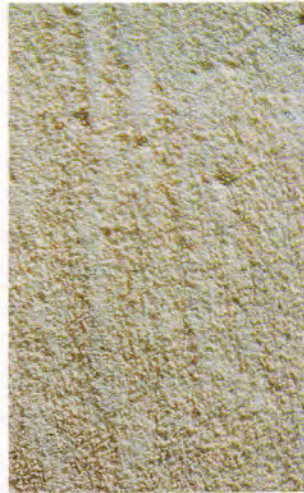
**Fig. 28.** "Sugaring"

d) *"Sugaring"*: Intergranular decohesion and loss of marble crystals from the surface (Fig. 28).

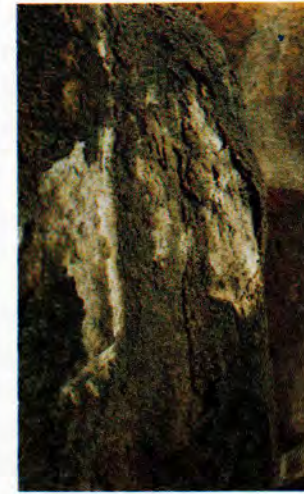
**Fig. 29.** *Disintegration of the marble in conjunction with deposits of soot and the formation of black crust.*

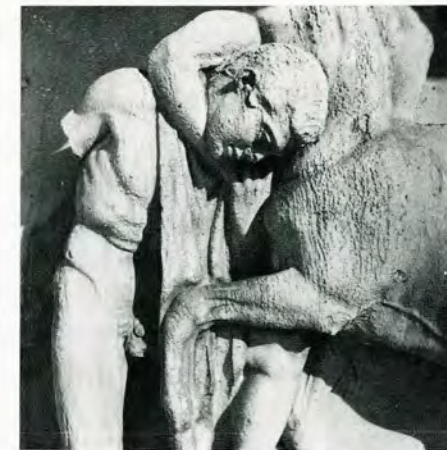
**Fig. 31.** *Differential weathering.*

g) *Differential weathering*: Non-uniform reduction of the marble surface, determined by the geological heterogeneity of the material (Fig. 31).

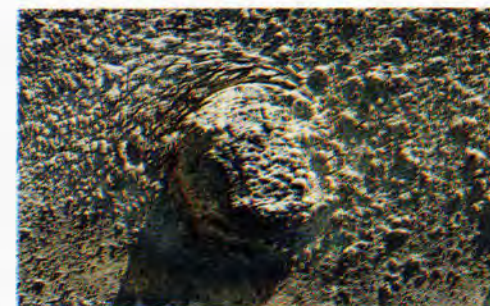
Fig. 33. *Black dendritic crust on a Parthenon mutule..*

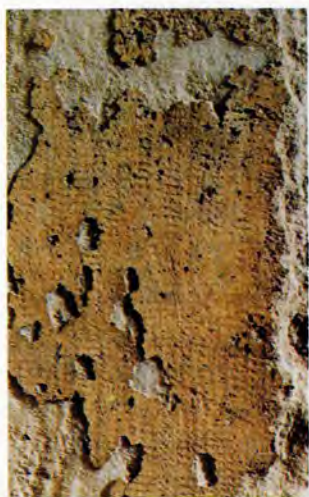
**Fig. 34.** Detail of orange-brown layer on the Parthenon.

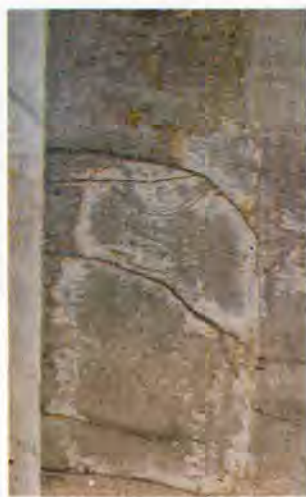
**Fig. 35.** Engraved ship on a Parthenon column (graffiti).

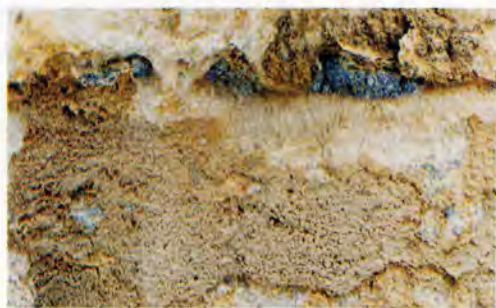
**Fig. 36.** Egyptian blue can be discerned under the beige coating. A.T.P. 13. Parthenon.

Traces of ancient painted decoration are preserved today in a fragmentary form on the surface of the monuments (57, 74) (Fig. 36).

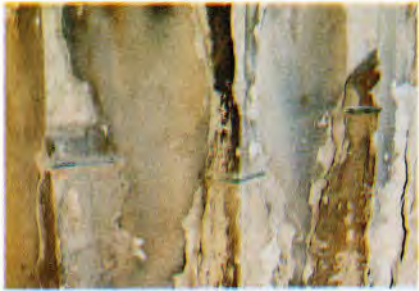
**Fig. 37.** Detail from previous consolidation intervention in 1922-1933 with Meyer cement and copper rivets. Parthenon A.K. 2.11.

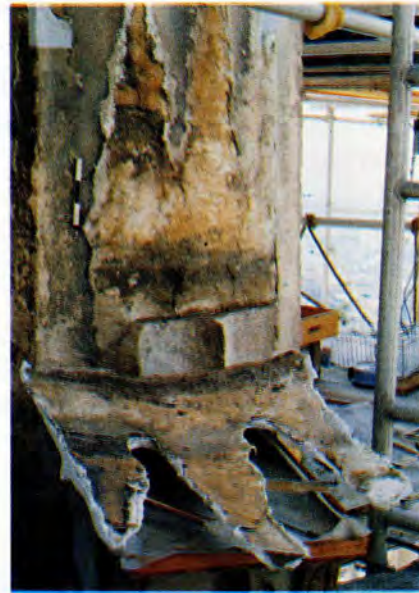
**Fig. 38.** Same region as shown in Fig. 37, after the delaminated piece has been detached. Parthenon A.K. 2.11.

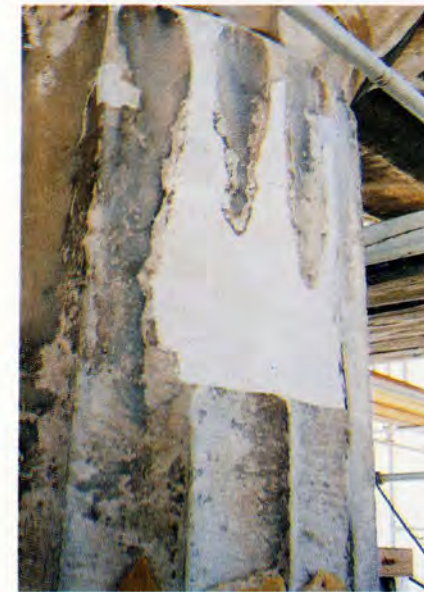
**Fig. 39.** The delaminated area after cleaning of the broken surface. A.K. 2.11.

a) *Attachment:* The fragments of marble which have become loosened or detached are cleaned on the broken surface and attached with white Portland cement. When the fragment is in good condition, the bond is reinforced with a titanium dowel. When spalls or small flakes are to be attached, a mortar of reduced strength is used consisting of a mixture of cement and lime with the addition of 6%  $\text{CaCO}_3$ . (54).

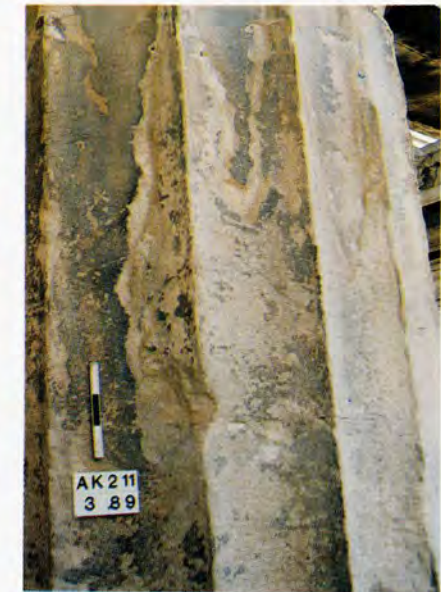
**Fig. 40.** After the reattachment of the delamination. Parthenon A.K. 2.11.

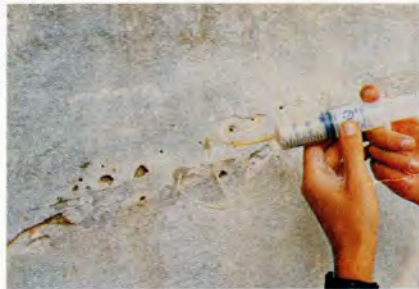
**Fig. 41.** Injection grouting of internal cavities. Propylaea. B-Δ.0.6.

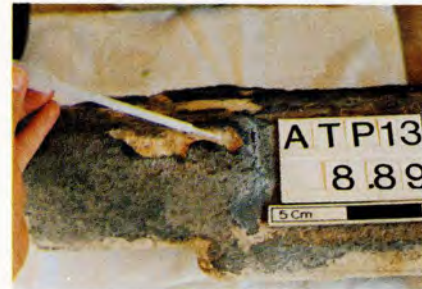
**Fig. 42.** Impregnating disintegrated marble to restore the coherence of the crystals.

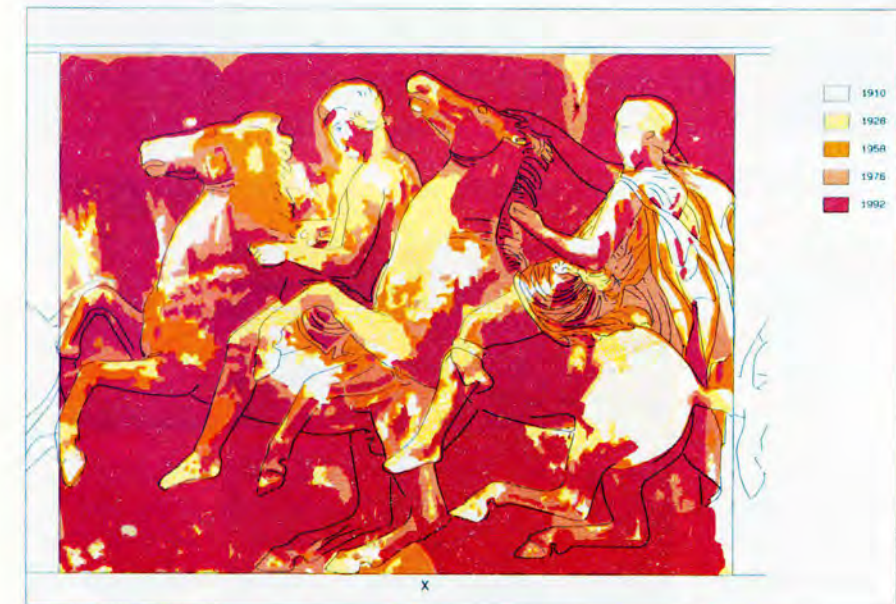
Fig. 46. West frieze of the Parthenon. Block X. Ancient surface layers. Comparison over time 1910 to 1992. (Mapping A. Galanou, Y. Dogani).

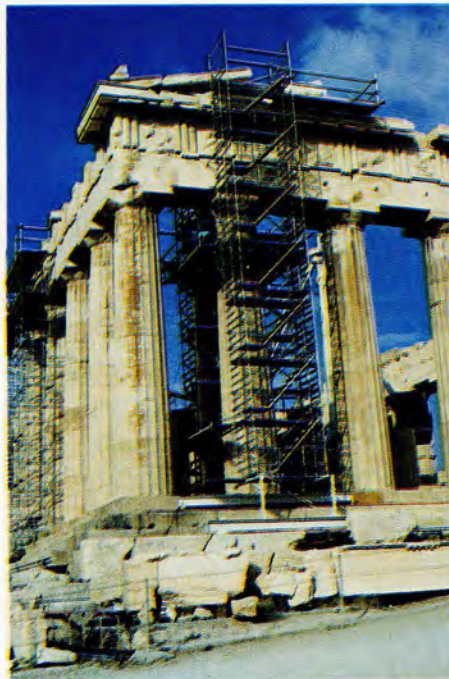
Fig. 47 View of scaffolding on east side of Parthenon.

- a) Scaffolding (Fig. 47) and special tool kits for *in situ* work on the monuments.
- b) On site workshops
