M. Ioannidou, Research and technology in the restoration of the Acropolis

Ch. Bouras, The work of the Acropolis Restoration Service in 2004

News Letter of The Acropolis Restoration Service of the Hellenic Ministry of Culture

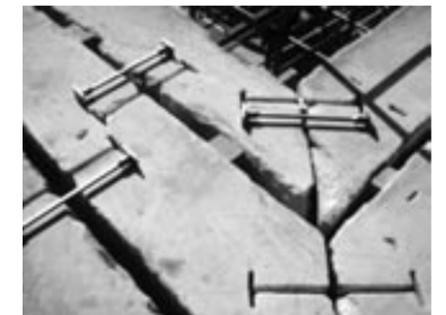
The new titanium clamps that replaced the iron ones of the Balanos' restoration. Photo S. Mavrommatis

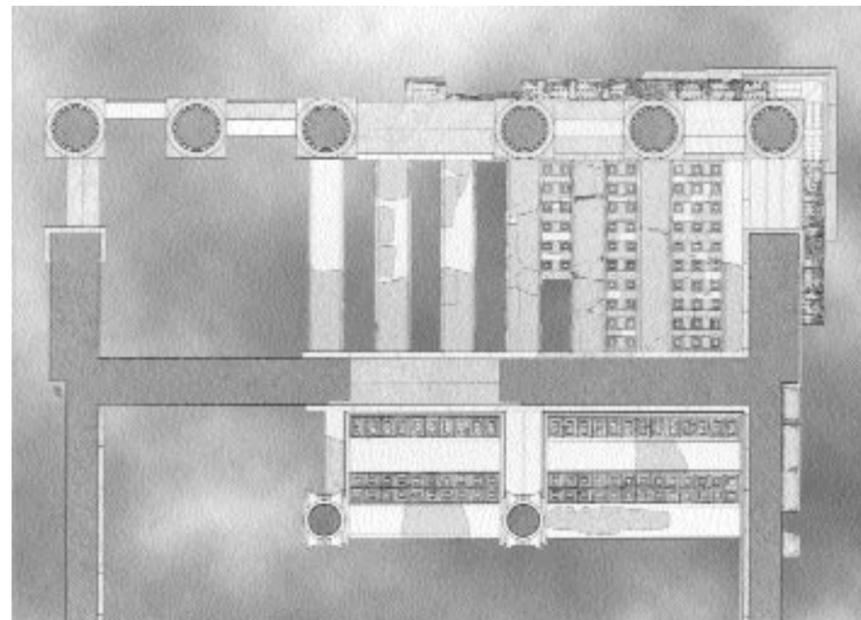
Propylaea. Proposal for the restoration of the coffered ceilings. View from below. Photorealistic drawing Th. Moutopoulos

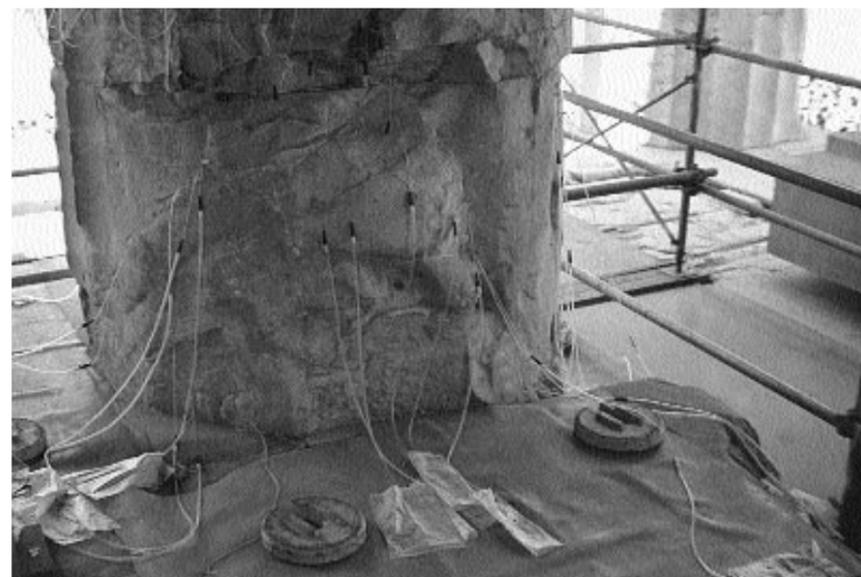
Parthenon. Structural restoration of the drums of the opisthonaos columns with hydraulic grouting. Photo A. Panou, 1998

- Development of original and new applications in the course of the works. Representative examples are: 1. repair *in situ* of the cracks in columns of the Parthenon Opisthonaos caused by thermal fracture in antiquity. In order to avoid dismantling them and to retain their authentic structure, after research, the cracks in the drums were injected with an hydraulic grout especially prepared for this purpose. 2. Cleaning of the surfaces of the dismantled blocks of the Parthenon west frieze with an original Laser system working on two wave lengths (infrared and ultraviolet) with different levels of power. By means of this original system, developed by the Institute of Electronical Structure and Laser of the Technological and Research

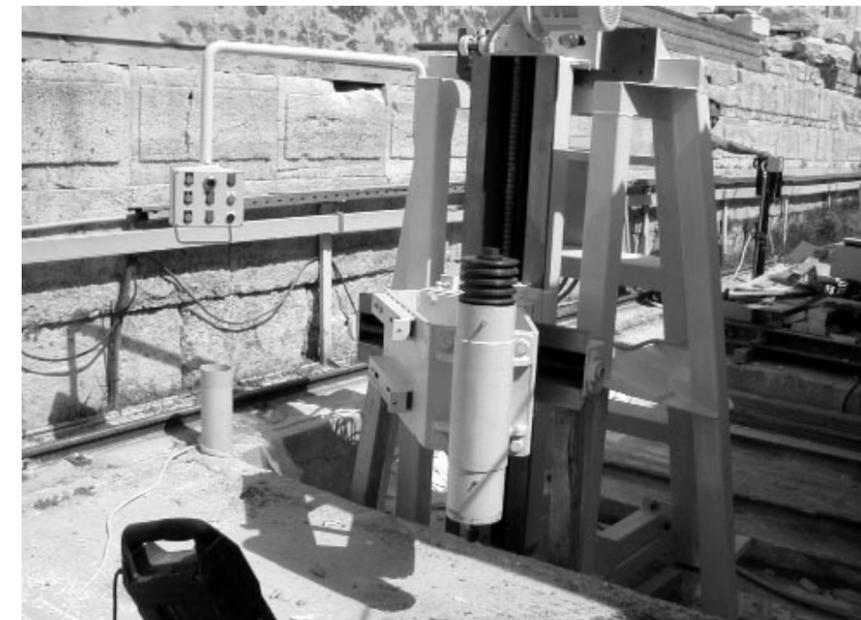
Parthenon. Machine for cutting the flutes of the column drums in new marble. Photo Sp. Oikonomopoulos, 2002

It should be noted also that for cutting the flutes of the columns of the north side, the machine designed by the mechanical and electrical engineer, Mr. Spyros Oikonomopoulos, has been used with great success. Moreover, in order to accelerate the work a second pantograph was acquired, the bridge-crane was redesigned so

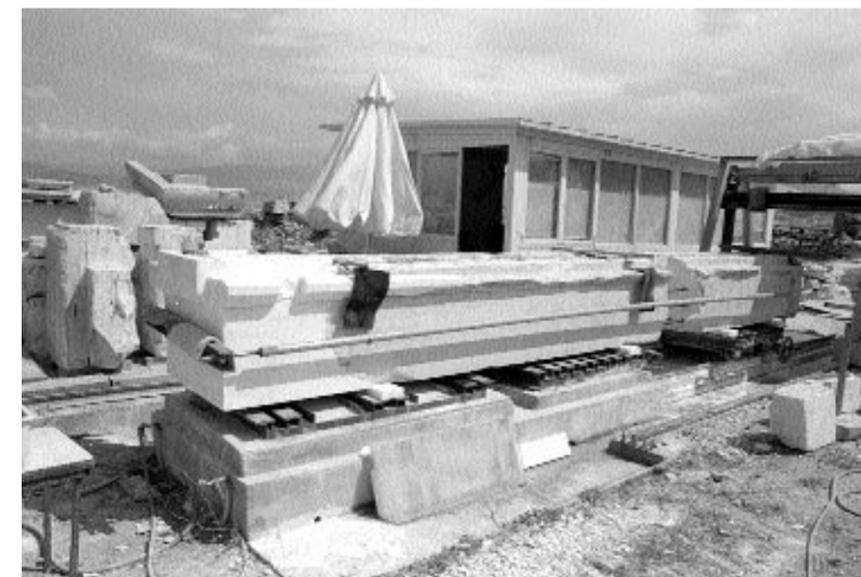
Propylaea. Structural restoration of a ceiling beam using a steel wagon on rails. Photo K. Karanasos, 2004

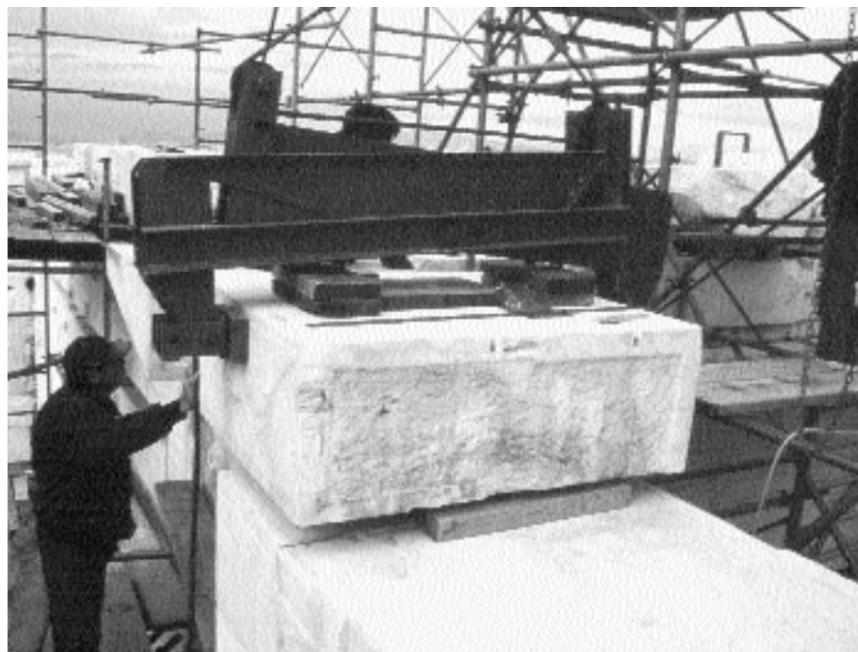
Propylaea. Dismantling of blocks using a special suspension cramp. Photo K. Karanasos, 2001

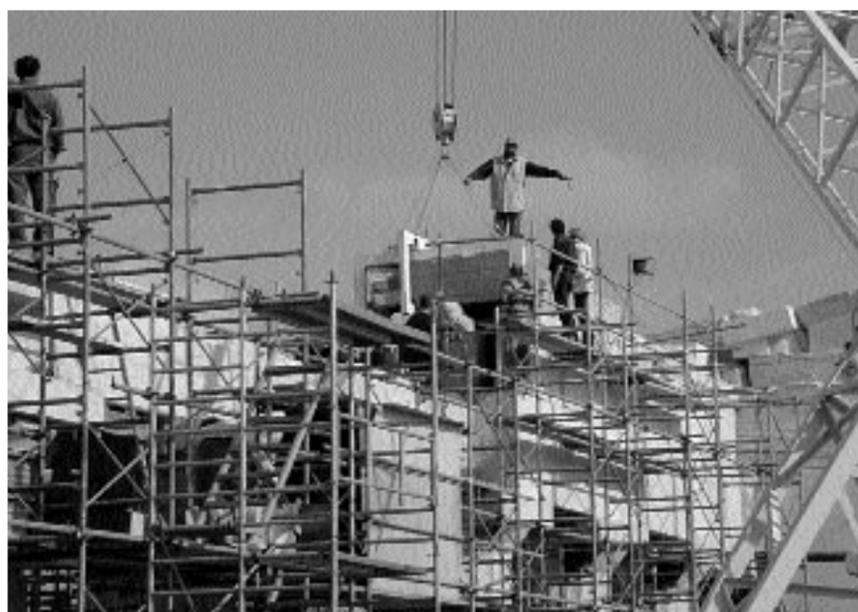
Parthenon. Dismantling of the cornice of the north colonnade using a special suspension cramp. Photo L. Lambrinou, 2001

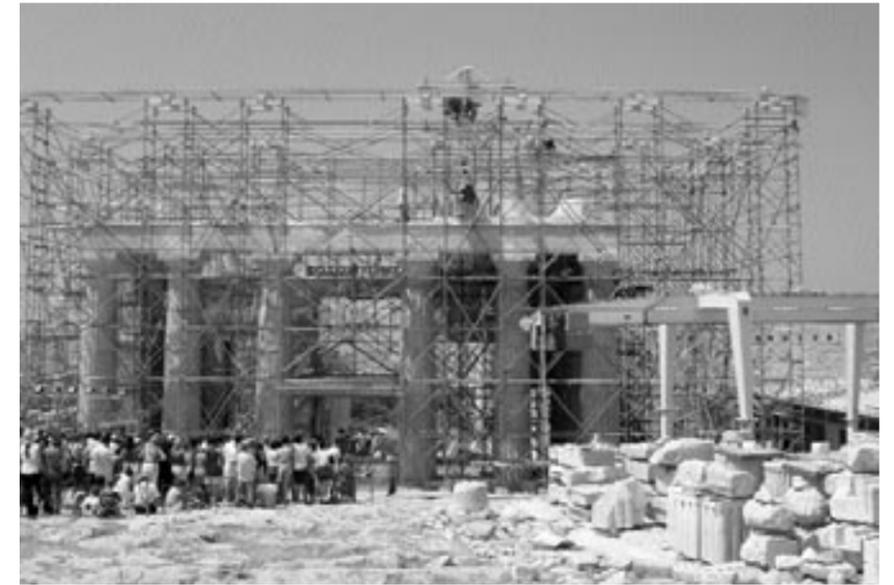
Propylaia. The east portico from the east, with the ceiling beams of the north section restored and in place. Photo T. Tanoulas, August 2004

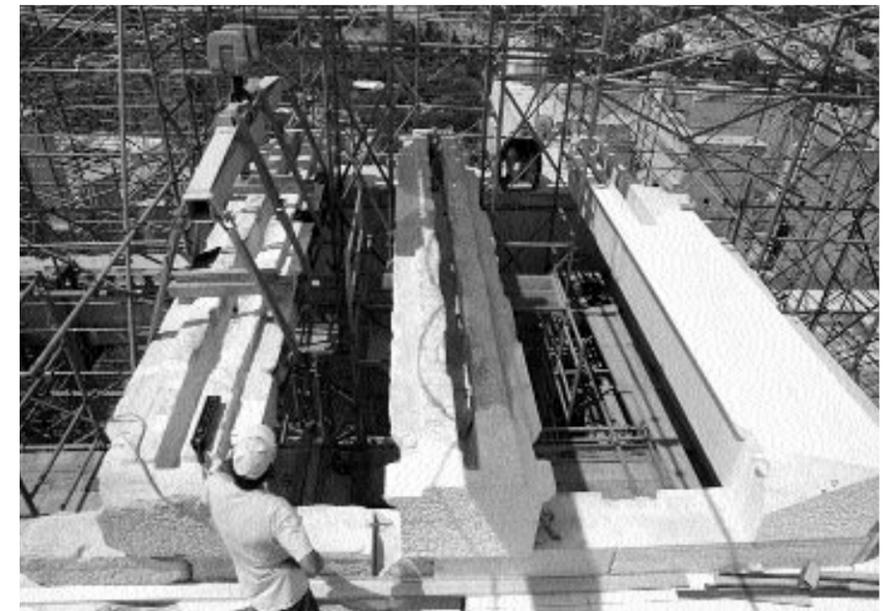
Propylaia. The three north ceiling beams of the east portico restored. Photo V. Papavasileiou, 2004

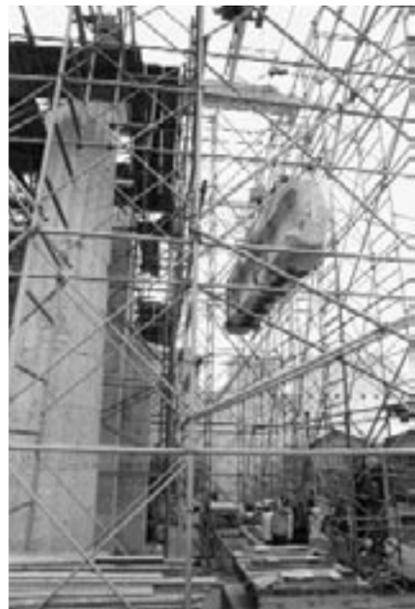
Propylaea. Resetting the central architrave block of the east portico. Photo. K. Karanassos, 2004

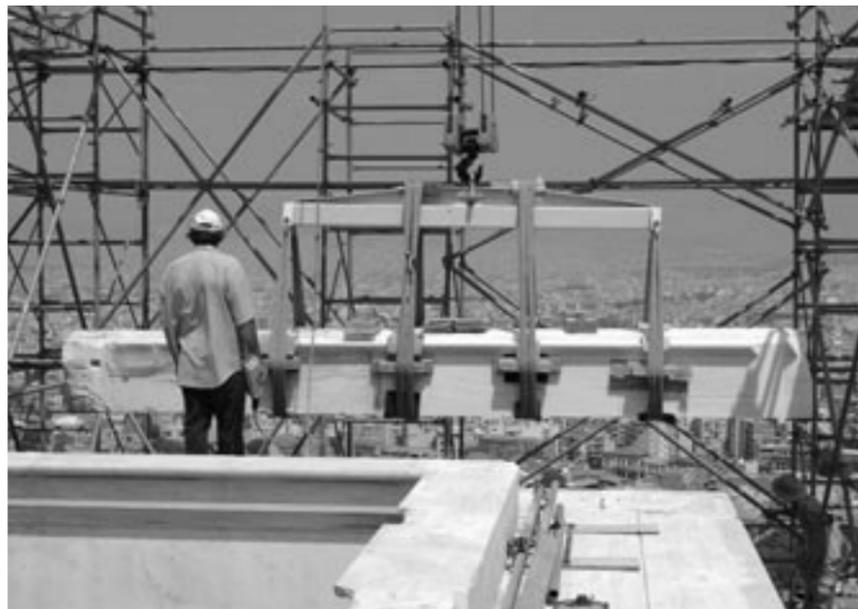
Propylaea. Resetting a wall beam of the east portico. Photo. K. Karanassos, 2004

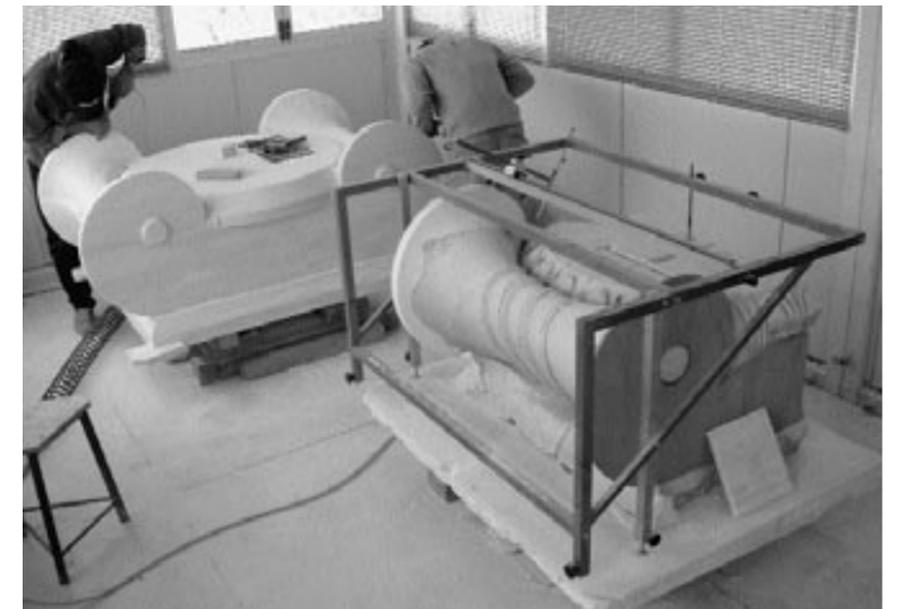
Propylaea. Cutting the Ionic capitals of the western hall of the central building in new marble. Photo T. Tanoulas, 2004

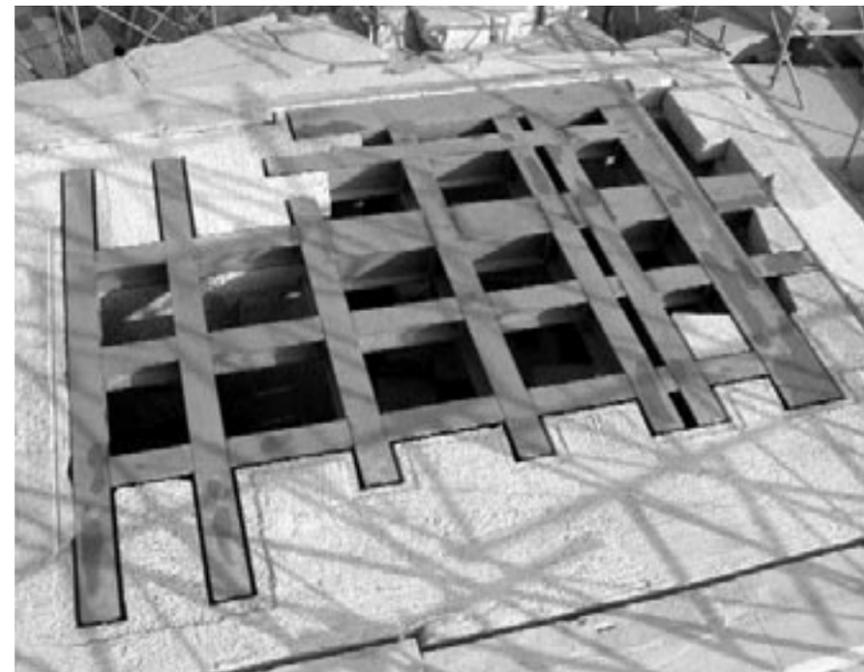
Athena Nike Temple. Steel grid for supporting the classical building. Photo K. Mamaloungas, 2004

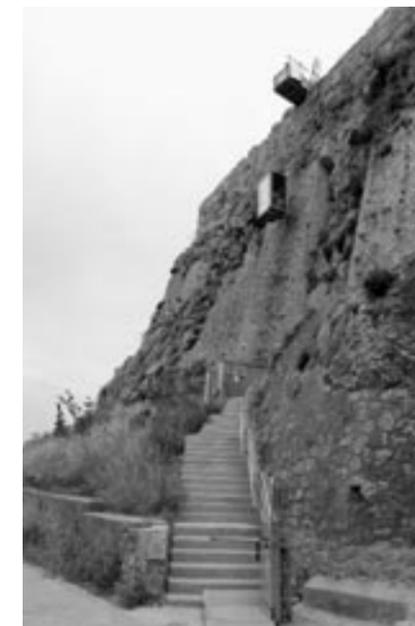
The lift for the disabled on the north slope of the Acropolis. Photo P. Konstantopoulos, 2004

Concerning the technical details of the system, the following may be noted: the lift, installed by the “B-Lift VALSAMIDIS” company, spans a 25m height from the

The whole power unit and control gear are fixed to the cabin frame and follow it as it travels. There is no engine room, only a roofless ground station booth. Electric power is supplied through an electric cable, following the upward movement of the cabin through special guides, while on its way down it is coiled into a barrel in the ground station. The 4kW electric motor is inverter controlled, securing progressive starting and braking. The motor is equipped with a spring loaded safety brake, that applies automatically in case of power failure, and can be released by a hand operated lever to park the cabin at the ground station by gravity, and release the passengers.

The lift, type P600, is made by the Italian company “CIMAR Ponteggi S.p.A.”, licensed by the Swedish company “ALIMAK AB”. It has a 5-person or 600kg load capacity. The cabin floor dimensions of 1m x 31,5m allow the simultaneous transport of a wheelchair and three standing passengers (including the operator). Two upwards sliding transverse doors 0,93m broad are used to enter and leave the cabin (west at the ground and east on top). The doors have a steel frame and a dense strong grid, allowing visibility and low wind resistance. The cabin speed is 0,43m/s, covering the vertical distance of 25m in approx. 1min.

A construction-site lift travelling along a trussed mast of small cross-section without “well” or engine room was considered suitable. Additional advantages of this type of lift are: the suspension of the motor mechanism from the cabin frame, allowing easy safety-parking of the cabin at the ground, stop by the operator in case of power failure, and the availability of a type with a

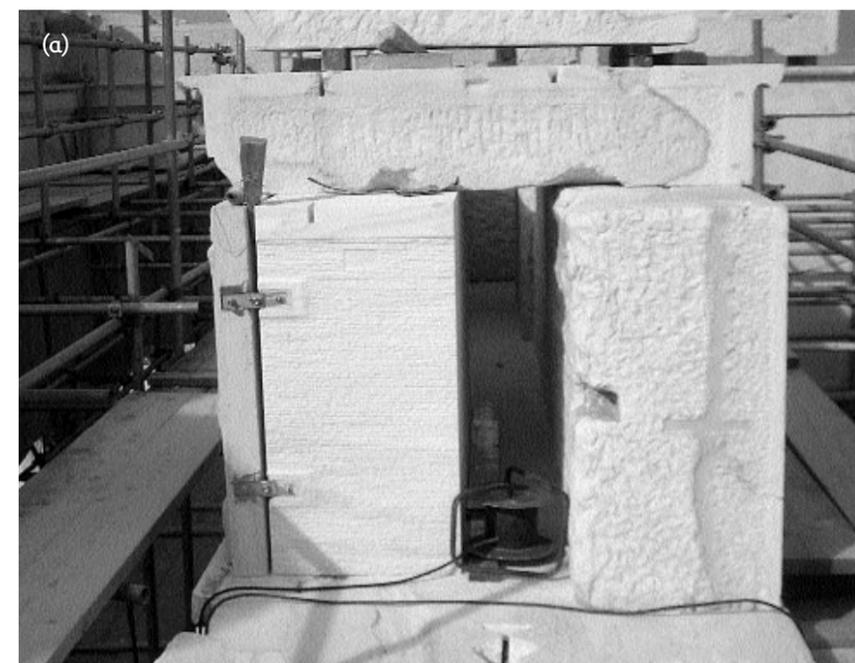
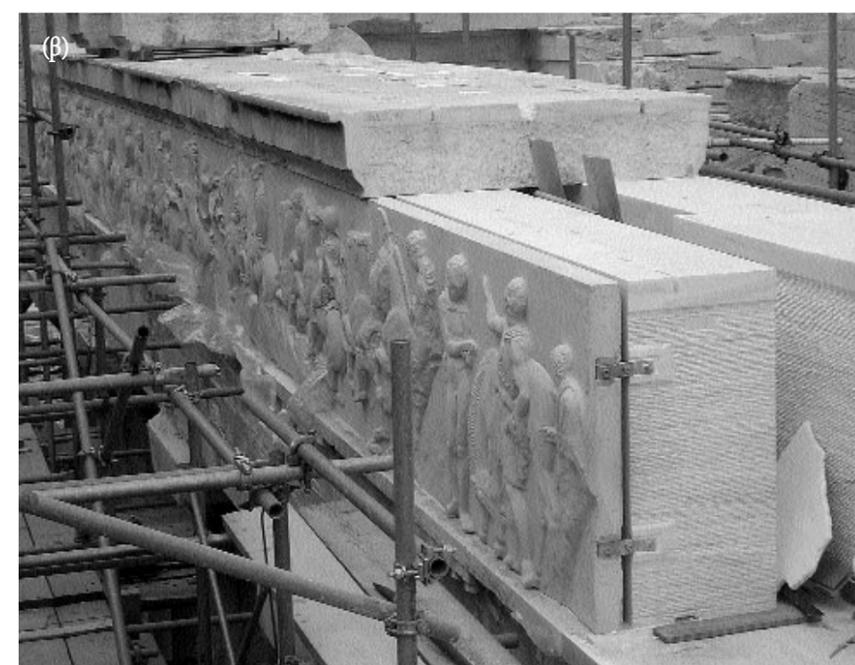
The structure of the frieze of the opisthonaos during its anastelosis: (a) view toward the north and (b) view toward the NE, showing clearly the structure of the artificial members that replaced the frieze blocks. Photos E.-E. Toumbakari, 2004

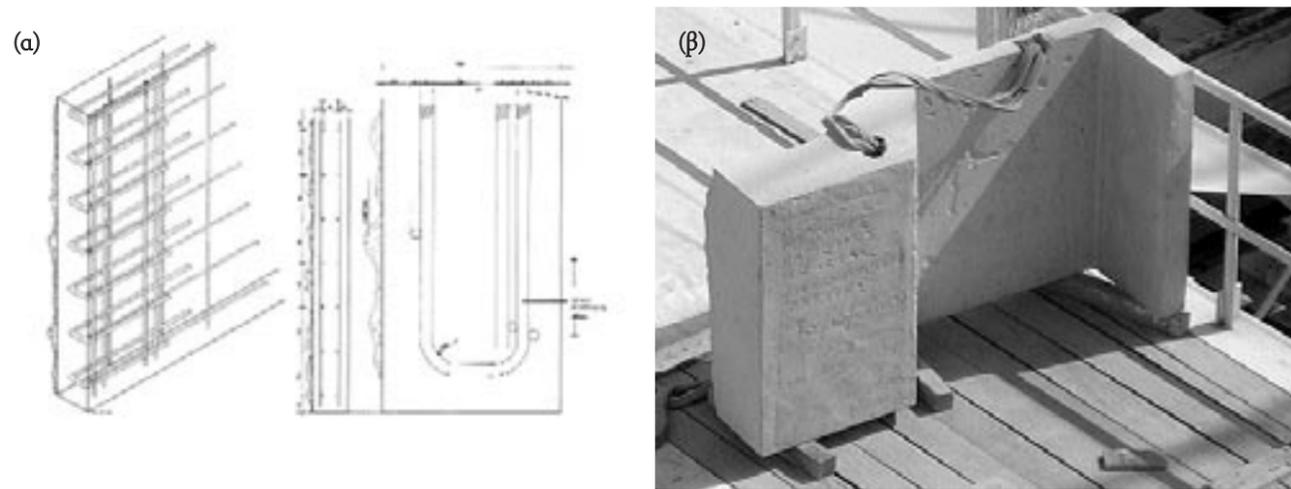
(a) Reinforcement of a typical slab (study by: E.-E. Toumbakari), (b) the special case of the copy of the frieze block SW: the joining of the thin slab and a fully cast section. Photo E.-E. Toumbakari, 2003

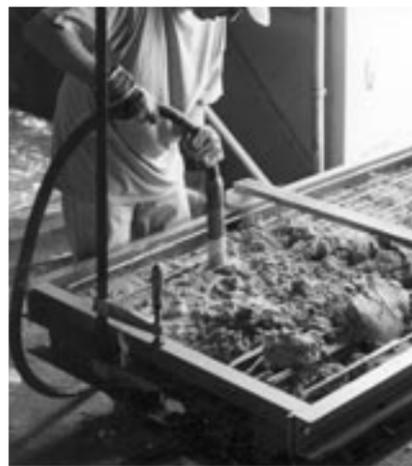
Concreting the artificial stone for the production of the copy of block W II. Photo A. Baibas, 2003

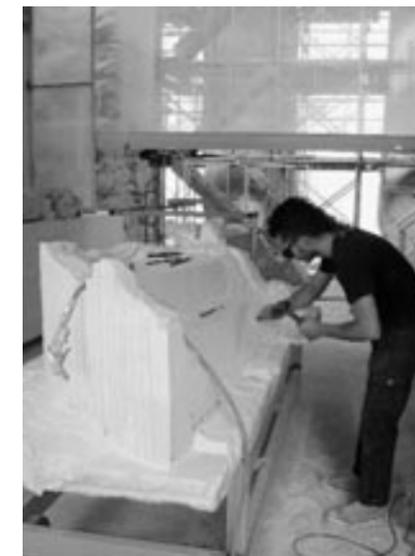
Filling in an architrave block from the north colonnade with new marble. Photo L. Lambrinou, 2004

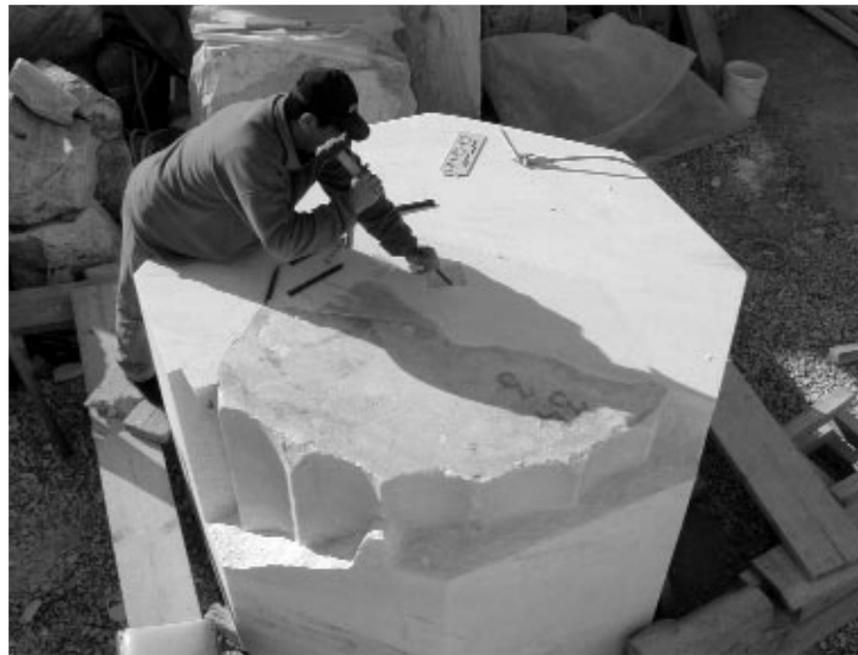
Trimming a filling of new marble in a column drum of the north colonnade.
Photo L. Lambrinou, 2004

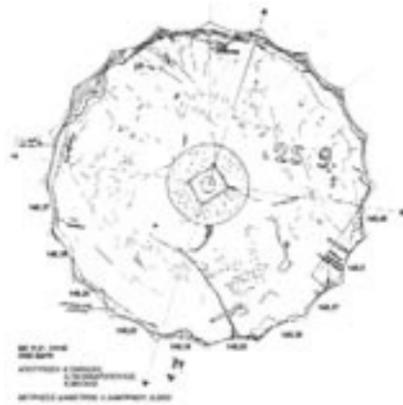
Survey and measurements of the diameters of the upper resting surface of a drum from the north colonnade.
Survey by C. Paraschis, A. Papandropoulos, C. Matala, measurements by L. Lambrinou, September 2003

Apart from the question of meaning, the phenomenon of discrepancy in the section of the flutes makes the setting of adjacent drums unique. Since the section of the columns, on the vertical level, forms a continuous even curve, these increase/decreasings of the interior diameters of each drum can only be alike, with corresponding increase/decreasing of the initially adjacent drums, the identification of which we have explored in the study for the rearrangement. The matching of the drums does not depend so much on the diameter of one, but of all ten, if indeed corresponding fluting is preserved. Thus, the correspondence of as

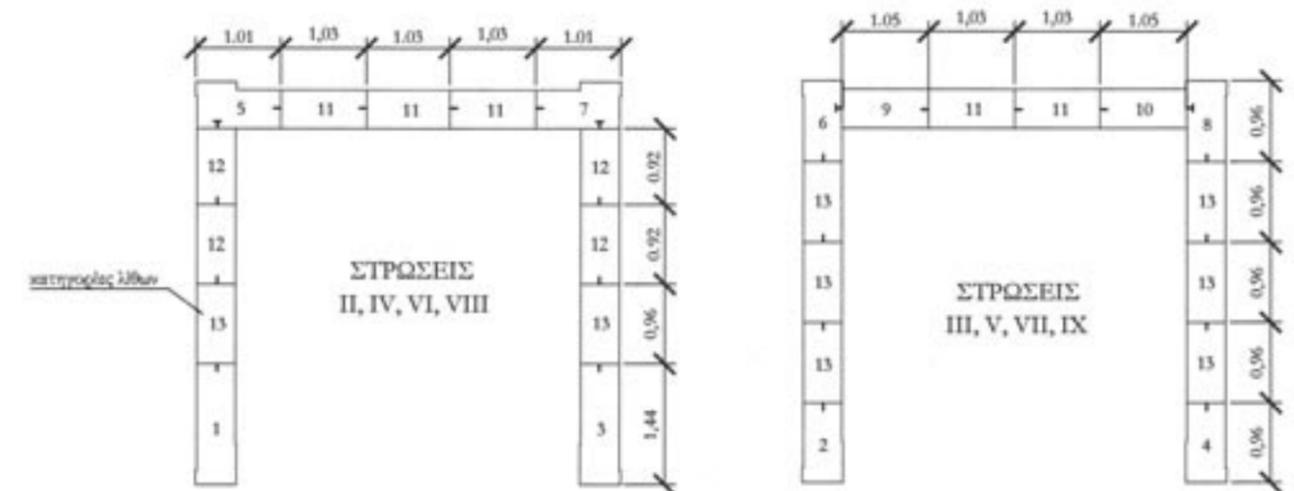
Athena Nike Temple. Setting the wall courses on the basis of the categories of the blocks. Study and drawing by K. Mamaloungas, 2003

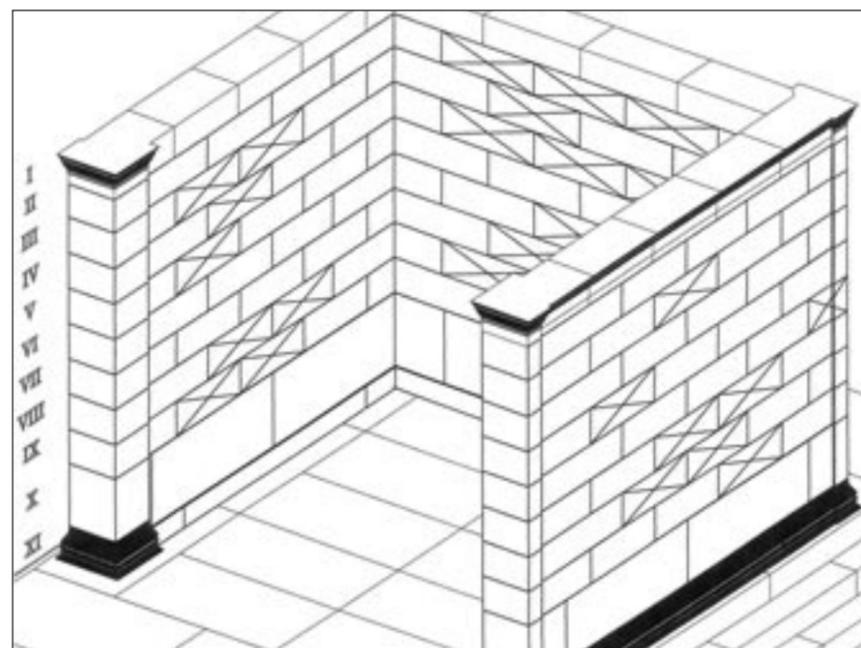
Athena Nike Temple. Proposal for restoration of the walls, showing the blocks moved to new positions and the fragments that have been reset. Study and drawing by K. Mamaloungas, 2003

- Twenty-two blocks were moved from the positions they had in the previous intervention.
- A new wall block, found during the course of the work east of the work-site, has been put in place on the monument.
- Two large fragments of wall blocks, recognized as belonging to the temple in D.

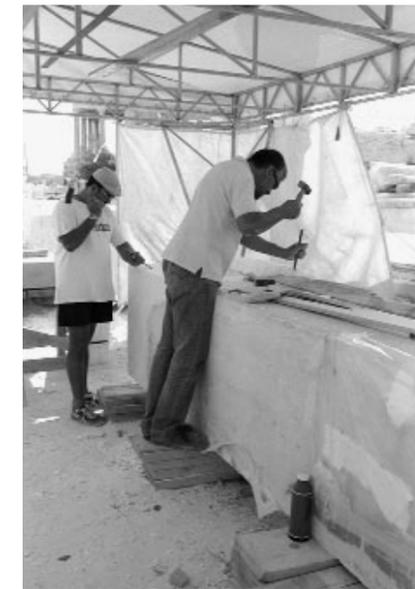
Filling in the ceiling beams of the Propylaea with new marble. Photo K. Karanasos, 2004

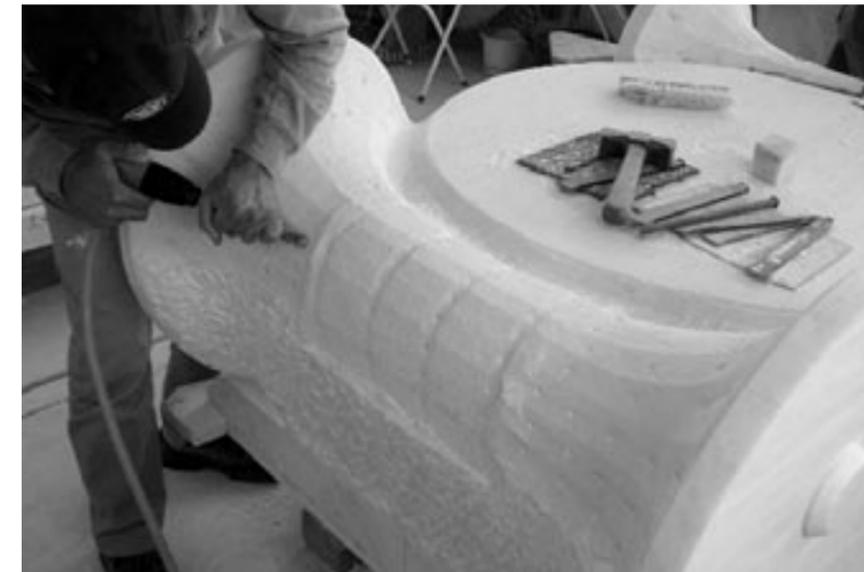
Carving the new Ionic columns of the west hall of the central building of the Propylaea. Photo T. Tanoulas, 2005
