- T. Tanoulas, The modern marble copies of the Ionic column capitals of the Propylaea
Ch. Bouras, Restoration Works on the Acropolis in 2005
M. Ioannidou, Seismic action on the Acropolis monuments
M. Mentzini, Structural interventions on the Acropolis Monuments
K. Karanasos, Restoring again the Ionic columns of the Propylaea
V. Manidaki, The Circuit Wall of the Acropolis: documentary works and studies
F. Mallouchou-Tufano, News from the Acropolis

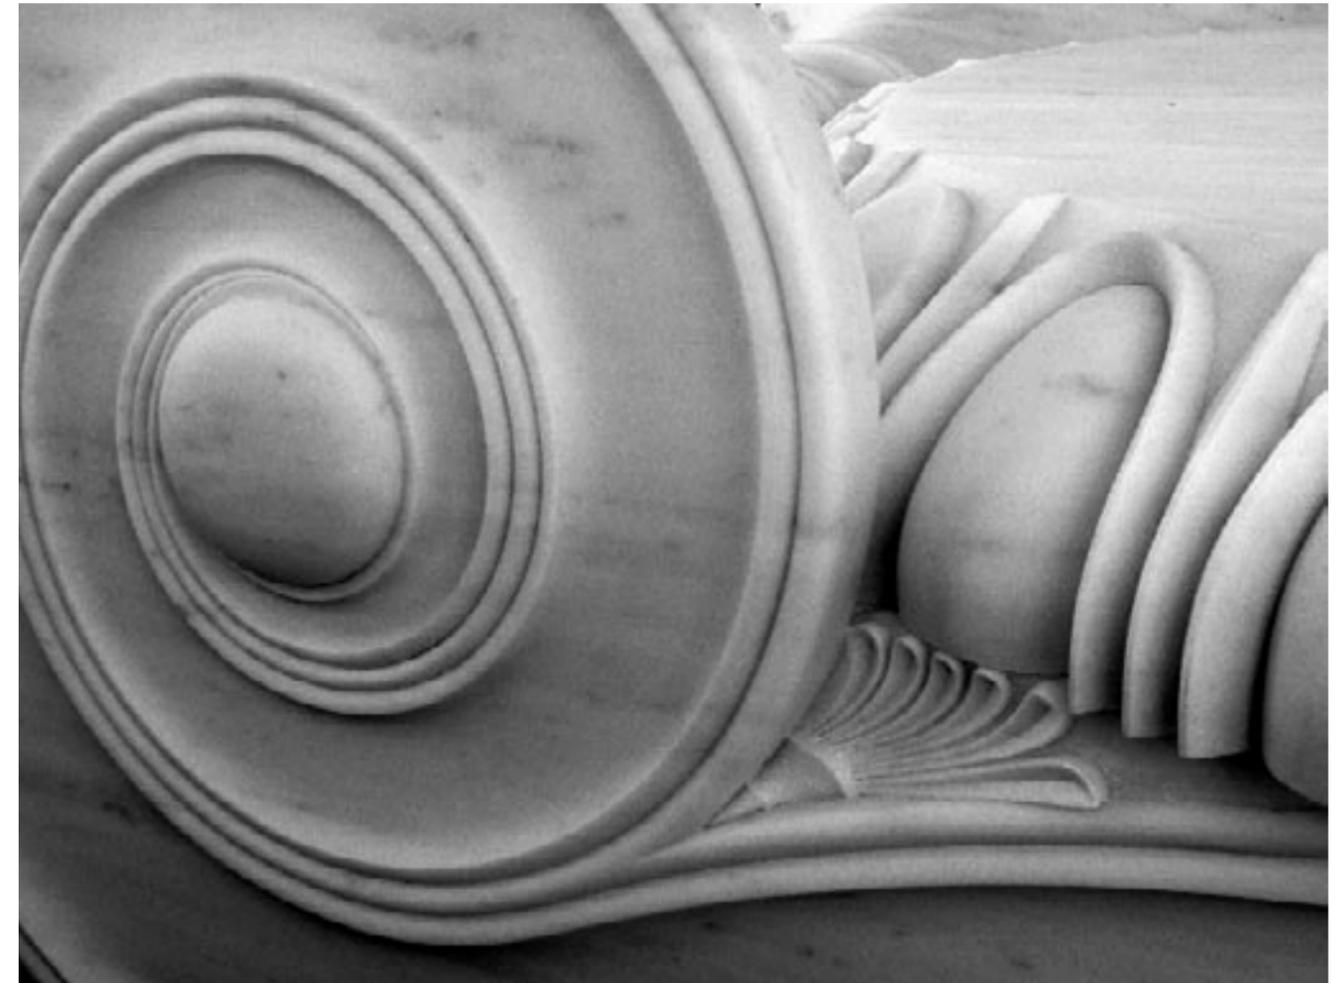
Detail of volute of the new Ionic column capital of the Propylaea. Photo T. Tanoulas, 2005

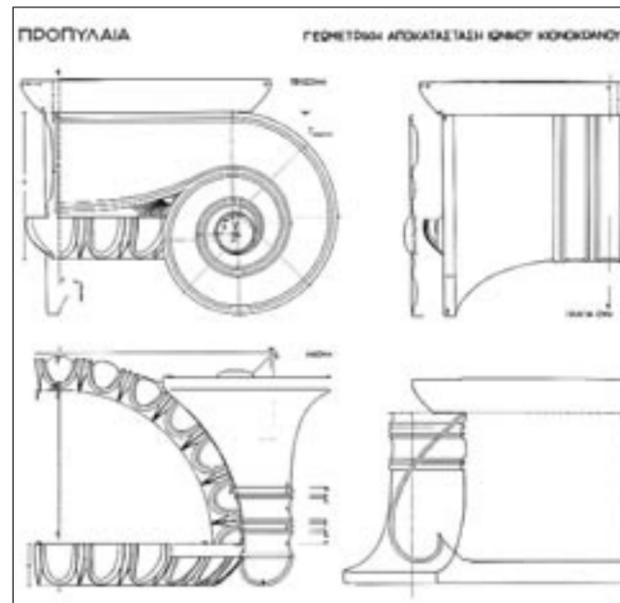
Geometry of the new Ionic column capital of the Propylaia, restored. Elevation, side view, view from below, section across the middle and the top end of the pulvinus. Study-drawing by T. Tanoulas, 1999

It was absolutely necessary to reconstruct the form of the column capitals so as to make two new capitals of new marble to be incorporated in the present anastelosis. First of all, the necessary blocks of marble had to be found at the Dionysos quarries. The two massive blocks arrived at the work-site of the

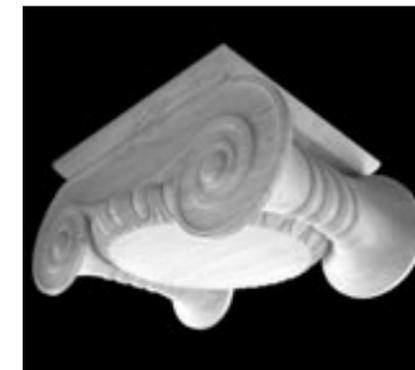
The Ionic column capital completed. Photo T. Tanoulas, 2006

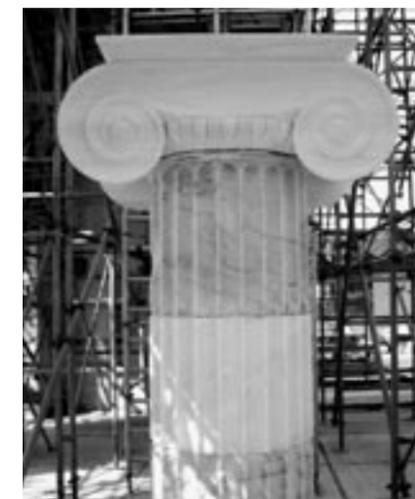
The Ionic column capital temporarily exhibited in the east portico of the Propylaia. Photo T. Tanoulas 2006

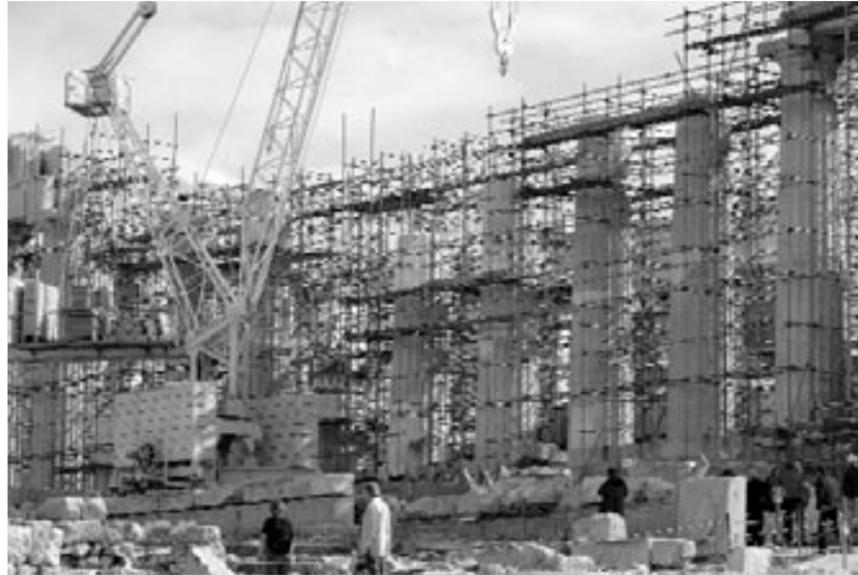
*The north colonnade of the Parthenon under restoration from the NW.
Photo S. Mavrommatis, November 2005*

In 2005, the filling and setting of the drums of the eight columns of the north colonnade were completed, after a new, exhaustive study by Lena Lambrinou. She has carried out inspection of the work together with Mrs. Mentzini who is in charge of the static stability of the columns. There is little use in reviewing again what is known already

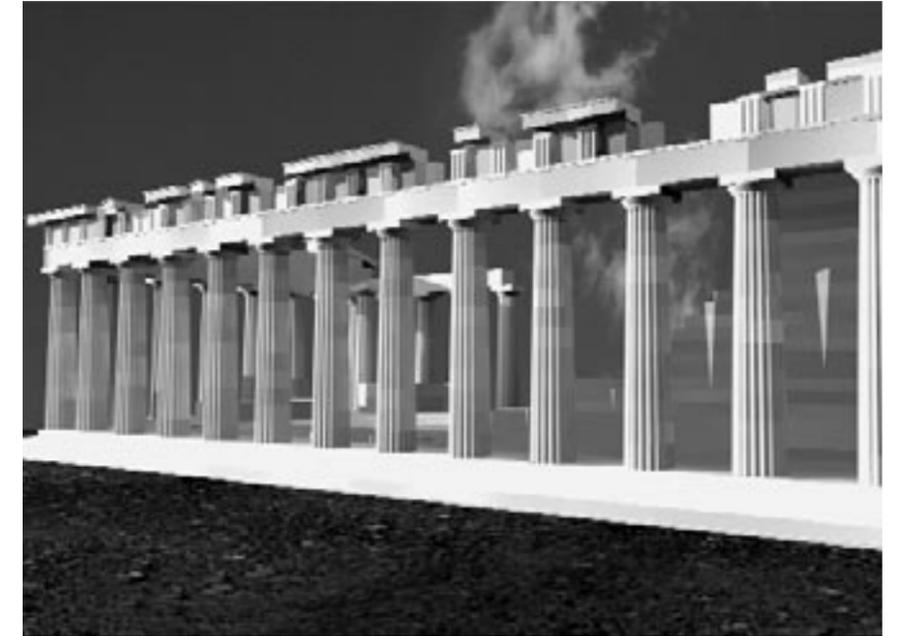
The north colonnade of the Parthenon restored. Photo-realistic drawing by P. Konstantopoulos, 2005

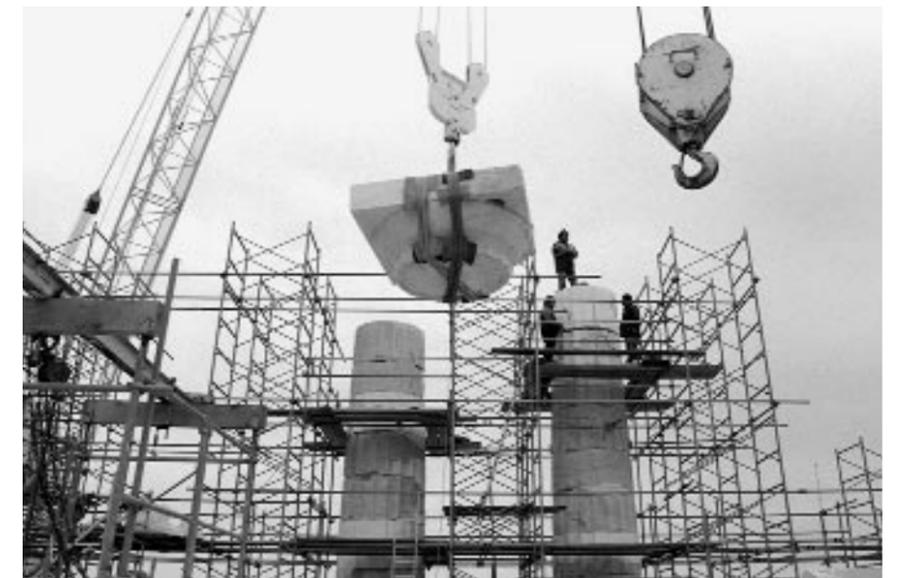
*Resetting a column capital in the north colonnade of the Parthenon.
Photo A. Papandropoulos, March 2005*

nificance in demonstrating the contiguity of two vertically continuous drums. To check the entasis, they were compared with two columns that were undamaged since antiquity, the third and the twelfth from the east. The column capitals were subsequently set in their correct places on the basis of their height, thus revealing the total height of each column as 10 metres, 43 cm and 6 mm. The architraves, which comprise three pieces across the width, were placed correctly on the basis of four identifying factors: orientation, original design, joining and the damage suffered. Located in addition were the correct positions of fragments that have been recovered and belong to the architrave.

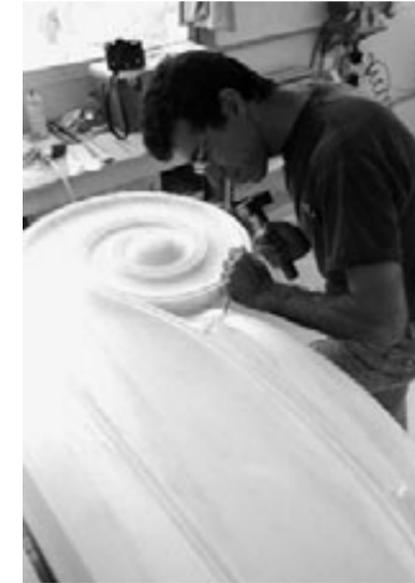
The marble technician, G. Desypris, working on the new Ionic column capital of the Propylaea. Photo Tanoulas, 2005

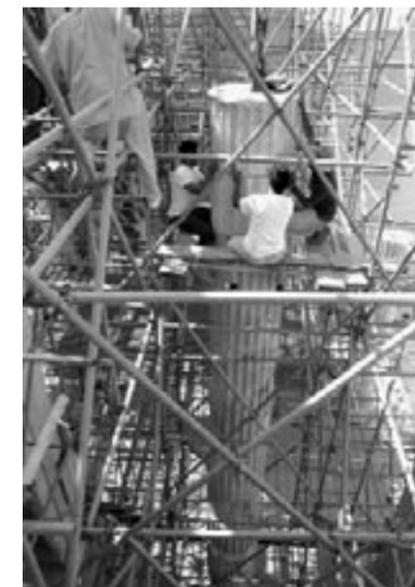
Restoring the NE column of the west hall of the central building of the Propylaea. Photo K. Karanasos, July 2005

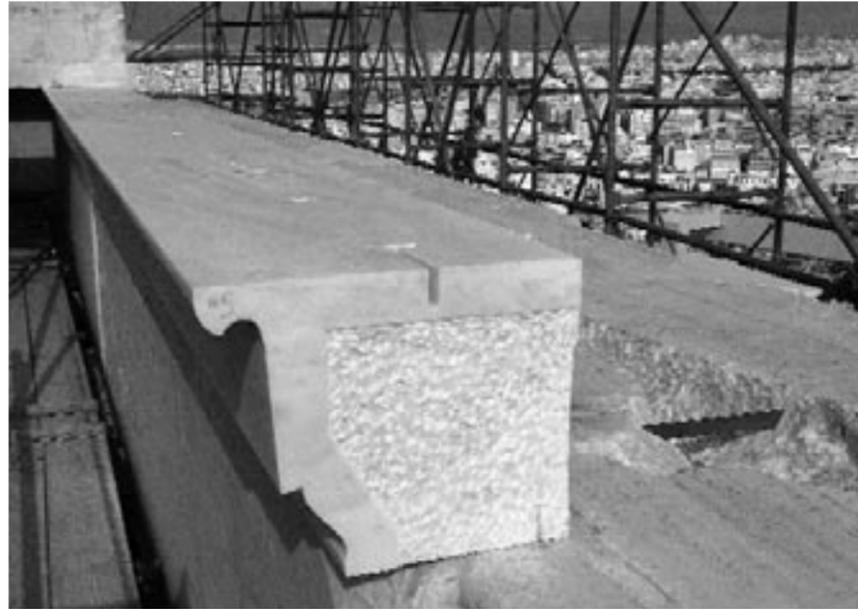
The crown block (thranos) of new marble of the Propylaea east portico. View from N. Photo S. Mavrommatis, November 2005

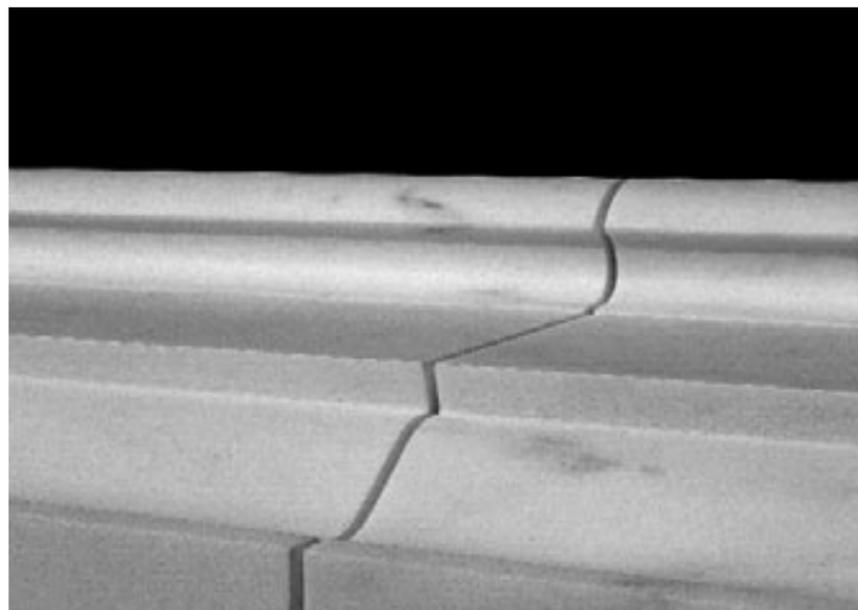
Joint between two pieces of the new marble crown block of the east portico of the Propylaea. Photo S. Mavrommatis, November 2005

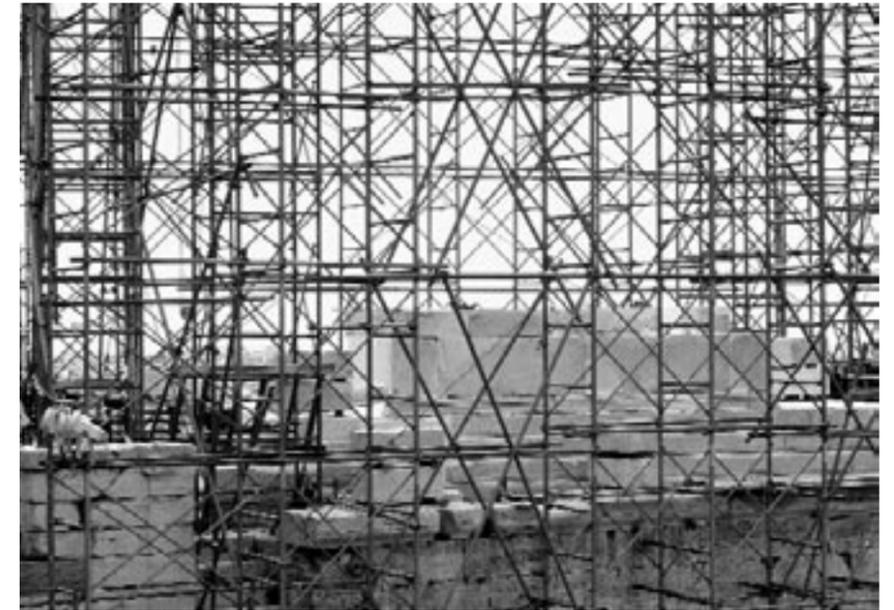
The Temple of Athena Nike under restoration from NE. Photo S. Mavrommatis, November 2005

In the **Temple of Athena Nike**, despite efforts to increase the pace of work, the numerous fillings required in the blocks of the cella walls and the ambiguities resulting from their cutting during previous restorations of the monument, have made the work of restoration extremely time-consuming and adhering to the schedule has become problematic. The director of the works here is the civil engineer Dionysia Michalopoulou. Collaborating with her are the architect Kostas Mamaloukas, the archaeologist Evi Lempidaki and the conservator Anthi Tsimereki. In 2004, a completely rigid grill of stainless steel was set over the space beneath the temple. Last year eight enormous floor slabs and the blocks of the *crepis* of the temple in new marble were set in place. Following this, work has begun on resetting the orthostates and blocks of the cella walls. Last June the Committee decided to add two more works to the technical report: 1) reinforcement of the old reinforced cement slab around the temple and 2) anastelosis of the frieze and cornice together with rebuilding part of its east pediment. Studies for these two projects have not yet been submitted to the Central Archaeological Council for approval.

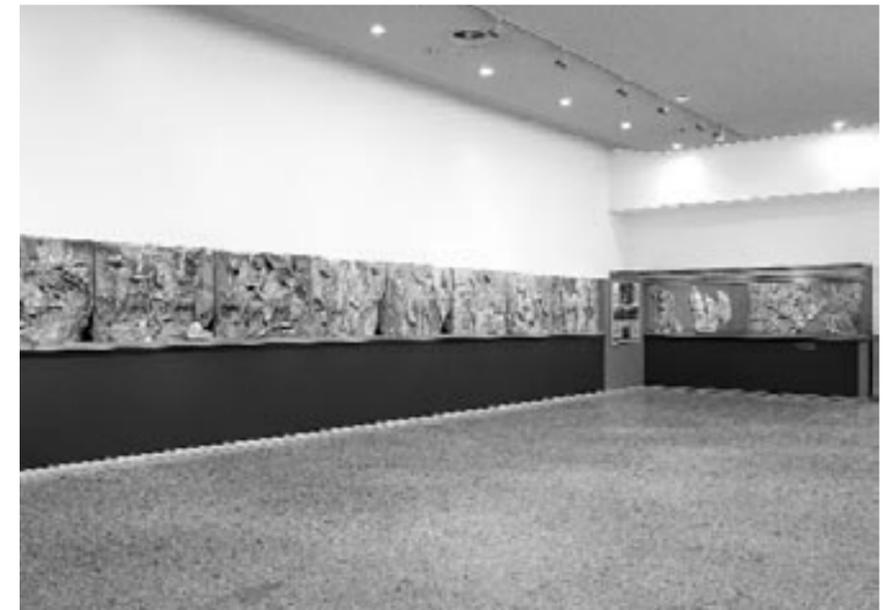
The Parthenon west frieze, recently cleaned and conserved, on exhibition in the Acropolis Museum. Photo S. Mavrommatis, June 2006

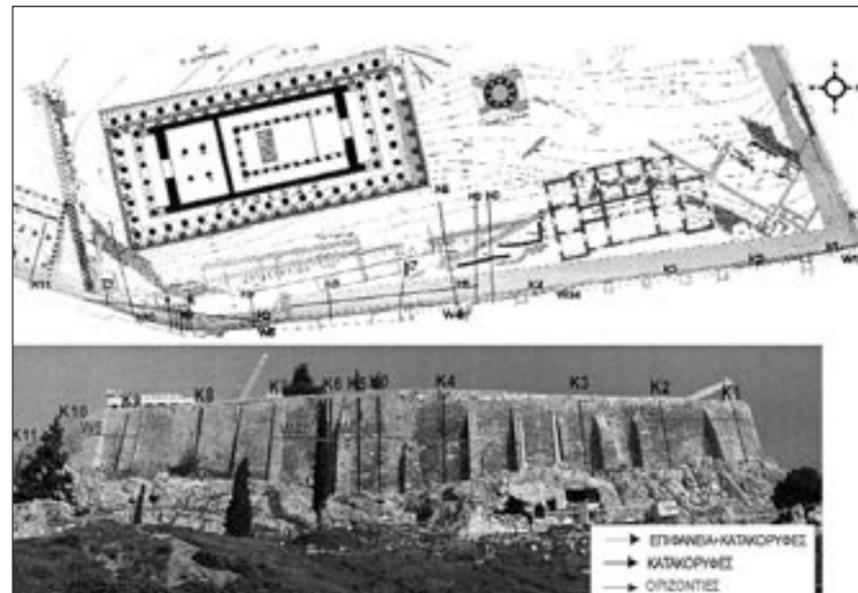
Electrical resistivity tomographies on the South Wall of the Acropolis. Photo Applied Geophysics Laboratory, Aristotle University of Thessalonike, 2006

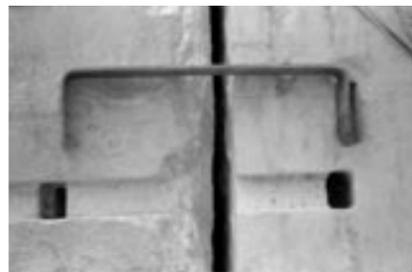
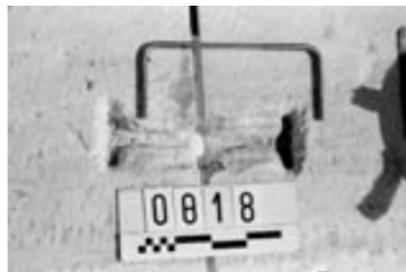
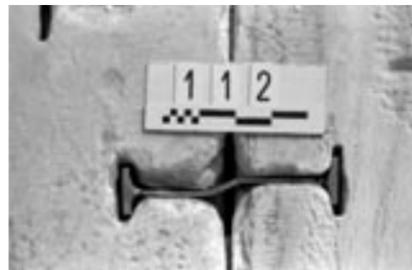
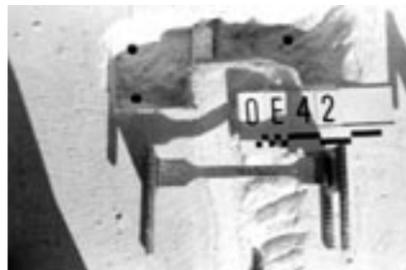
New joining elements of titanium. Above: II-shaped joining elements that replaced the clamps of earlier intervention. Below: joining elements of special shape. Photo R. Christodoulou, 2003-2004

Wherever the ancient cuttings (sockets) are preserved, I – shaped clamps are set, following the form of the ancient clamps with heads that are thicker in relation to the stem. The long stem has a neck so that

The restoration of the joining elements that have been damaged by stress or by the rusting out of the iron is an intervention that contributes to the resistance of the building in seismic strain. In case of earthquake, it is the clamps and dowels that assume the load and, together with the friction bond, they reduce the relative displacement of the marble blocks. The new clamps and dowels are made of titanium sheet and they are secured in the ancient

when the clamp is under tensile stress and the material exceeds its limit of yielding, it will be deformed and will therefore absorb a considerable amount of energy before it fails. The space between clamp and cutting and within an area of 1-2 cm on both sides of the joint is left free, without cement mortar, to allow room for possible cross-wise deformation of the clamp. If the original socket has been destroyed, two blind holes are drilled at the position of the original heads of the I – clamp. The holes are made to receive the vertical legs of the new clamp, which is now II – shaped. If the area where the clamps should be attached is broken, specially shaped joining clamps are designed. The designing of dowels is handled in similar fashion.

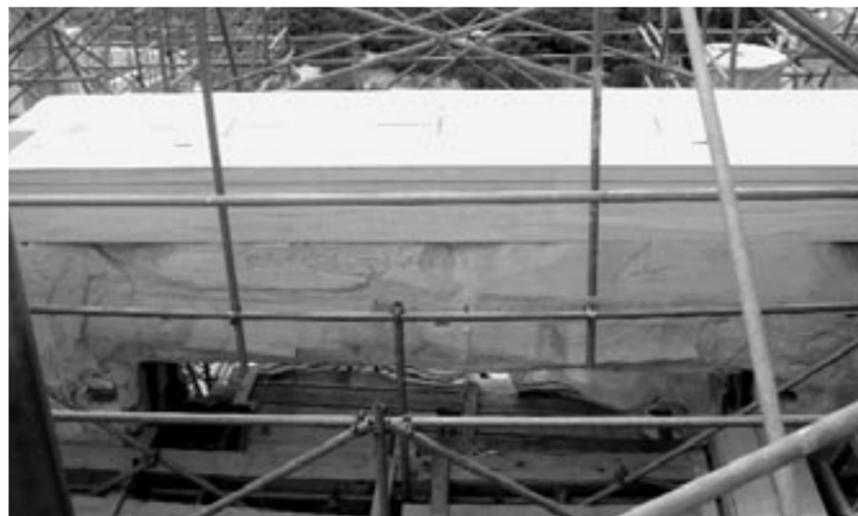
The lintel of the central doorway of the Propylaia, restored. View from E. Photo E. Petropoulou, June 2006

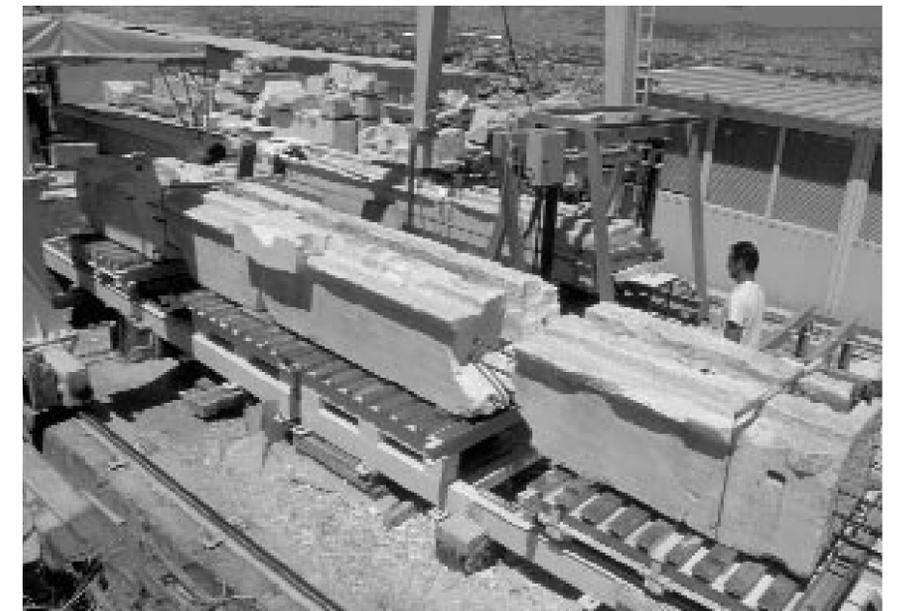
Structural restoration of a ceiling beam of the Propylaia east portico. Photo K. Karanasos, June 2004

Broken architectural members are restored to their original monolithic form by bonding the joining fragments with titanium rods and white cement. Because the members are placed on the monument in an isostatic system, with simple juxtaposition, each member can be considered as a integral unit in relation to the entire construction. Wall blocks are subject to single-axis compression, column capitals to bending and shearing and beams and architraves mainly to bending.

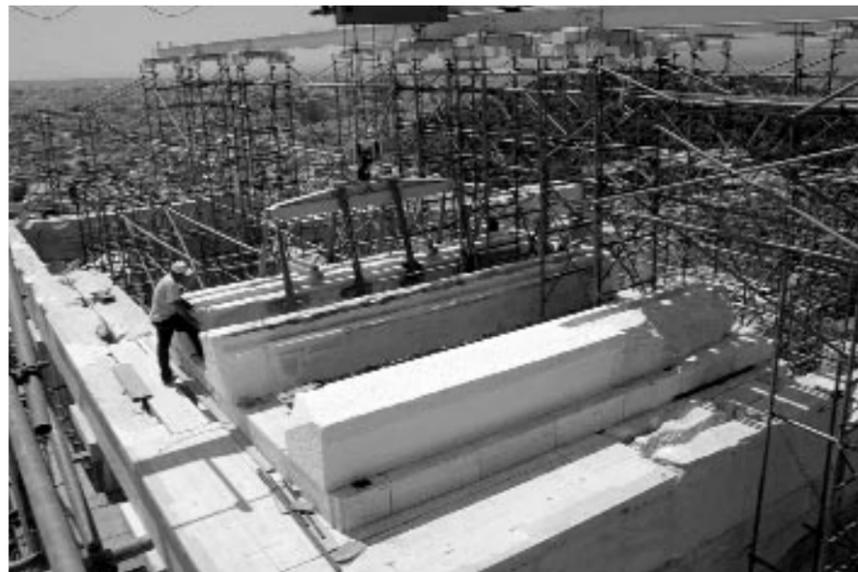
Resetting the marble ceiling beams in the east portico of the Propylaea. Photo V. Papavasileiou, August 2005

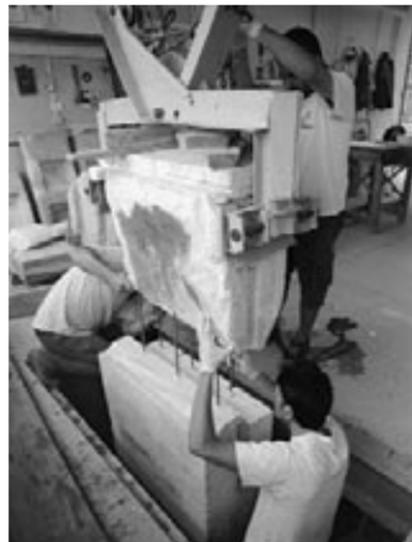
Structural restoration of a cornice block of the Propylaea east portico. Photo E. Petropoulou, 2005

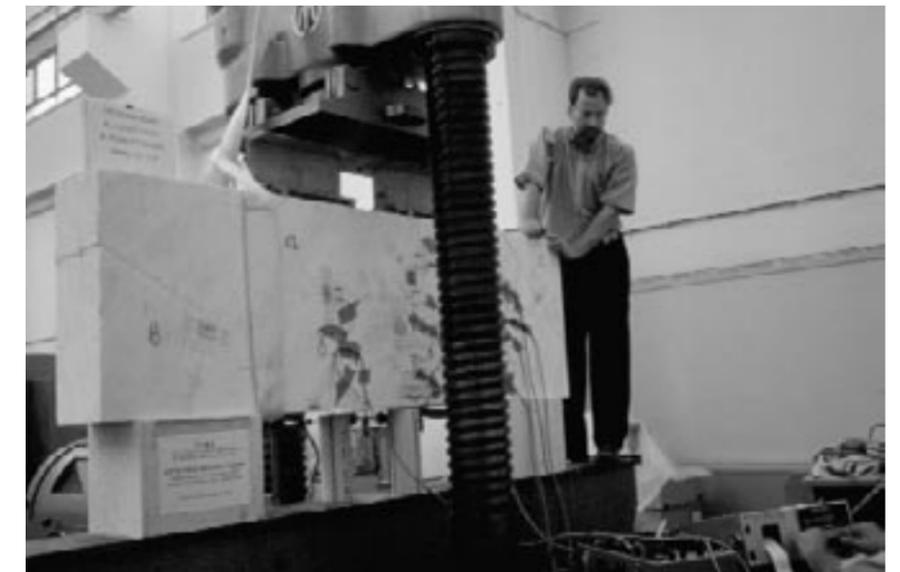
The model of the architrave block during the experiment in the Laboratory of Testing and Materials of NTUA. Photo M. Mentzini, 2002

the most damaged architraves of the north colonnade of the Parthenon. Simulated in the model in full detail was the geometry, the cracks, the discontinuities and the geological stratification of the ancient member. The model was reinforced to agree with the results of the design concept. The specimen was subjected to eight-point bending in the Laboratory of Testing and Materials of the National Technical University of Athens (NTUA). The load was applied statically, and was increased gradually and its final value was two times the one expected for the specific architrave. Then the load was removed. The behaviour of the model is considered satisfactory since the specimen behaved as an intact structural element. Indeed the relation between the deflections of the lowest side

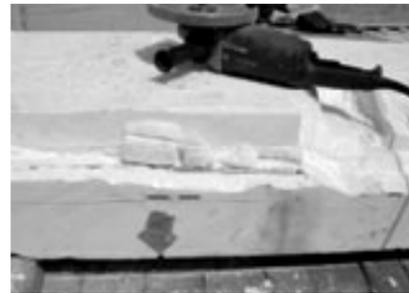
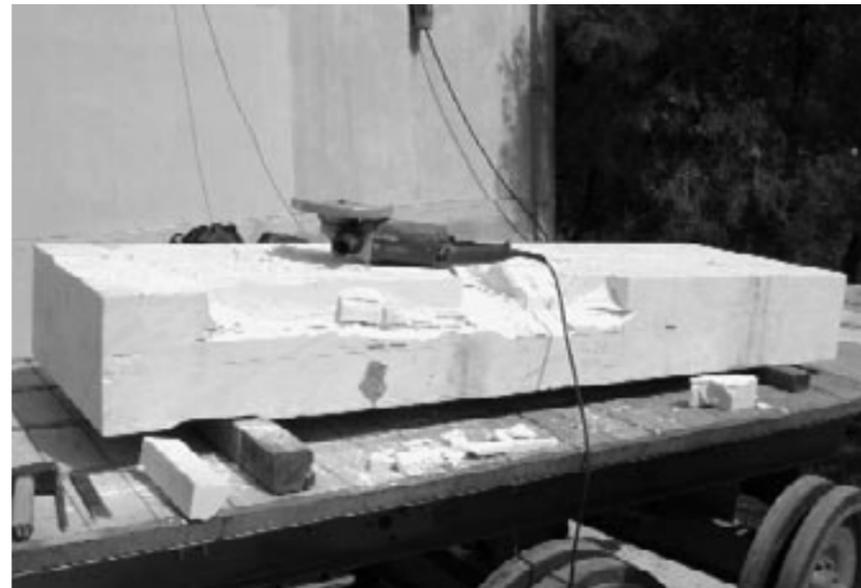
View of the back and resting surface of the model during the revealing of the reinforcements for control after the end of the experiment. Photo M. Mentzini, 2003

The final conclusions of the experiment showed agreement between theory and practical application, and verified the strong ductility of the titanium. It was found that after the unloading, the crack at the point of joining (a desired presupposition in any

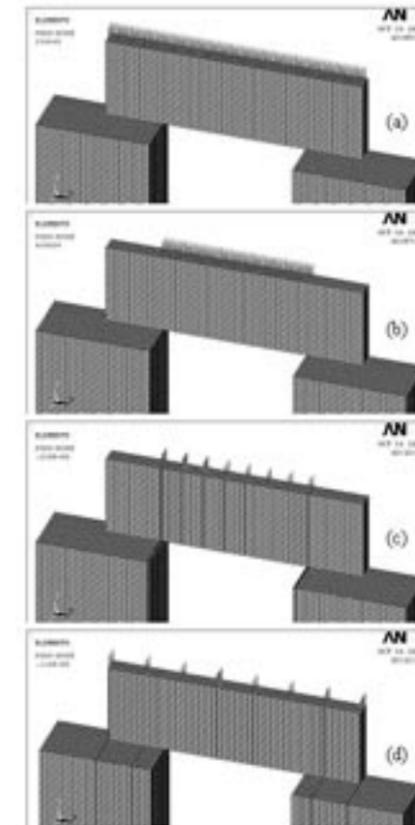
The four loading cases studied numerically: a) uniformly distributed load along the total length, b) uniformly distributed load along the span, c) eight-point bending along the span, d) eight-point bending along the total length

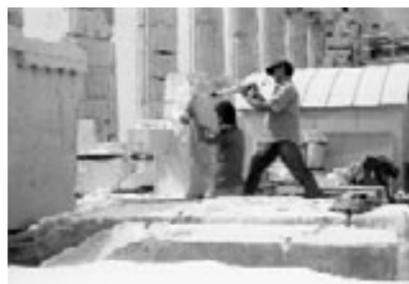
Structural restoration of an architrave block of the north colonnade of the Parthenon: a) setting the titanium bars, b) application of cement mortar around the titanium bars. Photo M. Mentzini, 2005

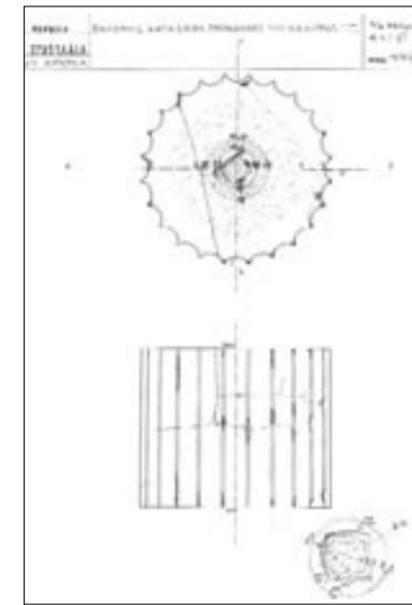
Drawing of the upper contact surface of the seventh drum of the SE column of the west hall of the Propylaea central building, preserved in situ. Survey-drawing K. Karanasos, 2005

deepest point of the channel of the flutes is 886,5 mm and the height of the drum 782 mm. It is necessary to reinforce the seventh drum with titanium rods, in order to increase its structural strength in view of the load the column is expected to bear in accordance with the approved study. Of the two available eighth drums still on the ground, the drum numbered 5679 of the Archive of Members Scattered on the Acropolis (AAD) was chosen. Its original

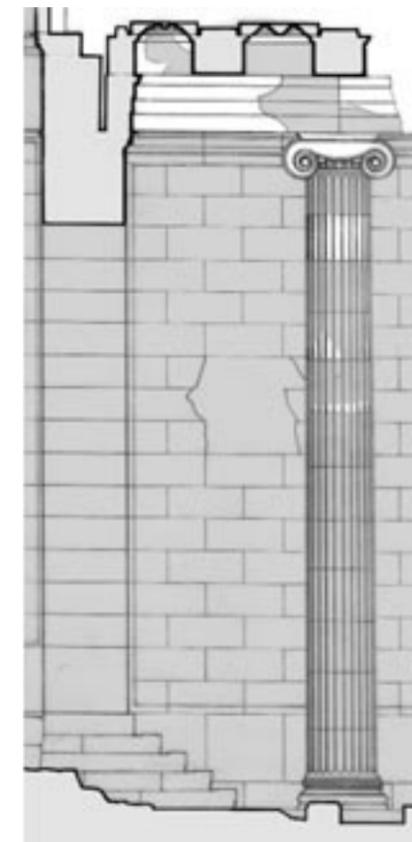
Proposal for the restoration of the SE column of the west hall of the Propylaea. Study-drawing, K. Karanasos - T. Tanoulas, 2005

The restoration of yet another column of the Propylaea west hall, in addition to that restored by Balanos at the beginning of the second decade of the 20th century, is indeed a significant event in the history of the monument. With the setting of the chosen column drums and the new capital, after some three centuries the column will

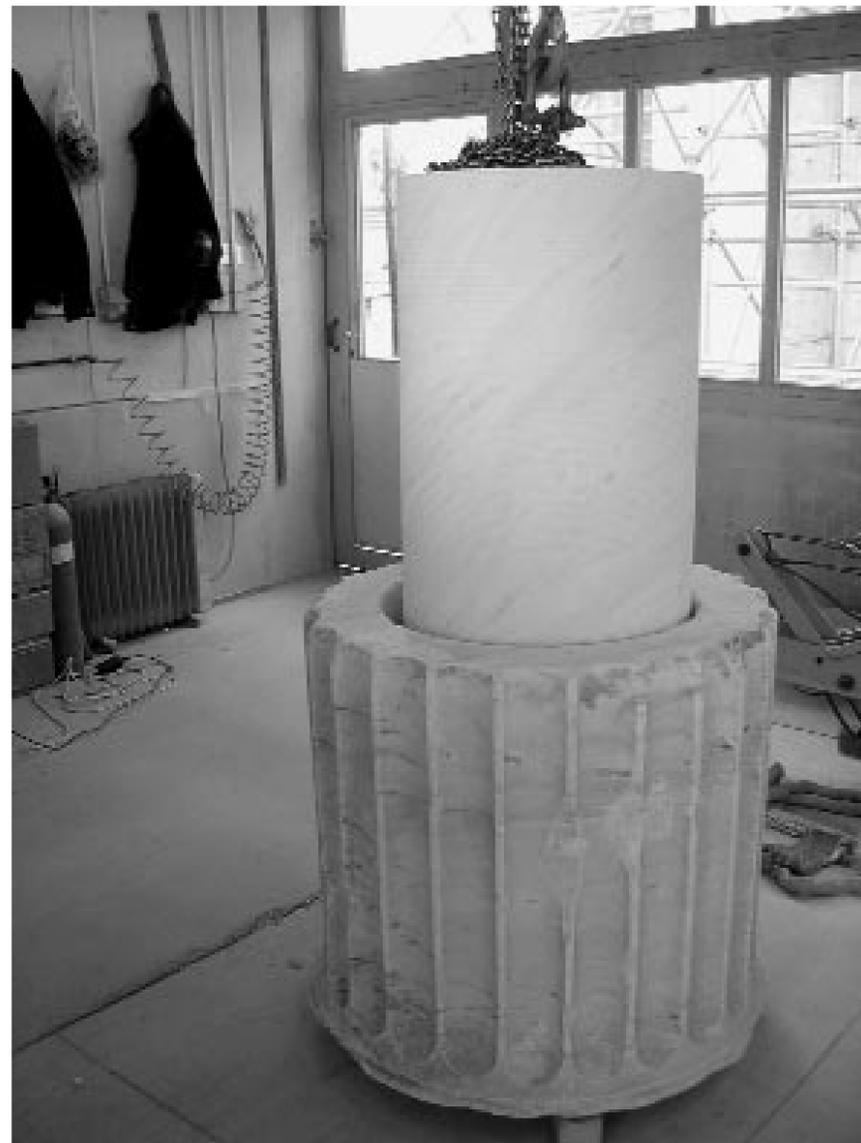
Filling in with new marble of the twelfth drum of the SE column of the west hall of the Propylaea central building, which had been used as well-head in the Middle Ages. Photo K. Karanasos, 2006

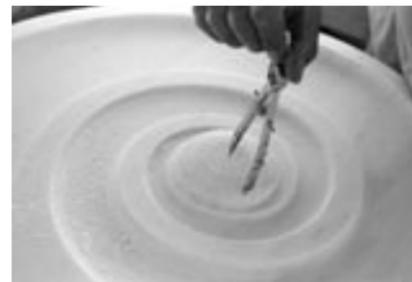
Carving the new Ionic column drum of the Propylaea. Photo K. Karanasos, 2006

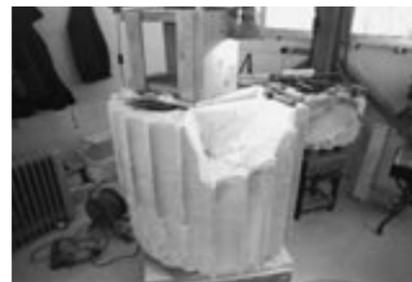
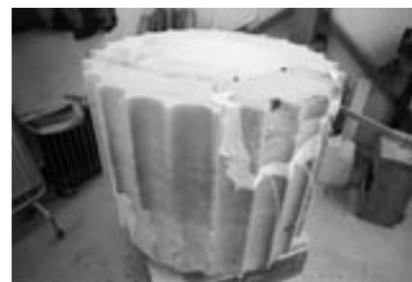
Inserting an ancient fragment in the third drum (from below) of the NE Ionic column of the Propylaea. Photo K. Karanasos, 2006

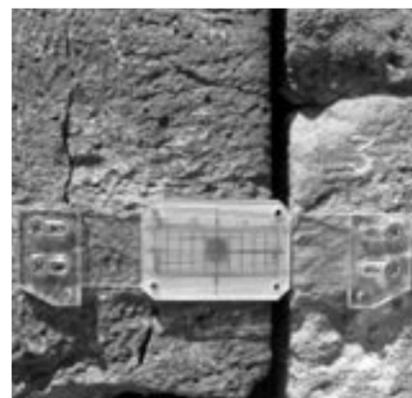
Acrylic crack-metre installed on the South Circuit Wall of the Acropolis. Photo V. Manidaki, 2004

Mechanical crack metres have already been set on the cracks in the Wall. The information they provide is local but useful, since they collect reliable information as to whether and to what extent the cracks are "active". In 2004-2005, eighteen acrylic crack metres were installed in order to monitor the cracks in the southeast corner of the Wall. They are inspected regularly. To date, indications of minor movements at the base of the Wall have not surpassed

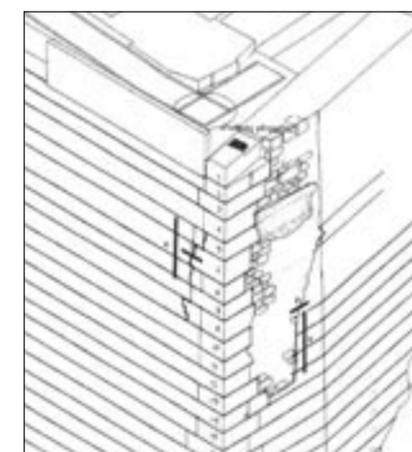
Positions of the electronic sensors on the SE corner of the Acropolis Wall. Drawing V. Manidaki

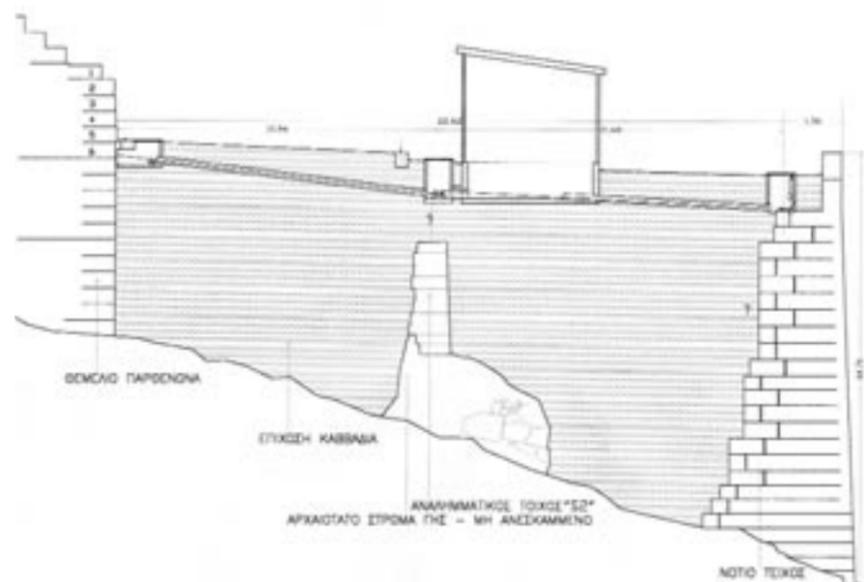
Installation of INVAR wire on the South Circuit Wall of the Acropolis. Application drawing. Cross-section and detail of ending shaft. Drawings by V. Manidaki

been set in place at points that are presumed to have cracks, c) Invar wires, non-expandable, have been placed connecting the Wall and the solid foundation of the Parthenon, d) an electronical system has been installed to record every movement of the Wall and the Rock with great accuracy, e) geophysical prospection of the ancient Wall and of the invisible surface of the Rock. We note here that a suspension platform has been installed for direct inspection of the mortar and the condition of the stones of the south Wall.

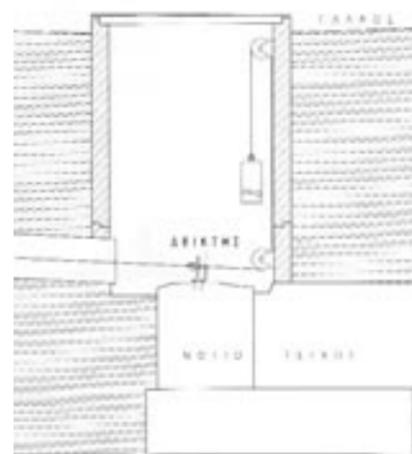
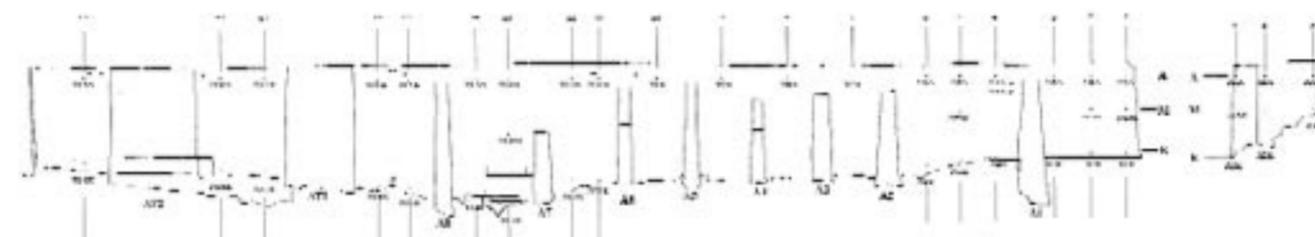
Installation places of specific surveying prisms on the South and East Walls for monitoring the deformations. Drawings by V. Manidaki

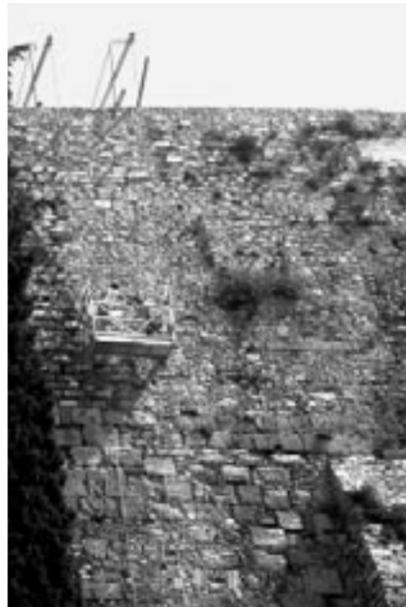
*Working platform on the S Wall.
Photo V. Manidaki, 2005*

Aside from the use of the above technologically advanced methods, inspection is always a reliable method of examining structural damage. It was considered necessary to acquire a suspended work-platform system that would allow access to the exterior surfaces of the Wall. A small hand-operated work-platform accommodating two people was chosen. It is made of aluminium so that it weighs very little (75 kg) and can be transferred from place to place by hand (to be sure, with all the difficulties involved in such transfers). The platform

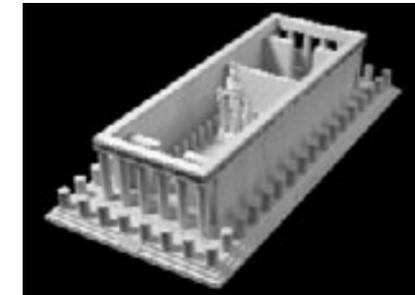
*The new educational model of the Parthenon,
scale 1:60*

Published in Greek and English, in 2005, was a new educational booklet, "The Gods of Mt. Olympus on the Parthenon Frieze". In addition, an abstract model of the Parthenon at a scale of 1:60 was made with funding by the Organization for the Building of the New Acropolis Museum (OANMA) and under the supervision of the President of the OANMA, Professor D. Pantermalis. The model was designed especially in order to act as a base for the educational game of reconstructing the Parthenon frieze. Likewise in 2005, an article entitled "Education through the Athenian Acropolis" by C. Hadziaslani, the head of the Department, and her colleagues E. Kaïmara and A. Leonti was published in "The Journal of Classical Teaching", the specialized journal devoted to the teaching of classical studies in England.

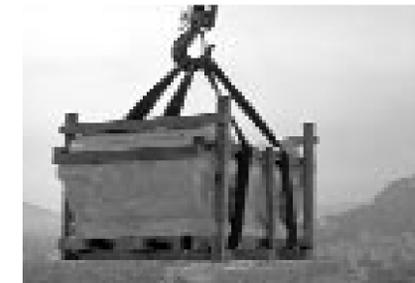
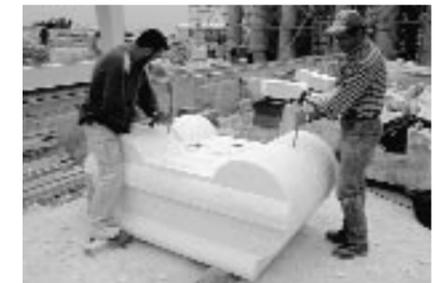
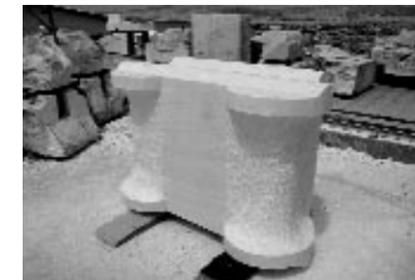
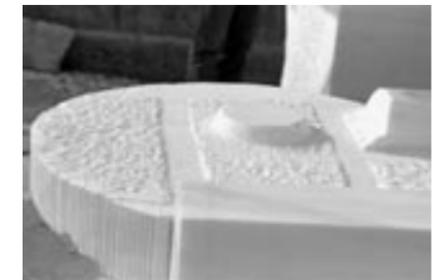
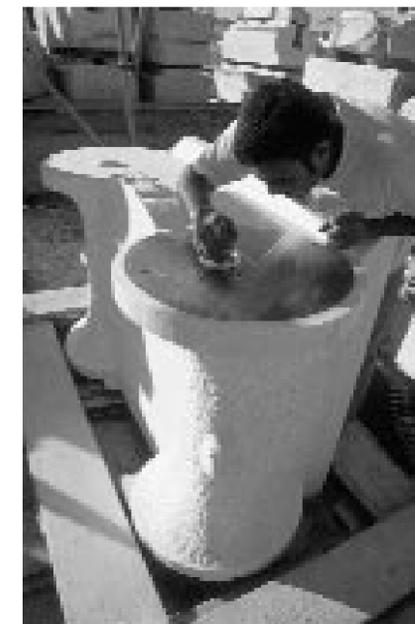
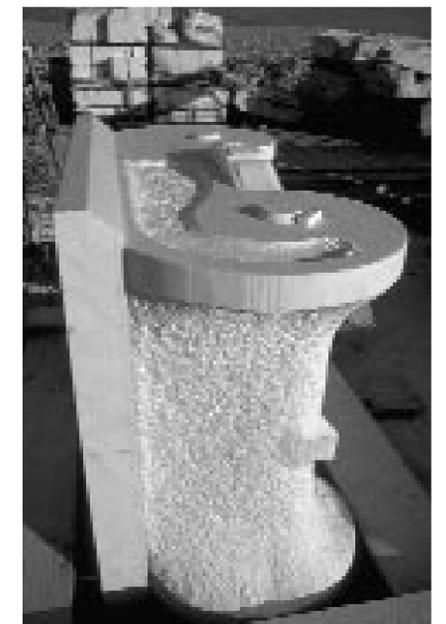
The successive phases of construction of the new Ionic capital of the Propylaia. Photo K. Karanasos, 2002-2003

made that was smoothed out in the finishing. With this surface as a starting point, the two axes of symmetry of the column capital were determined and, following this, the two slightly inclined levels of the volutes, the lower resting surface of the capital—that is, the lower surface of the echinus—the periphery of the echinus, the lower side of the abacus and, roughly, the pulvinus. In order to have full control of the continuously changing curve of the pulvinus, a specific kind of pointing tool was devised, the so-called “stela”, with the help of which the position of many other points were marked on the

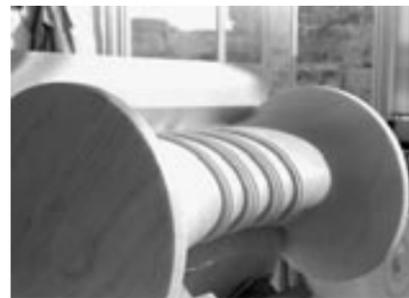
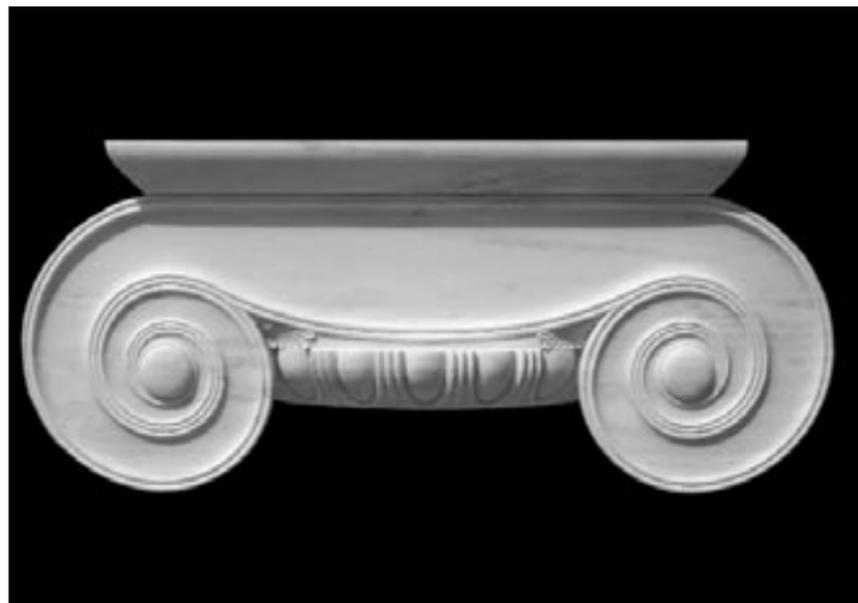
The successive phases of construction of the new Ionic capital of the Propylaea. Photo T. Tanoulas, 2004-2006
