General view of the Acropolis from the southeast. Photo G. Paganis, January 2008

- M. Ioannidou, 2007-2008, progress of the Acropolis Anastelosis Works
M. Ioannidou, Conservation and Restoration of the Acropolis Monuments: interventions planned for the period 2009-2013
V. Eleutheriou, V. Manidakis, A. Vrouva, Restoration of the west side of the Parthenon. General programming of the work and proposals for intervention
D. Mavromati, The use of orthophotography in the geometric documentation of the Parthenon
E. Sioumpara, Inventorying the Scattered Members of the Acropolis
D.N. Englezos, D. Moullou, Preservation of the Circuit Wall of the Acropolis: past and future
F. Mallouchou-Tufano, News from the Acropolis
F. Mallouchou-Tufano, Honouring the marble technicians of the Acropolis: the Gold Cross of the Order of the Phoinix to Nikos Skaris

Anastelosis on the Acropolis continued at undiminished pace during the second half of 2007 and the first half of the present year. The works, as is well known, are carried out by the Acropolis Restoration Service (YSMA) itself, a special Service of the Ministry of Culture, with the academic supervision of the Committee for the Conservation of the

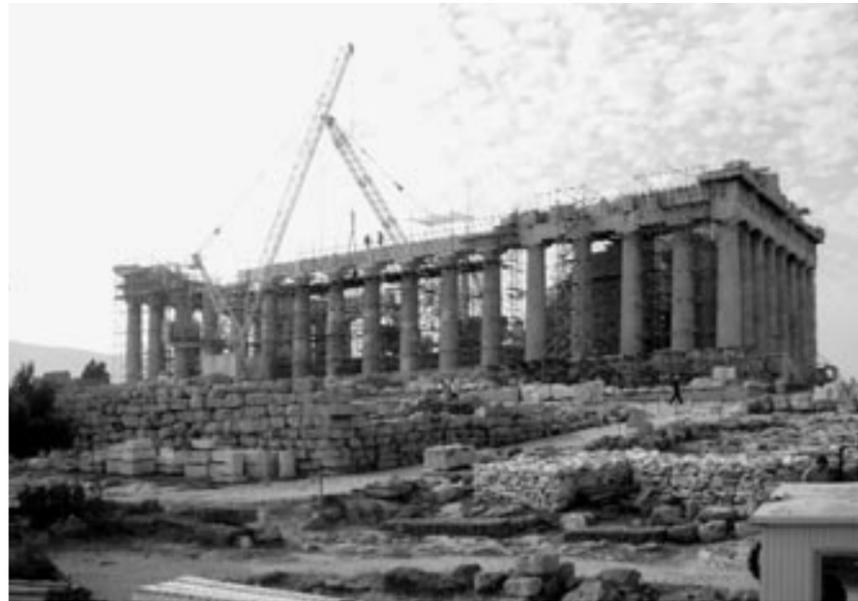
The north colonnade of the Parthenon, in course of restoration, from the NW. Photo A. Kafourou, June 2008

In the **Parthenon**, structural restoration of the dismantled members of the north colonnade

was continued. During the second half of 2007 the eight columns were reset in place and work began on resetting the entablature, at the level of the architrave, under the supervision of the architect-archaeologist Lena Lambrinou, responsible for the relevant study and the civil engineer Antigoni Vrouva. Work on the west end of the north colonnade was also initiated with the dismantling of the metopes.

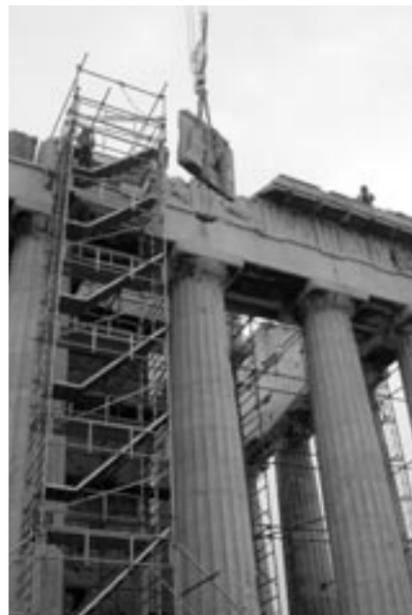
Dismantling a metope from the western end of the Parthenon north colonnade. Photo A. Kafourou, May 2007

Six metopes, three filling blocks and one triglyph were dismantled from the west end of the north side. Their structural restoration was begun, and work proceeds on copying the metopes to replace the originals on the monument.

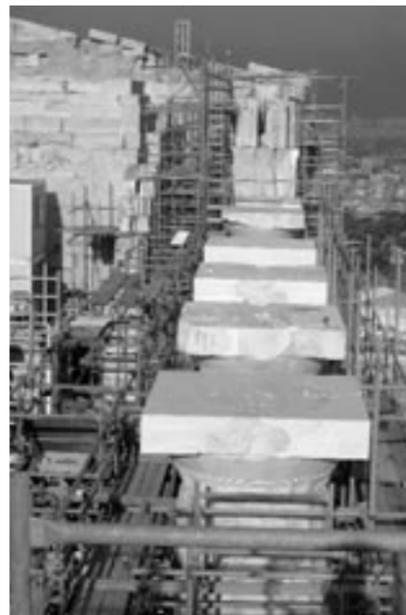
The north colonnade of the Parthenon, in course of restoration, from the east. Photo L. Lambrinou, July 2008

Specifically, from June 2007 to June 2008, the structural restoration of 34 members (two column capitals, four architrave blocks, five filling blocks, ten frieze blocks, seven cornice blocks) was completed, and 24 members were reset on the monument (six drums of the 4th column, four column capitals and fourteen architrave blocks).

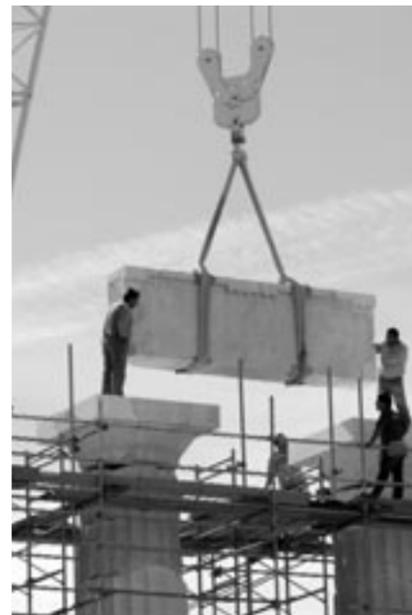
Replacing an architrave block on the Parthenon north colonnade. Photo L. Lambrinou, July 2008

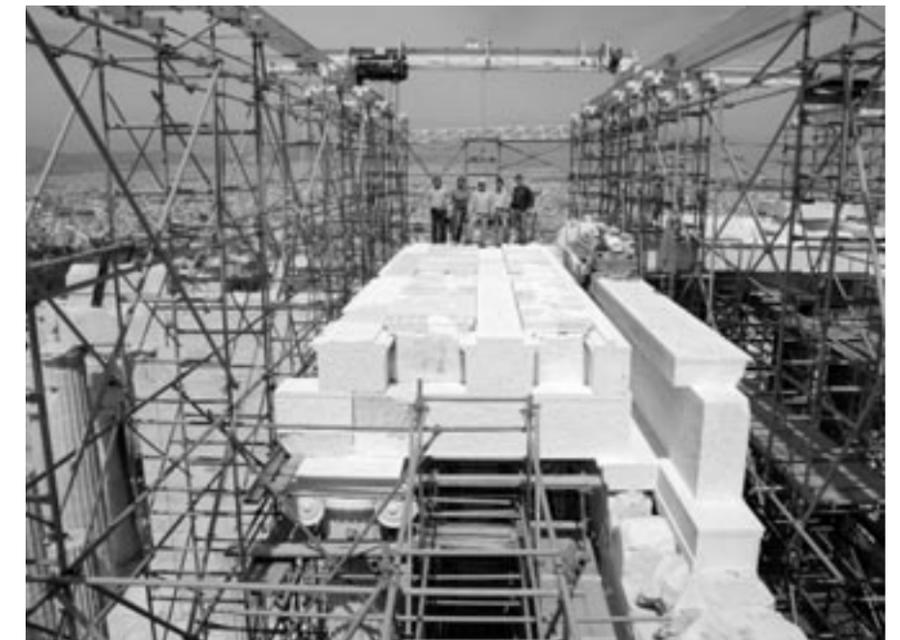
View from the south of the restored ceiling of the west hall of the Propylaia central building, with the marble technicians responsible for the intervention. Photo T. Tanoulas, June 2008

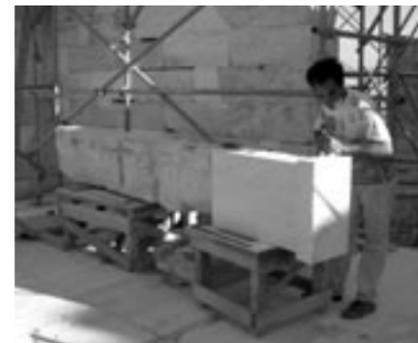
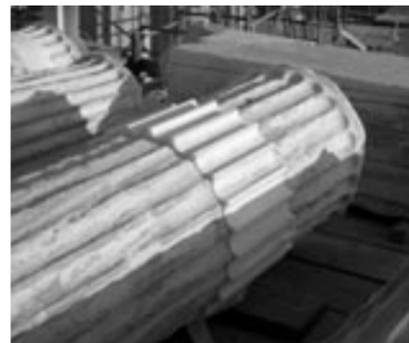
Structural restoration of the piers and columns of the temple of Athena Nike. Photo E. Lembidaki, June 2008

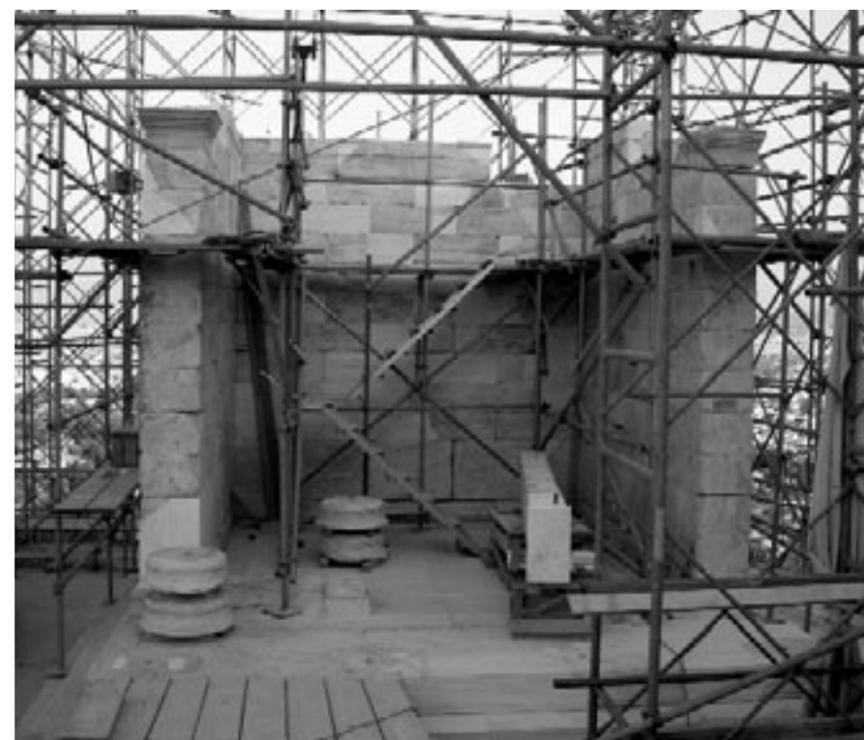
The temple of Athena Nike, in course of restoration, from the E. Photo E. Lembidaki, June 2008

as well as on the piers of the monument. Restoration of members of the columns has also been completed, and casts have been made of the figures of the original frieze for replacing them on the monument in artificial stone. Likewise completed is the study by the architects Kostas Mamalougas and Demosthenes Giraud for the arrangement and setting of the column capitals. Work on the temple of Athena Nike continues under the direction of the civil engineer Dionysia Michalopoulou.

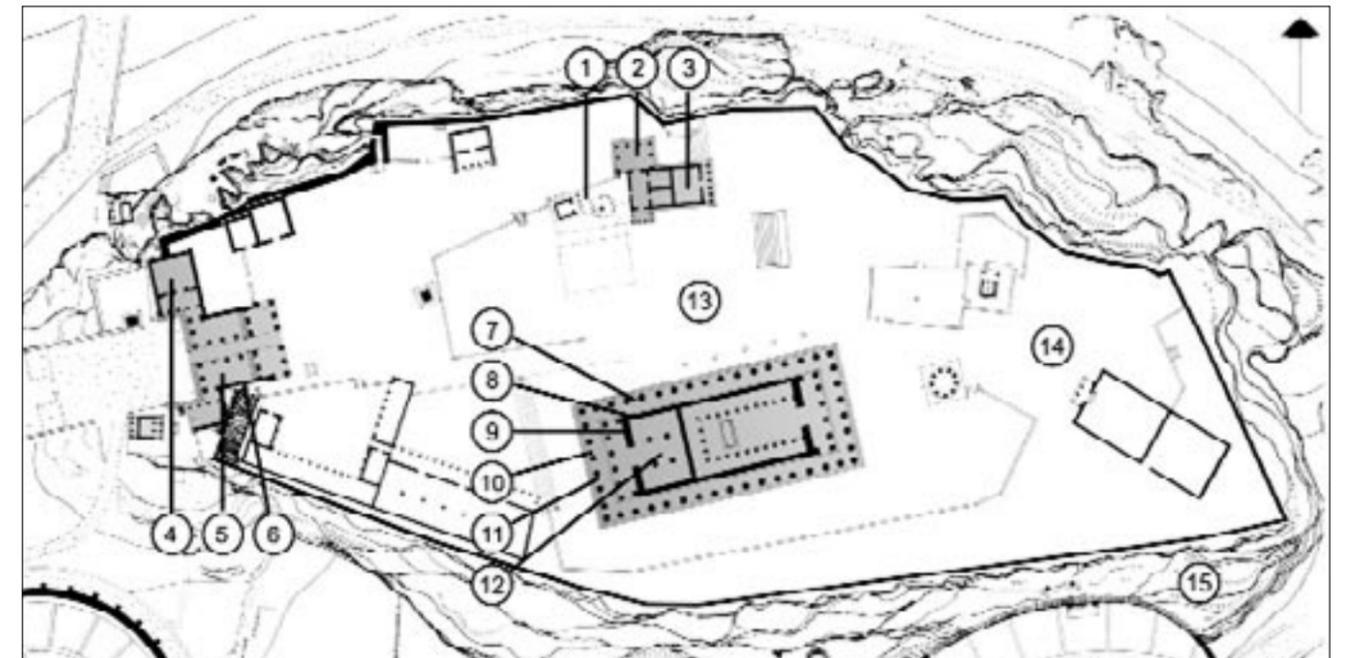
1. Restoration of the Pandroseion, 2. Sheltering of the Erechtheion north porch, 3. Filling in of the interior of the Erechtheion, 4. Restoration of the Propylaea north lateral wing, 5. Restoration of the Propylaea south lateral wing, 6. Partial anastelosis of the south wall of the west hall of the Propylaea central building, 7. Final cutting of the column flutes in the fillings of new marble of the restored columns of the Parthenon north side, 8. Anastelosis of the lateral walls of the Parthenon cella, 9. Restoration of the west wall of the Parthenon cella, 10. Restoration of the Parthenon west façade, 11. Surface conservation of the Parthenon west façade, 12. Re-organization of the Parthenon work site, 13. Final display of the surface of the Acropolis plateau, 14. Conservation of poros architectural members, 15. Preservation of the Circuit Wall of the Acropolis

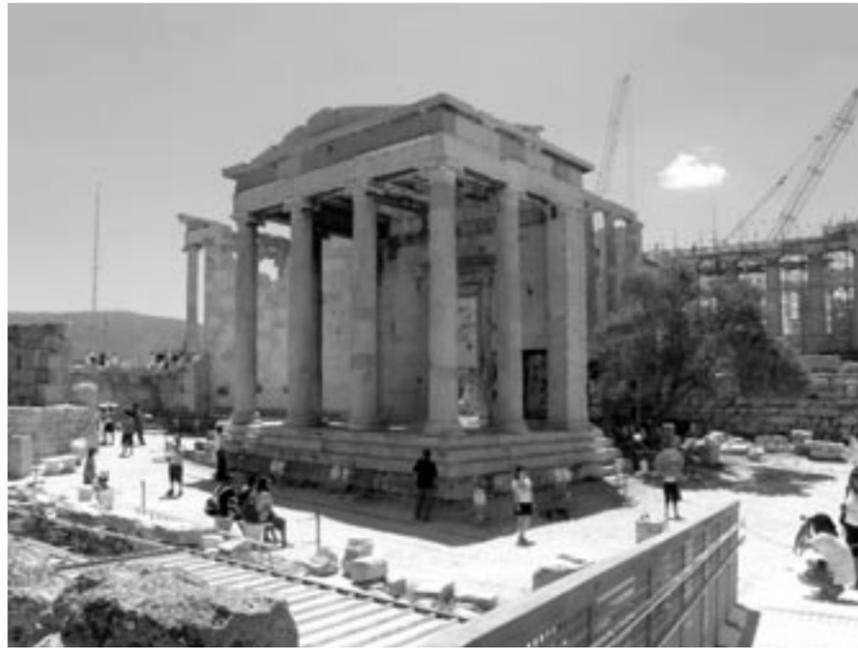
The north porch of the Erechtheion from the NW. Photo F. Mallouchou-Tufano, July 2008

1. *Sheltering of the north porch:* it is planned to shelter the north porch in order to protect it from the corrosive effect of rain-water. The relevant study, which calls for a light shelter of wood and titanium, has been carried out by the YSMA architect V. Manidaki and it has been approved by the ESMA.

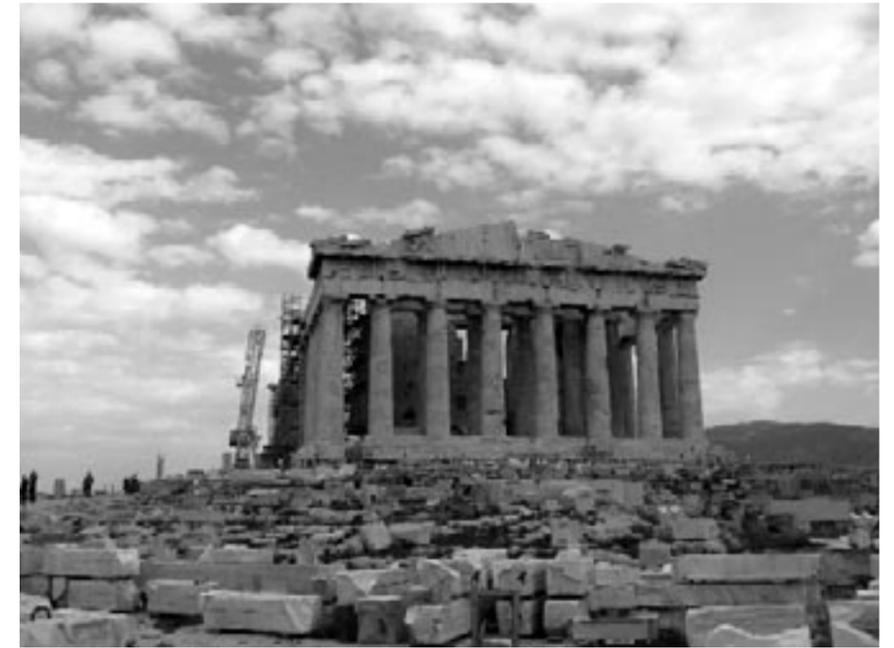
The west side of the Parthenon. Photo F. Mallouchou-Tufano, February 2006

1. *Intervention on the west façade of the monument:* the state of preservation of this side of the monument, in both the restored parts and the parts that have never been restored, is especially critical. The general preliminary study of Korres and Bouras of 1983 included replacement of the rusted metal joining elements in areas of the west façade that had been restored in the past and interventions to

reintegrate into this section fragments identified as ancient. The recent study by the YSMA architects V. Eleutheriou and V. Manidaki, which has been approved by the ESMA, calls for dismantling of the two previously restored corners of the west façade, structural restoration of the members and their resetting on the monument, removal of the metopes from the two corners and their replacement with copies in cast artificial stone. Infrastructure for plotting the entablature of the west façade comprised photogrammetric survey and the formation of an orthophotomosaic by the YSMA rural and surveying engineer, D. Mavromati. This was carried out in collaboration with the Directorate of Topography, Photogrammetry and Land Register of the Ministry of Culture. The study is to be submitted directly to the Central Archaeological Council of the Ministry of Culture (KAS) for approval.

The west side of the Parthenon is indeed the best preserved, in that it did not suffer the serious damage or collapse inflicted on the other sides of the monument. As a result, it has not undergone restoration, with the accompanying mis-settings of ancient architectural members evident, for example, in the north side. Yet, during the long history of the building it suffered significant damage, such as cracks in the marble and opening of joints with measurable changes in the original

As might be expected, of great importance for evaluating the structural damage of the west side is the condition of the architrave blocks and the columns beneath them. A typical form of failure in the architrave blocks is their breakage especially around the clamps and dowels. More serious problems are seen in the exterior blocks of the two corners, where there are breaks that run right through the block, the penetration being due to the architrave blocks of the long sides (exterior blocks of the 1st, from north, and the 7th architrave blocks), which converge on these positions. After the earthquakes of 1981 and 1999, a crack of 1 cm appeared in the exterior block of the south architrave, at the SW corner. These breaks are consistent with the general picture of deformation in the entire colonnade, which indicates that the corners have shifted outwards.

As for the columns, the problems lie mainly in the notable lack of mass evident in a number of column drums, and in cracks that penetrate the drums. The capitals have suffered damage of various sorts from the overlying blocks. Breaks in the mass of their especially fine marble, caused by the ancient dowels of the architrave blocks, are observable in all the column capitals.

The addition of exterior iron joining elements by Balanos, along the full length of the entablature and the pediment, have caused extensive cracking and breakage, as has been noted frequently in the earlier interventions on the Acropolis monuments.

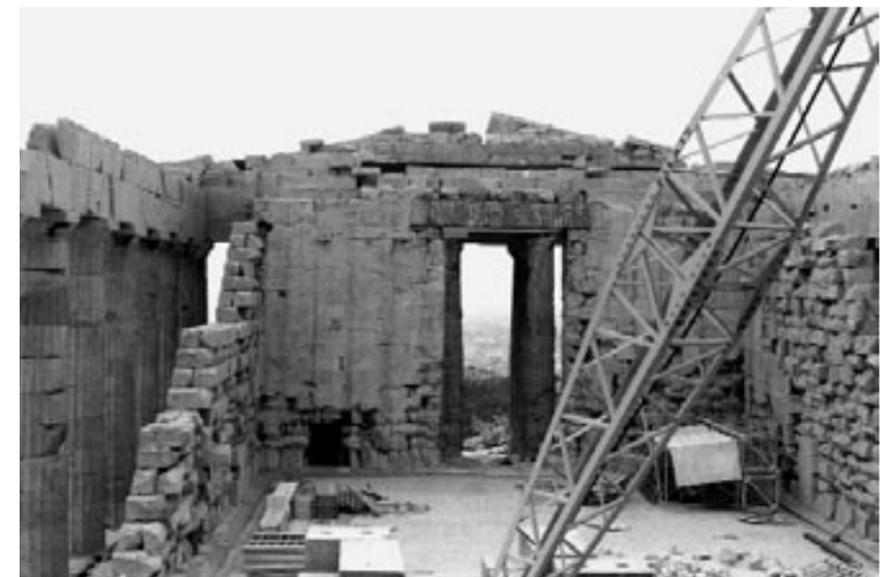
The west wall of the Parthenon from the east. Visible is the concrete ceiling of the west door from the Balanos intervention. Photo S. Mavrommatis, 1986

3. *Intervention on the west wall:* the work comprises chiefly the dismantling of the lintel of the west doorway, restored earlier using reinforced concrete, the replacement of this with new marble and the partial dismantling of the upper section of the west wall. The study for this intervention, made by Professor M. Korres, has been approved by the Central Archaeological Council and the definitive study is being carried out by the architect L. Lambrinou.

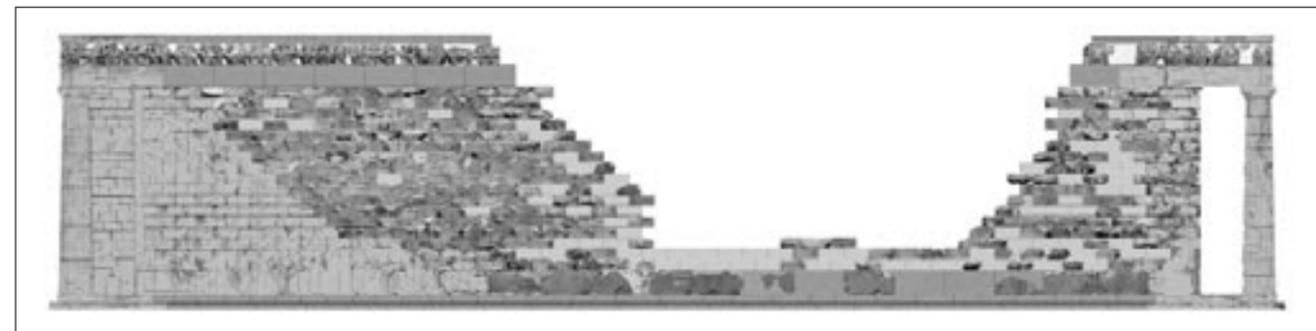
Proposal for the restoration of the south cella wall of the Parthenon. Photographic reconstruction by C. Paraschi and S. Mavrommatis, 2002

1. *Broad reconstruction of the wall blocks in the superstructure of the south wall of the*

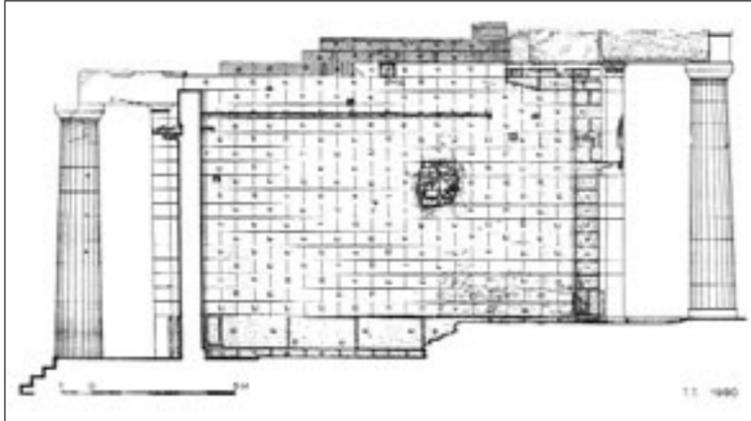
The programmed restoration of south wall of the west hall of the Propylaea central building. Study by K. Karanasos, original drawing by T. Tanoulas

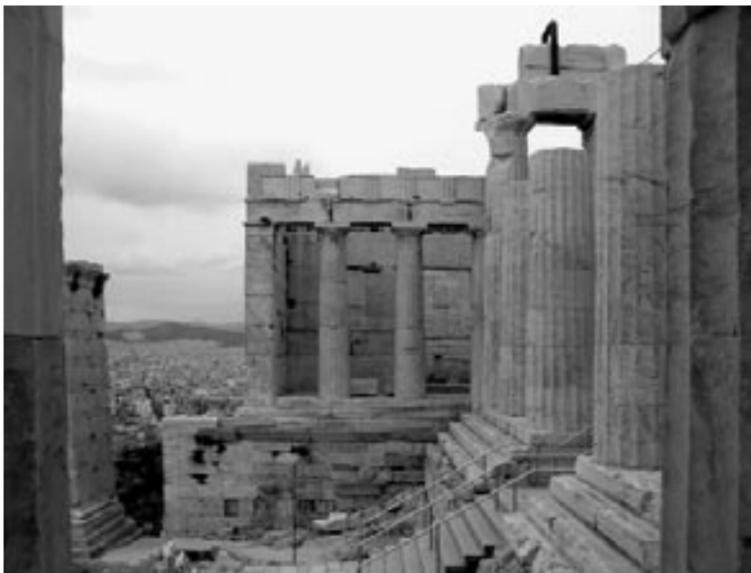
The north wing of the Propylaea from the south. Photo F. Mallouchou-Tufano, February 2007

following works: removal of the cement floor and its replacement with a metal flooring or conservation of the existing cement floor and filling in of the basement space, dismantling-conservation of the uppermost level of Frankish mediaeval additions and first underlying course. A crane will have to be installed within the north wing to perform the work.

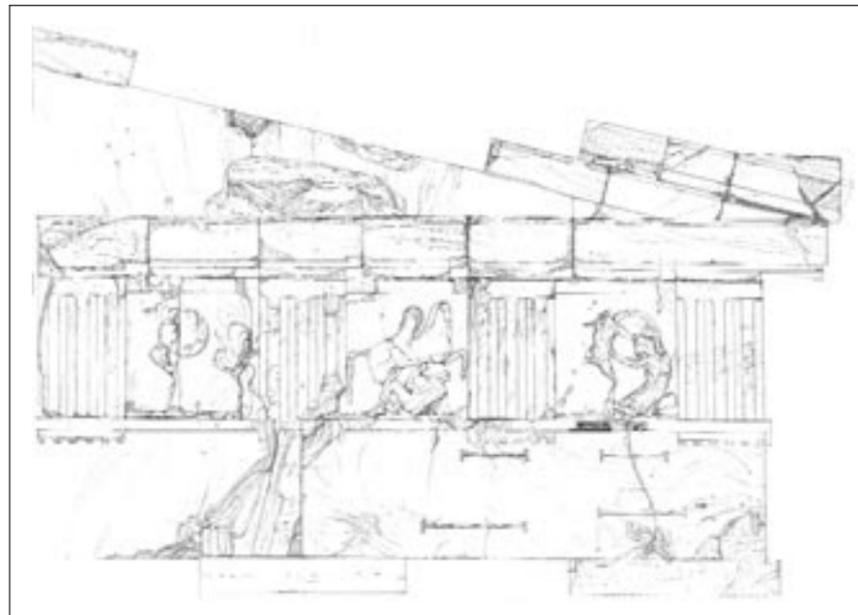
The Parthenon SW corner showing fractures of the architrave blocks and openings in joints of the end cornice blocks. Study-drawing by V. Manidaki, 2008

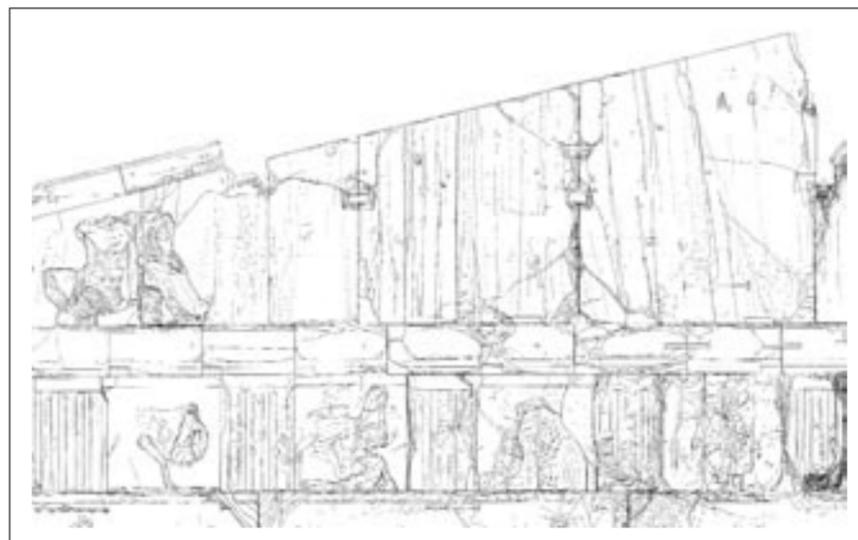
The tympanon orthostates of the central area of the Parthenon west pediment showing breaks at the joining elements, ancient and recent. Study-drawing by V. Eleftheriou, 2008

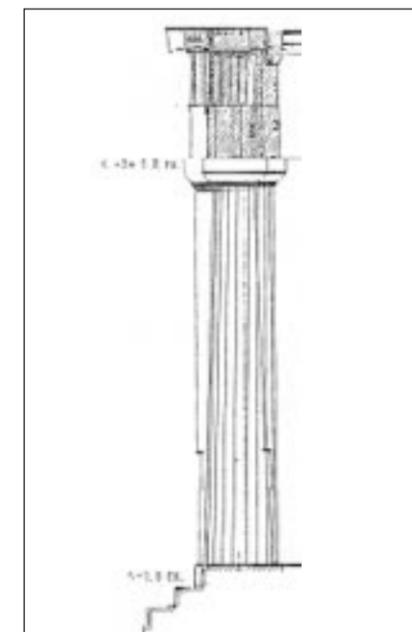
Deviation of the Parthenon NW corner towards the west. Study-drawing by V. Eleftheriou, V. Manidaki, A. Vrouva, 2008

As has been observed in earlier studies, the courses of the entablature have suffered significant horizontal displacement in an east-west direction, with characteristic outward shifting of the corners, forming a concave curve in plan. This deformation has been verified with new measurements made at the level of the architrave and the horizontal cornice blocks (a deflection in the nature of 7 cm and 12 cm respectively) was measured and it is analogous with the deformation verified in the opisthonaos.

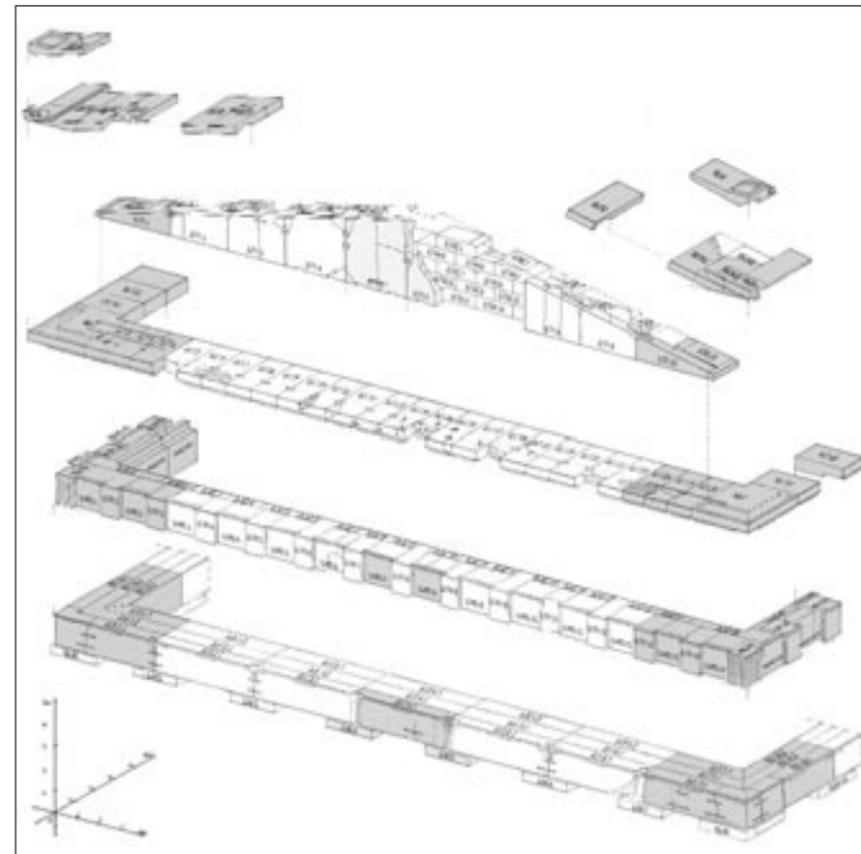
The areas of the programmed intervention on the Parthenon west side showing the blocks to be dismantled. Study-drawing V. Eleftheriou, V. Manidaki, A. Vrouva, 2008

Dismantling will be limited and will stay within the boundaries of Balanos' interventions for the restoration of the exterior plinth of the central architrave block and the tympanon of the pediment. There is therefore no problem about the extent of the area of

intervention. It is otherwise with the extent of the area of intervention on the two corners, as here there is a theoretical question concerning the type and quality of restoration. Determining factors in the extent of the area to be dismantled are the cracked and shifted architrave blocks of the two corners.

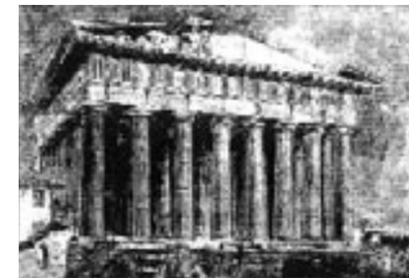
Illustrations of the Parthenon west side by W. Gell in 1801 (left) and S. Fauvel in 1790 (right)

It is proposed to set two new raking cornice blocks on the north wing of the tympanon and two underlying blocks of the backing wall, which are necessary for their support. The raking cornices and all the orthostates of the tympanon were preserved *in situ* to the end of the 18th century and are illustrated in drawings of the period (for example, in Fauvel's watercolour of 1790). The addition of the above new members will greatly improve

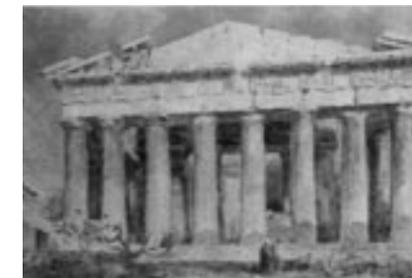
Restoration proposal for the Parthenon west side. Electroning editing of a S. Mavrommatis' photo by V. Manidaki, 2008

it is considered worthwhile to restore the central orthostate of the south side to its original dimensions by filling in with new marble the two identified fragments (the first fragment, which was set in place in the Orlandos anastelosis, and the second, which was identified by M. Korres). Restoration of the 7th orthostate, the only one of the entire series that is not preserved, will complete the intervention on the tympanon of the pediment. This will be done for both aesthetic and structural reasons.

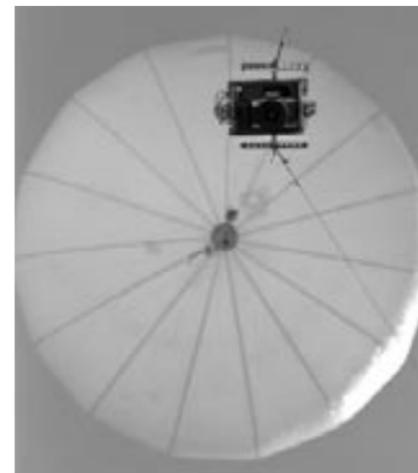
Meteorological balloon for lifting the photogrammetric camera

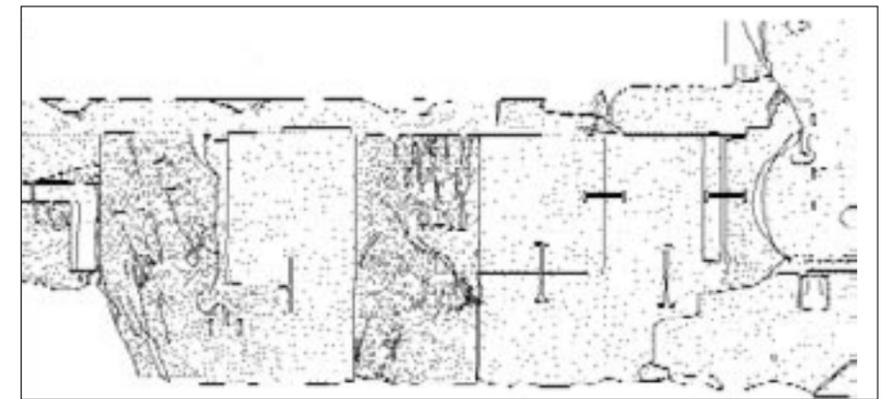
Digital surface model: part of the plan of the west part of the Parthenon north colonnade entablature. D. Mavromati, 2008

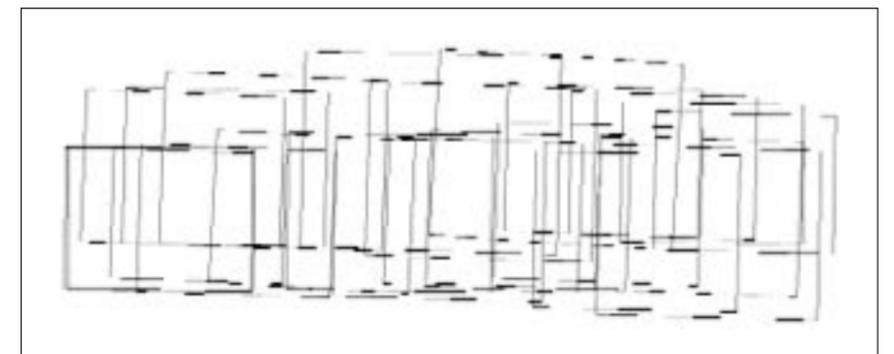
Footprints of the images of the plan of the west part of the Parthenon north colonnade entablature. D. Mavromati, 2008

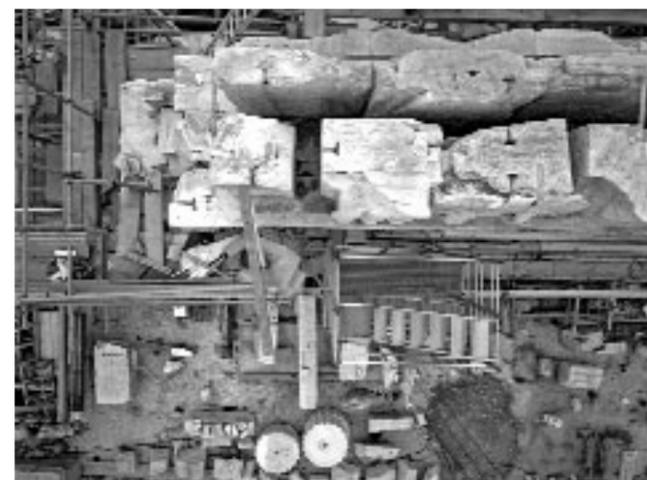
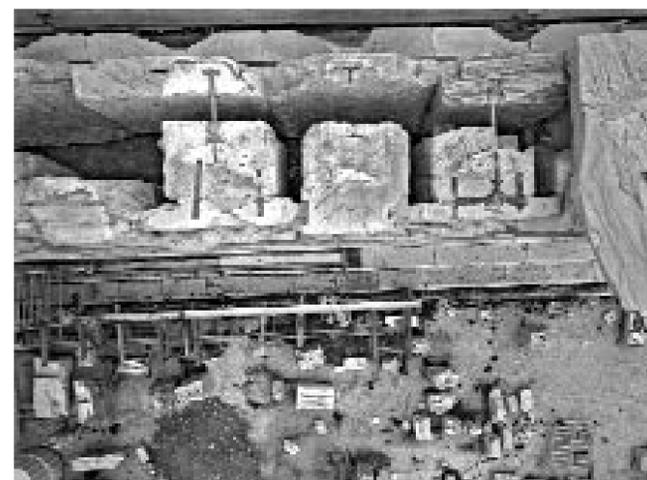
Original photographs of the plan of the west part of the Parthenon north colonnade entablature. S. Yesaphidis -A. Santrouzanos, 2008

The photographs were taken from a distance of 10 m with an analogue camera of medium format (60mm x 45mm) with a 45mm wide-angle lens by S. Yesaphidis and A. Santrouzanos (Directorate of Topography, Photogrammetry and Land Register of the Ministry of Culture). Eight images with an overlapping over 60% were used.

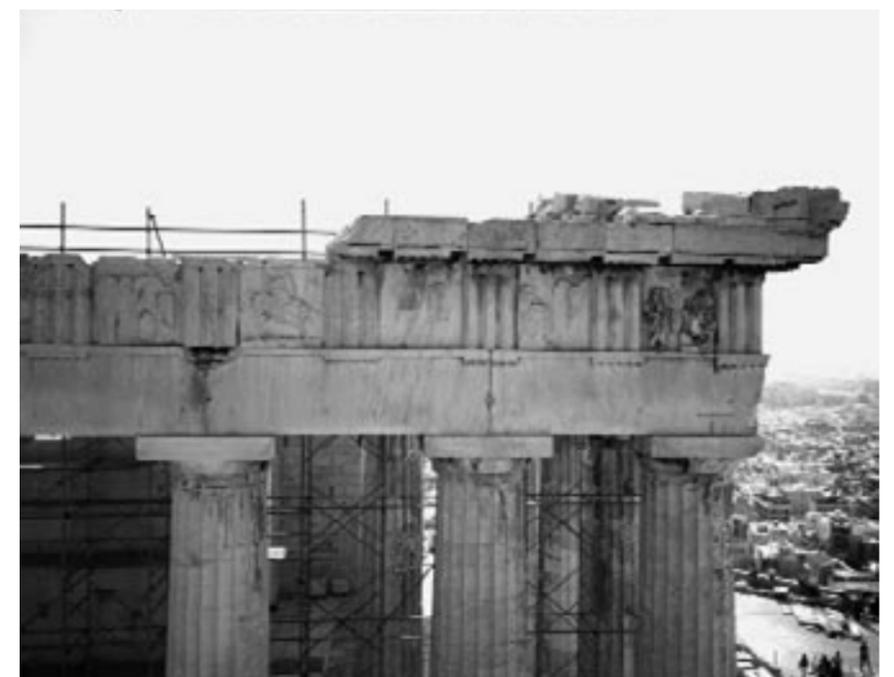
Original photographs of the elevation of the entablature of the Parthenon north colonnade. S. Yesaphidis-A. Santrouzanos, 2008

The photographs were taken from a distance of 10m with an analogue camera of medium format (60mm x 45mm) with a 45mm wide-angle lens by S. Yesaphidis and A. Santrouzanos (Directorate of Topography, Photogrammetry and Land Register of the Ministry of

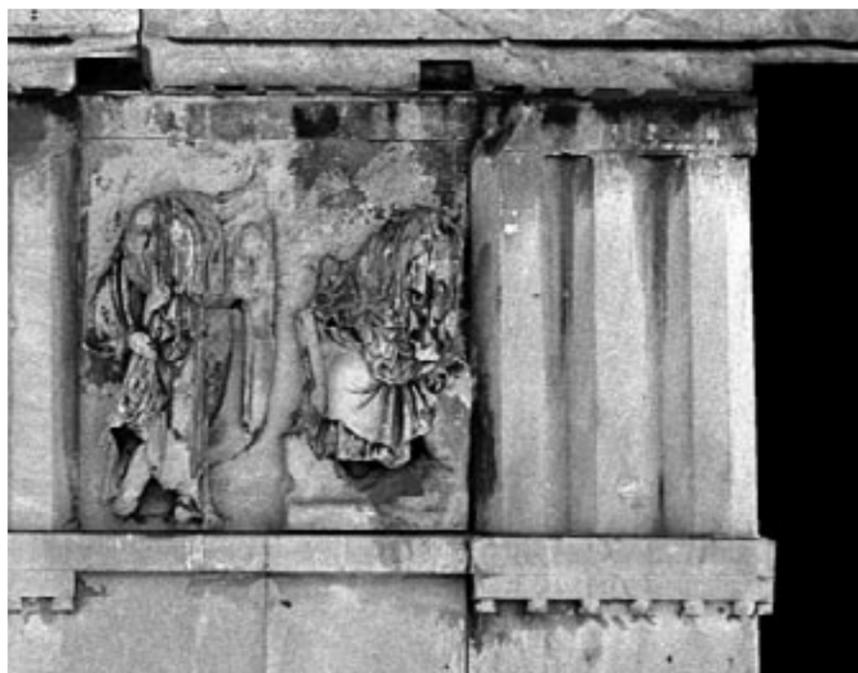
The westernmost metope of the Parthenon north side. Detail of the orthophotomosaic of the elevation of the west part of the entablature. D. Mavromati, 2008

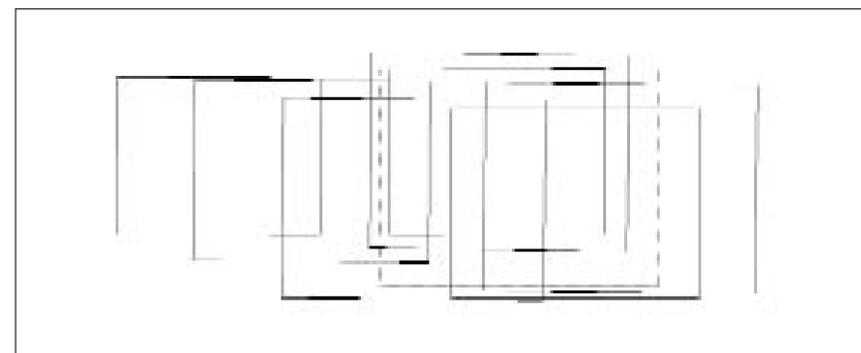
Footprints of the images of the elevation of the entablature of the Parthenon north colonnade. D. Mavromati, 2008

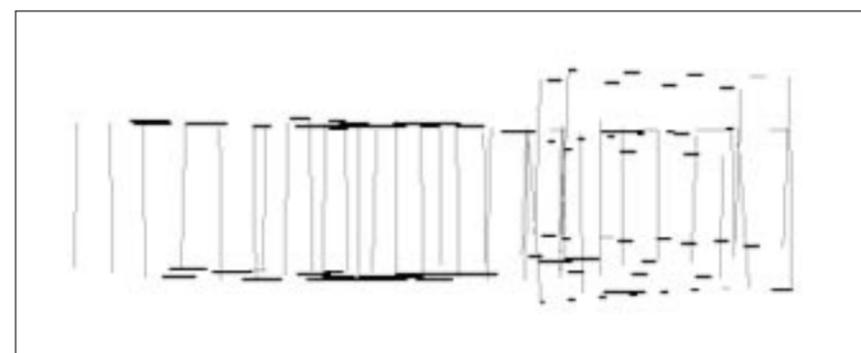
Footprints of the images of the elevation of the entablature and the pediment of the Parthenon west side. D. Mavromati, 2008

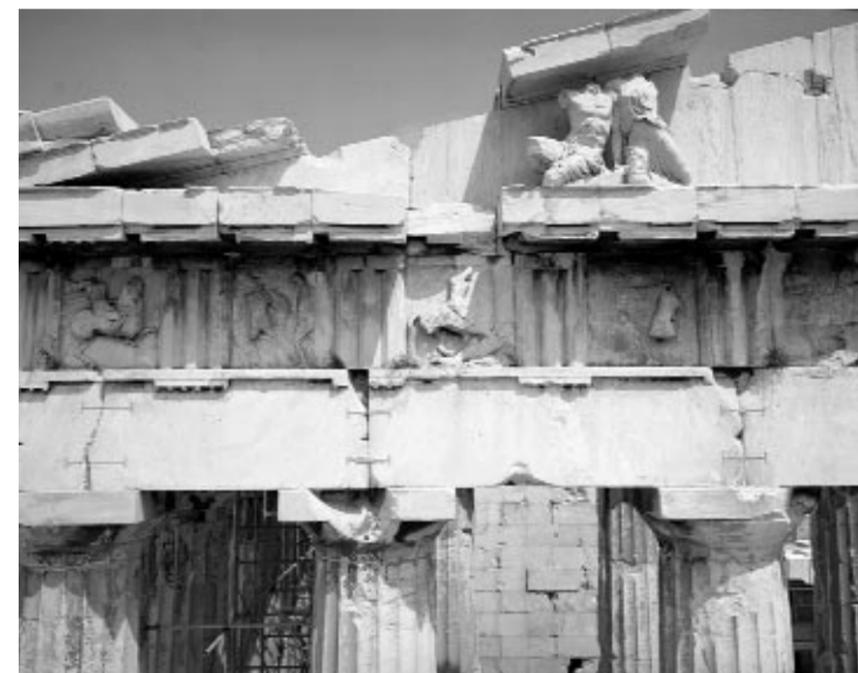
Original photograph of the elevation of the entablature and the pediment of the Parthenon west side. S. Yesaphidis-A. Santrouzanos, 2008

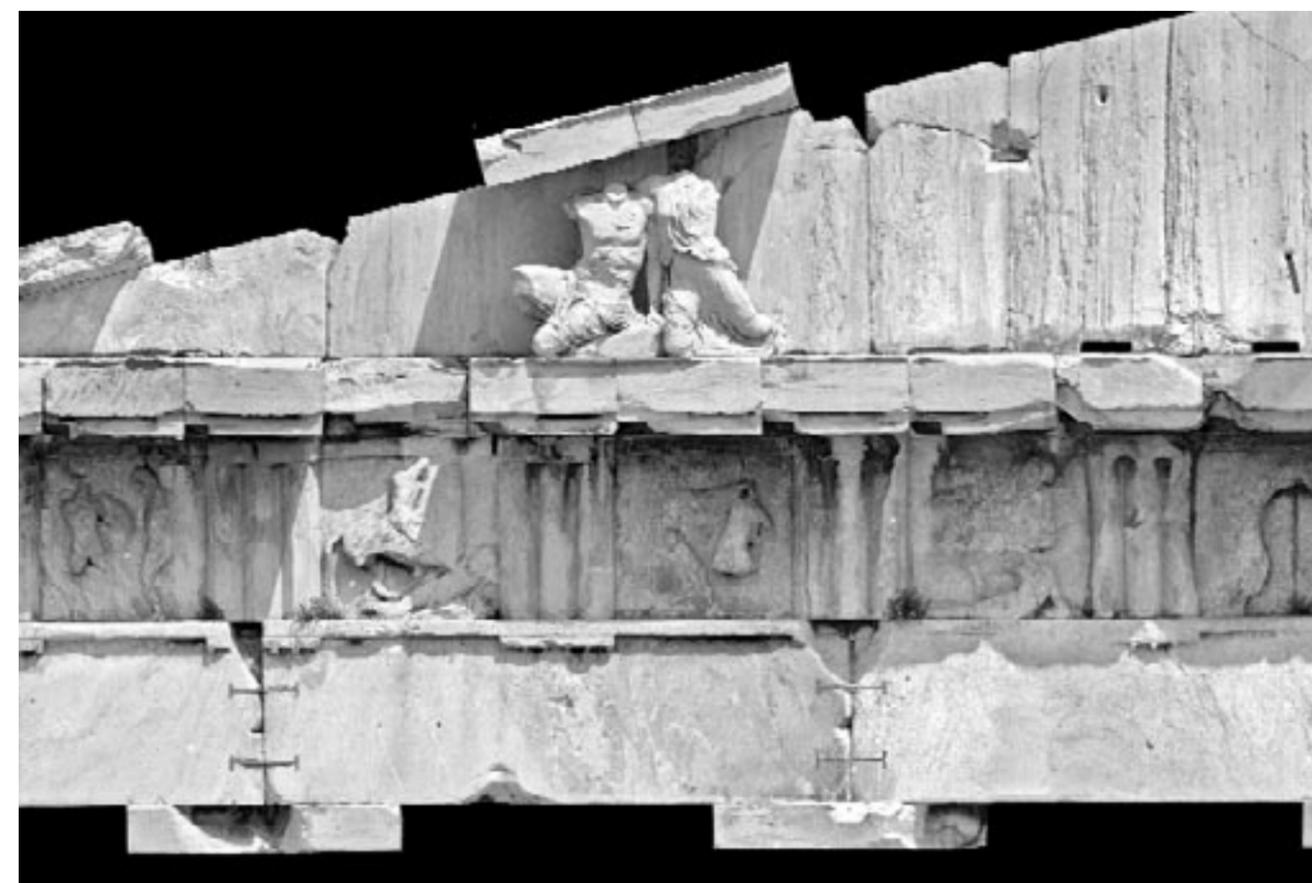
Detail of the orthophotomosaic of the elevation of the entablature and the pediment of the Parthenon west side. D. Mavromati, 2008

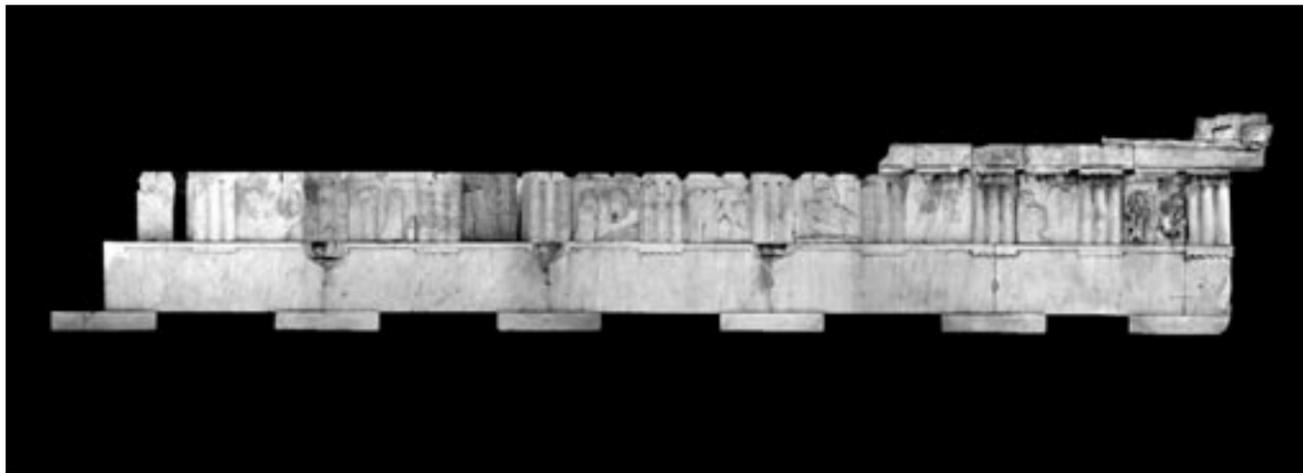
Final orthophotomosaic of the elevation of the west part of the entablature of the Parthenon north colonnade. D. Mavromati, 2008

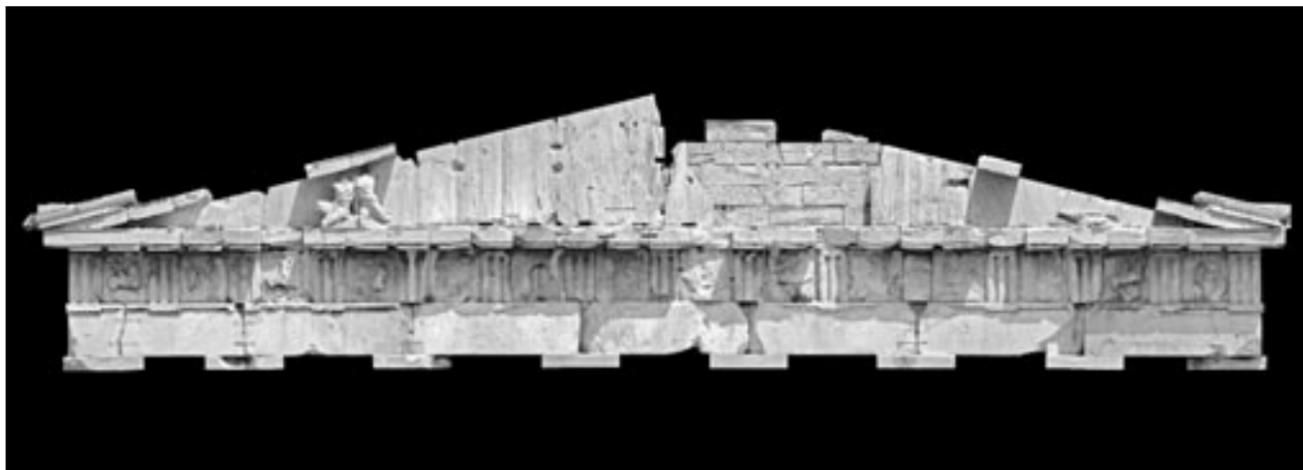
Final orthophotomosaic of the elevation of the entablature and the pediment of the Parthenon west side. D. Mavromati, 2008

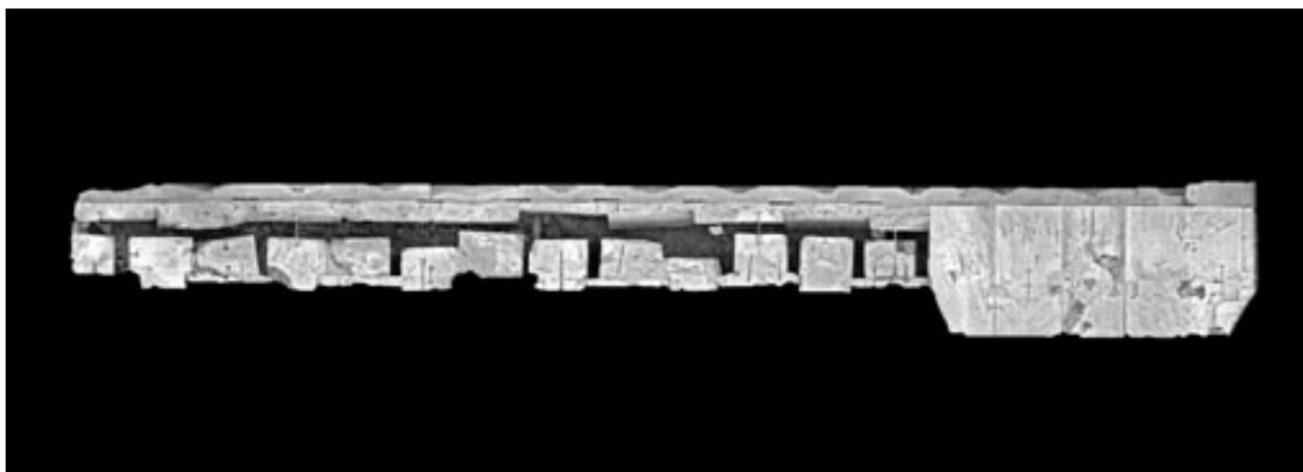
Final orthophotomosaic of the plan of the west part of the entablature of the Parthenon north colonnade. D. Mavromati, 2008

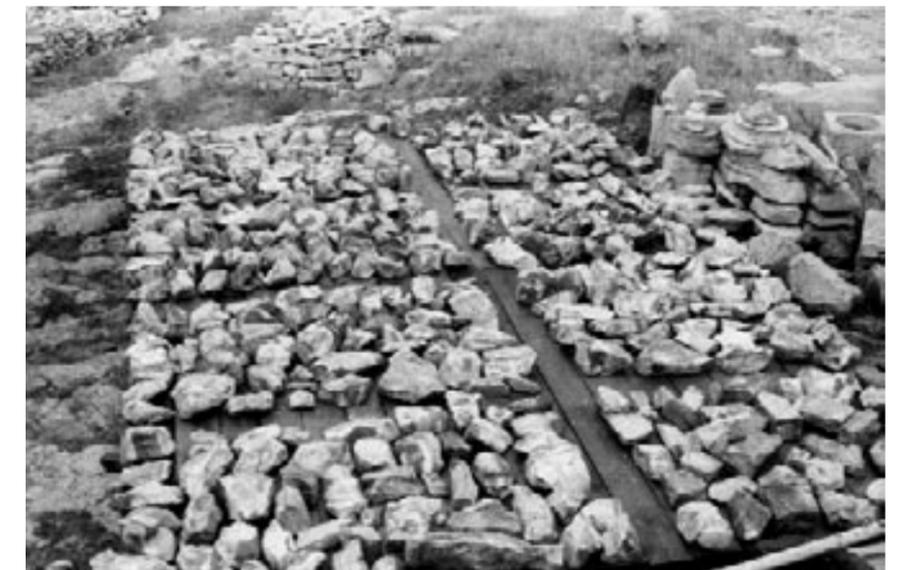
Scattered members of a stone pile preliminarily classified on wooden stands. Photo Th. Karabelas, 1997

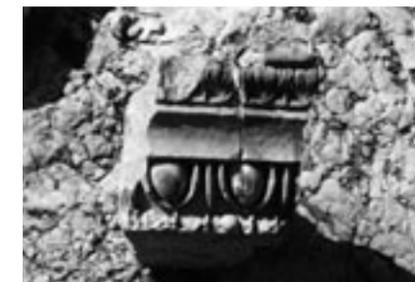
Photographic record of a scattered member: roman crown block with Lesbian and Ionic mouldings (Inv. No 1067). Photo D. Giraud, 1980

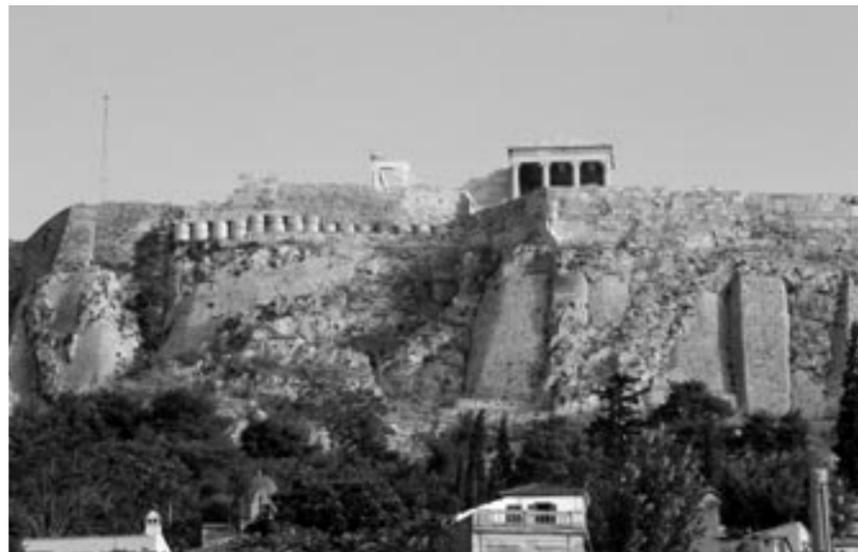
Elevation of part of the north Circuit Wall with visible signs of damage. Photo D. Englezos, 2007

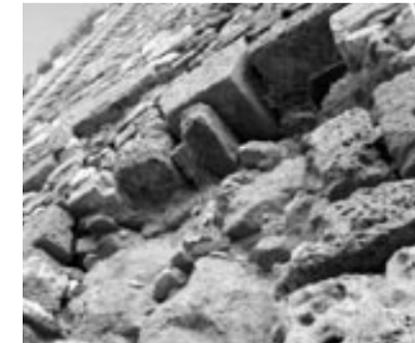
Characteristic erosion in part of the south Circuit Wall of the Acropolis. Photo D. Englezos, 2008

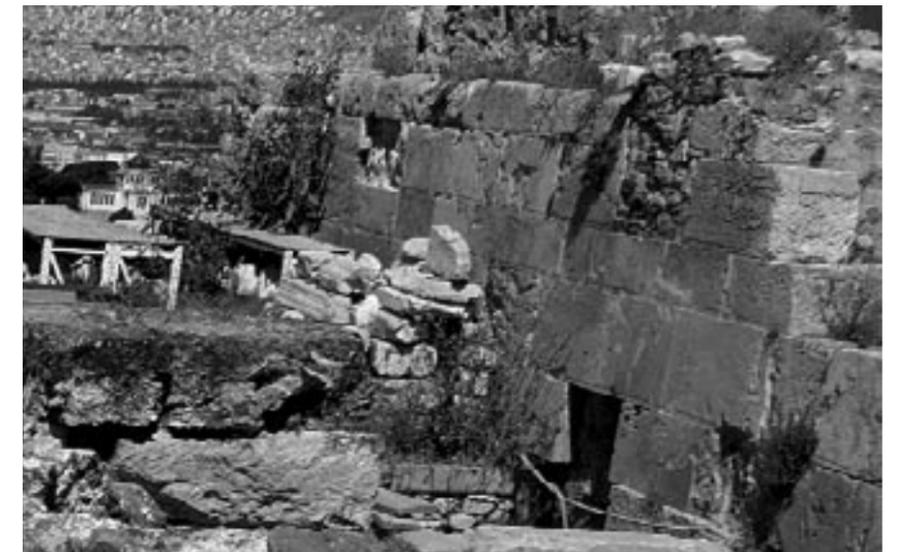
Deviation from the vertical axis in part of the north Circuit Wall of the Acropolis. Photo D. Englezos, 2008

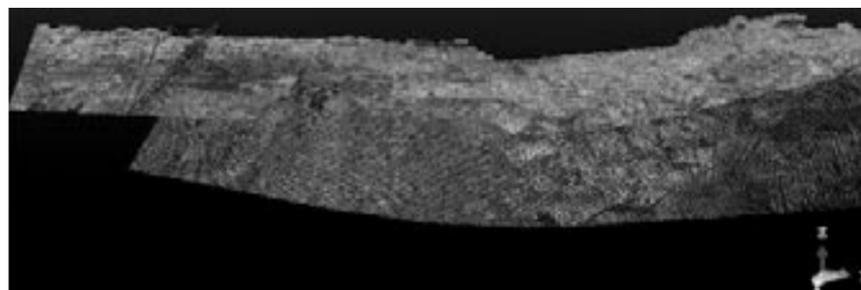
Point cloud from laser scanning of an area of the north Circuit Wall of the Acropolis. Photo of 2008

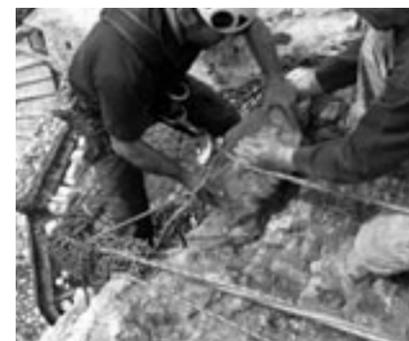
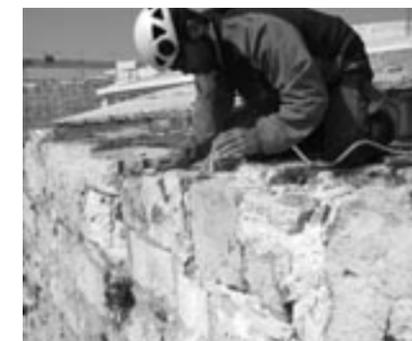
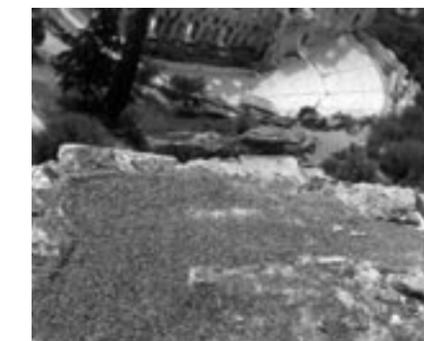
Structural restoration of a small part of the south Circuit Wall. Photo D. Englezos, 2008
