General view of the Acropolis from the southeast. Photo G. Paganis, January 2008

- M. Ioannidou, 2007-2008, progress of the Acropolis Anastelosis Works
M. Ioannidou, Conservation and Restoration of the Acropolis Monuments: interventions planned for the period 2009-2013
V. Eleutheriou, V. Manidakis, A. Vrouva, Restoration of the west side of the Parthenon. General programming of the work and proposals for intervention
D. Mavromati, The use of orthophotography in the geometric documentation of the Parthenon
E. Sioumpara, Inventorying the Scattered Members of the Acropolis
D.N. Englezos, D. Moullou, Preservation of the Circuit Wall of the Acropolis: past and future
F. Mallouchou-Tufano, News from the Acropolis
F. Mallouchou-Tufano, Honouring the marble technicians of the Acropolis: the Gold Cross of the Order of the Phoinix to Nikos Skaris

Anastelosis on the Acropolis continued at undiminished pace during the second half of 2007 and the first half of the present year. The works, as is well known, are carried out by the Acropolis Restoration Service (YSMA) itself, a special Service of the Ministry of Culture, with the academic supervision of the Committee for the Conservation of the

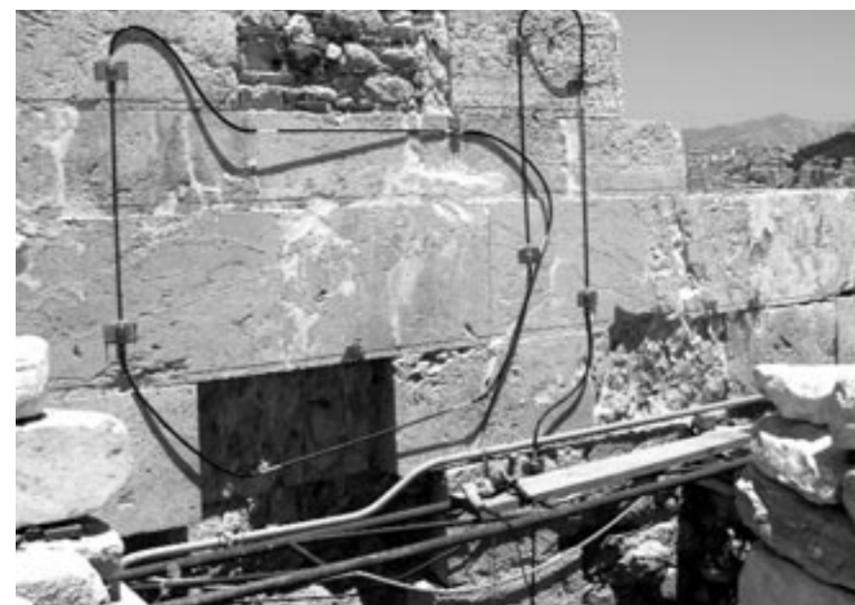
Placement of optical sensors in an area of the inner face of the north Circuit Wall showing considerable deformation. Photo D. Englezos, 2008

rotations, the stresses and the temperature. Monitoring insures first of all the timely diagnosis of possible disturbing phenomena related to the stability of the monument and therefore suggests a correct intervention. Moreover, the interrelation of information from the monitoring process with the information from the computational tools and the various analyses yields a scholarly correct simulation of the problem, so that the best measures from the standpoint of security and cost can be undertaken. With the completion of

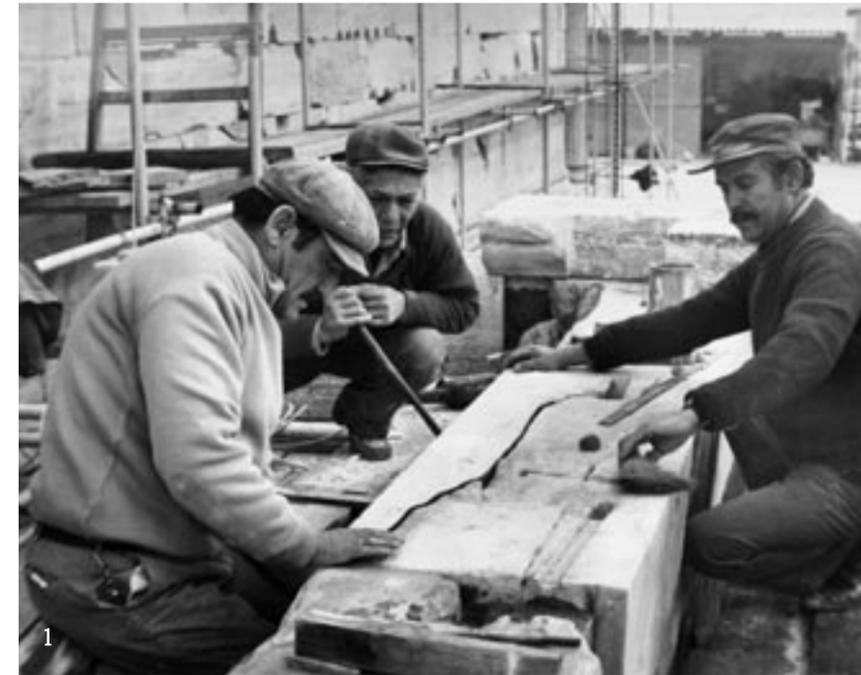
1

1. Nikos and Markos Skaris with Giorgos Sinanis (from right) in 1979, filling the orthostates of the podium of the Erechtheion south porch with new marble

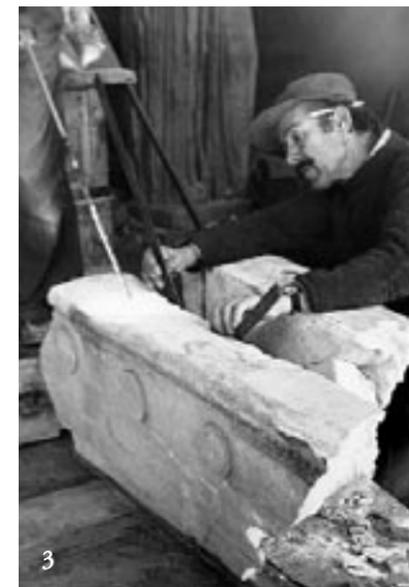
3

3. Marking an architrave of the Erechtheion south porch for inserting titanium rods for the structural restoration of the block, in 1979

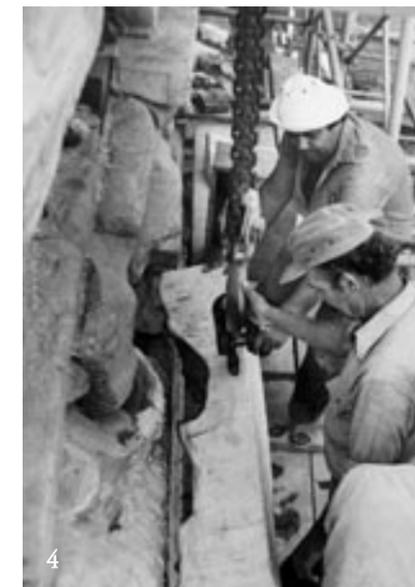
4

4. Nikos Skaris and Stelios Kafouros in 1982, filling an orthostate block of the Erechtheion south wall with new marble

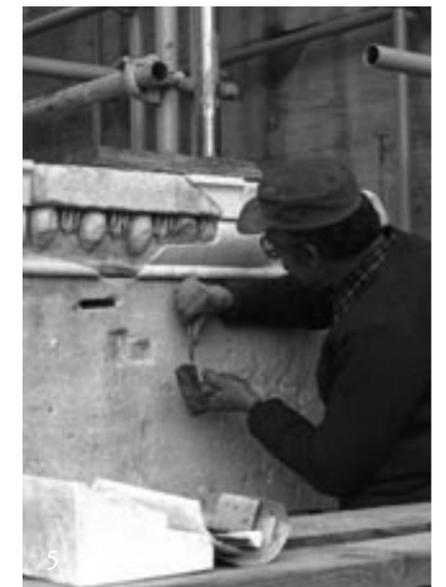
5

5. Carving the moulding of the new marble fillings of the crown of the podium in the Erechtheion south porch, in 1980

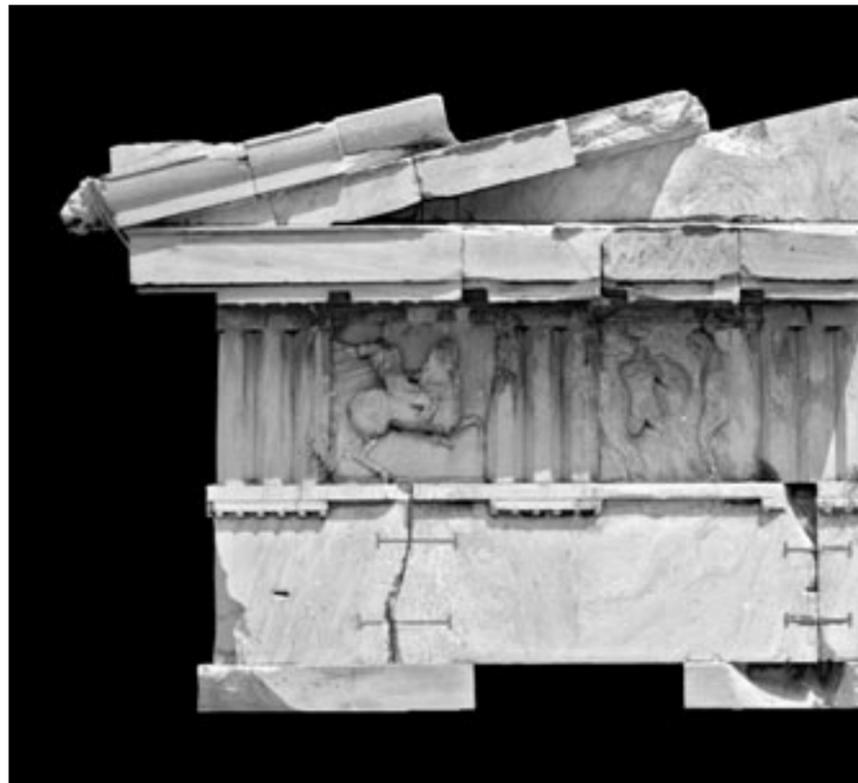
Orthophotomosaic of the northeast corner of the Parthenon west side. D. Mavromati, 2008

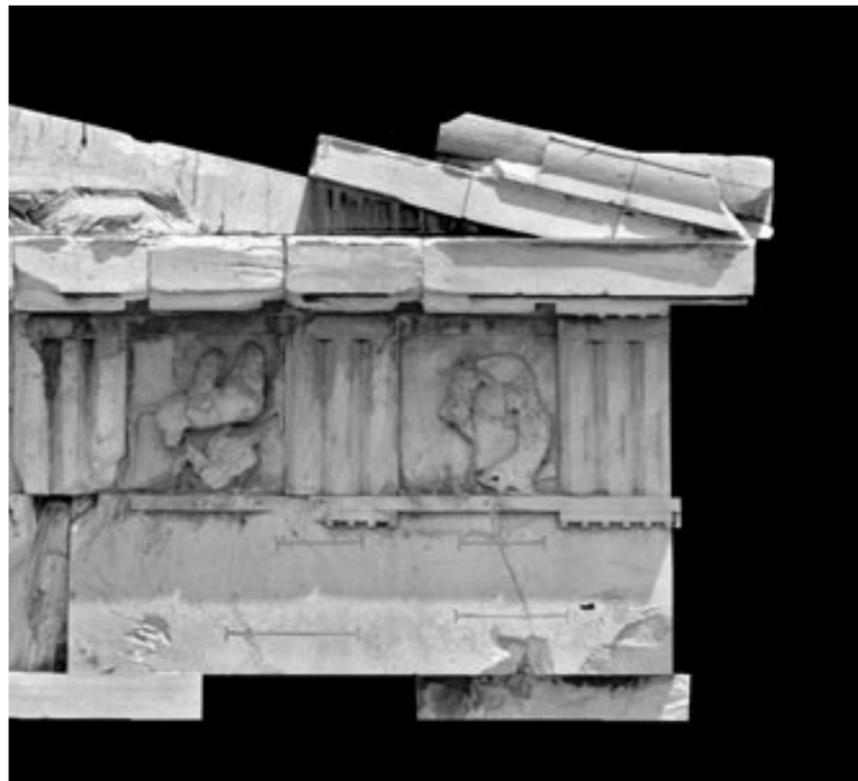
Orthophotomosaic of the southeast corner of the Parthenon west side. D. Mavromati, 2008
