PROCEEDINGS of a ONE-DAY CONFERENCE  
*Modern technologies in the restoration of the Acropolis*  
19 March 2010

### DIGITAL METHODS OF GEOMETRIC DOCUMENTATION OF THE MONUMENTS

### INSTRUMENTAL MONITORING OF DISPLACEMENT AND DEFORMATION

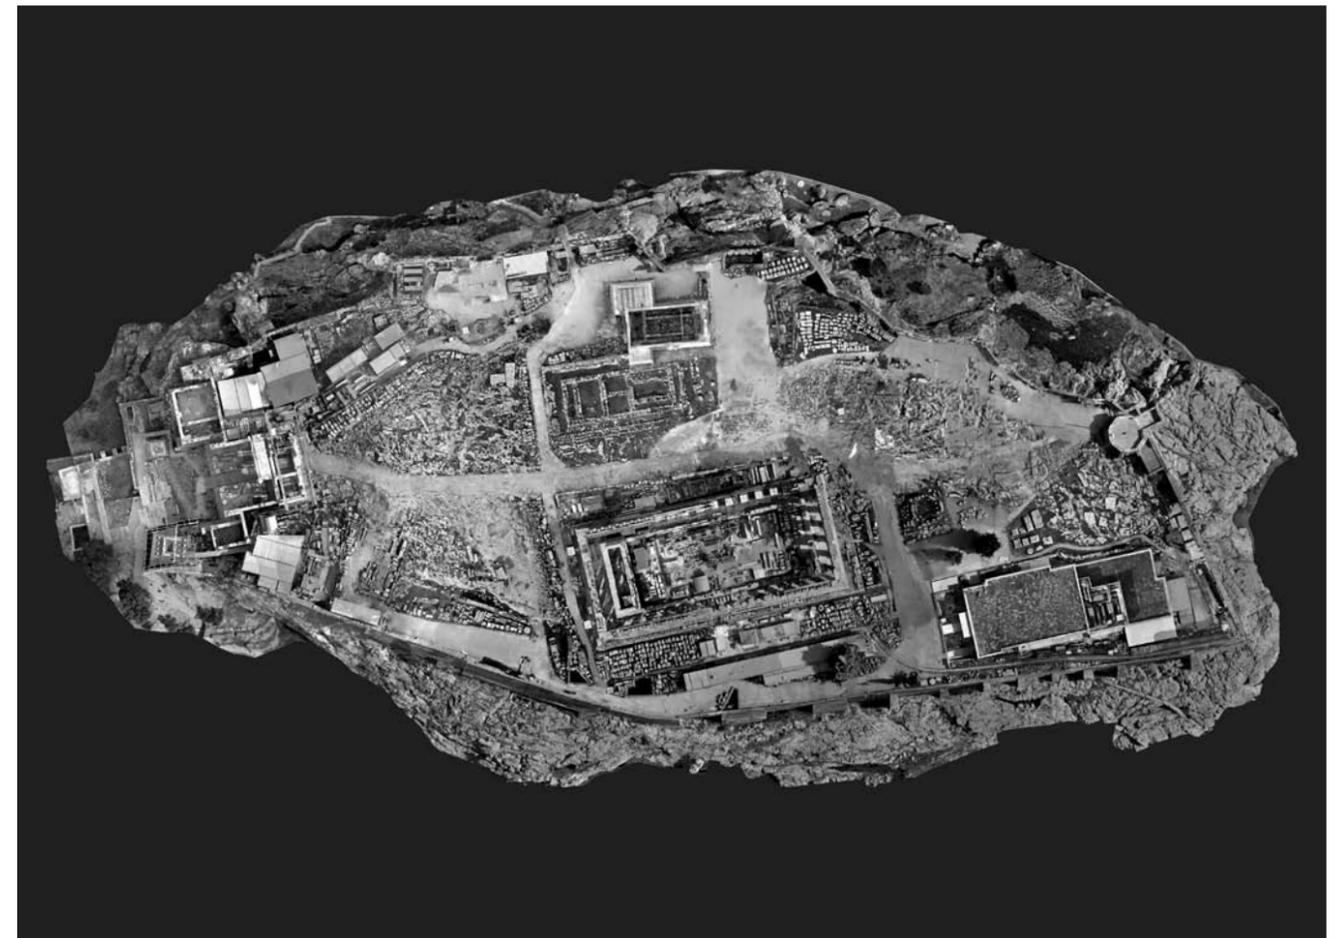
*Orthophotomosaic of the Acropolis rock. Study for the development of Geographical Information Systems on the Acropolis of Athens, 2009*

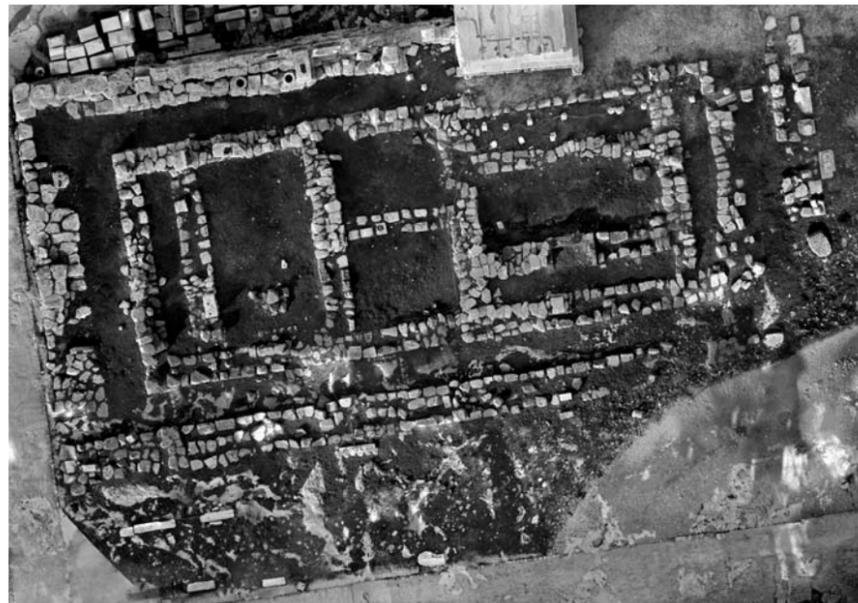
Fig. 3. Orthophotomosaic of the Archaos Naos. Study for the development of GIS on the Acropolis of Athens, 2009

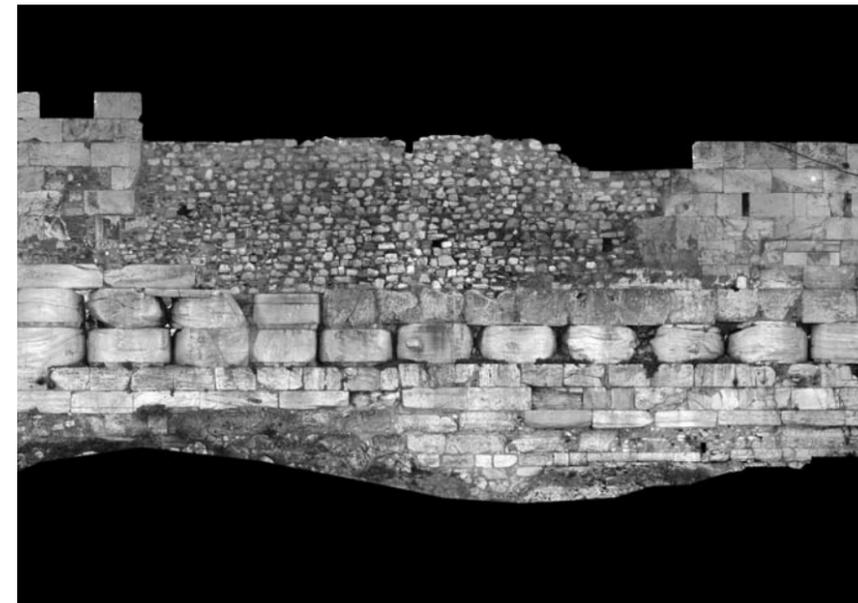
Fig. 4. Orthophotomosaic of the north Wall of the Acropolis. Study for the development of GIS on the Acropolis of Athens, 2009

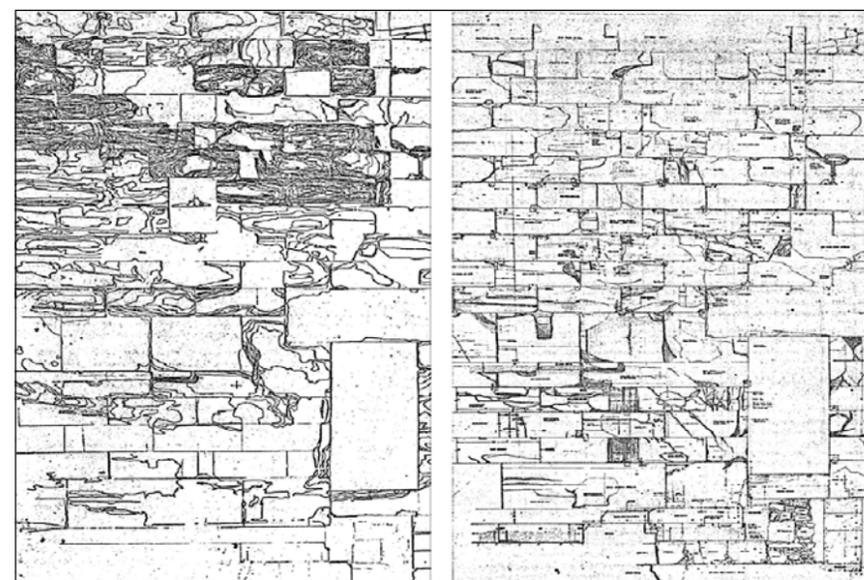
Fig. 3. Erechtheion, south wall. Left, photogrammetric line drawing, not processed by an architect (Photogrammetry Laboratory of the National Technical University of Athens). Right, line drawing of same area, based on the photogrammetric survey, completed by an architect with field observations (Plotting-drawing: E. Moutopoulos)

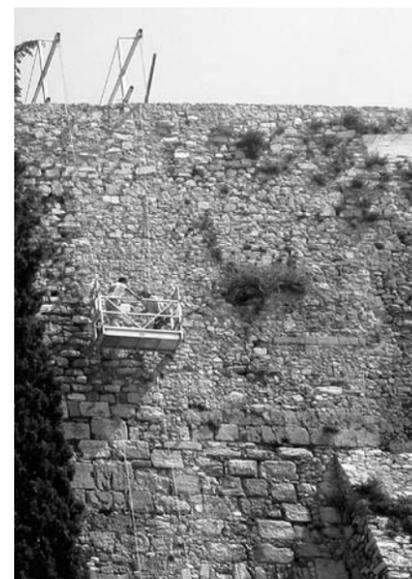
Fig. 4. Work platform at the south Wall. Photo V. Manidaki, 2005

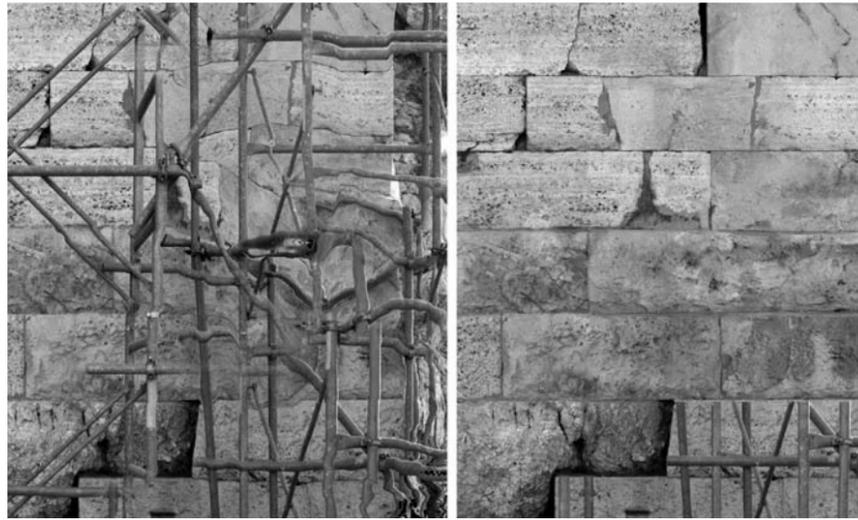
Fig. 2. Tower of the temple of Athena Nike. Deformed orthophotograph (left). Final orthophotograph (right)

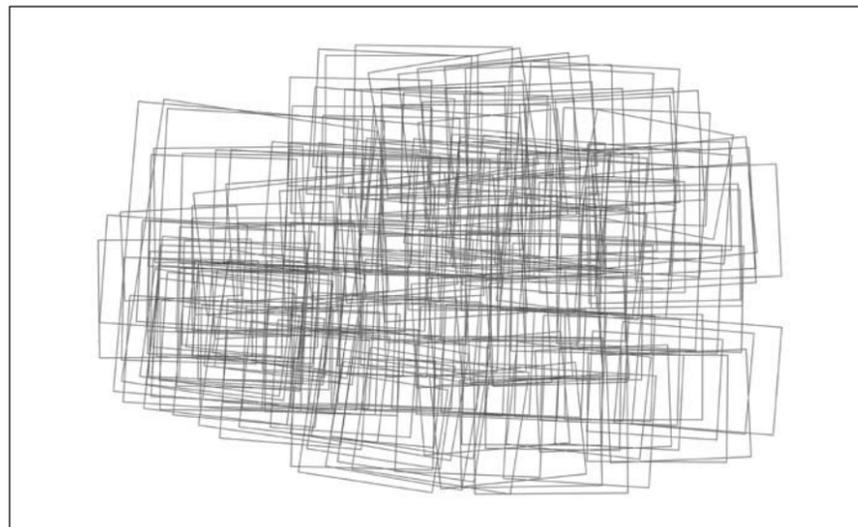
Fig. 1. Footprints of balloon images. D. Mavromati, 2006

In order to meet the predetermined accuracy of the phototriangulation, dense recording is needed to ensure adequate overlap and number of intersecting rays. This is in any case necessary so as to ensure that no areas are “hidden” because of perspective. It is like-

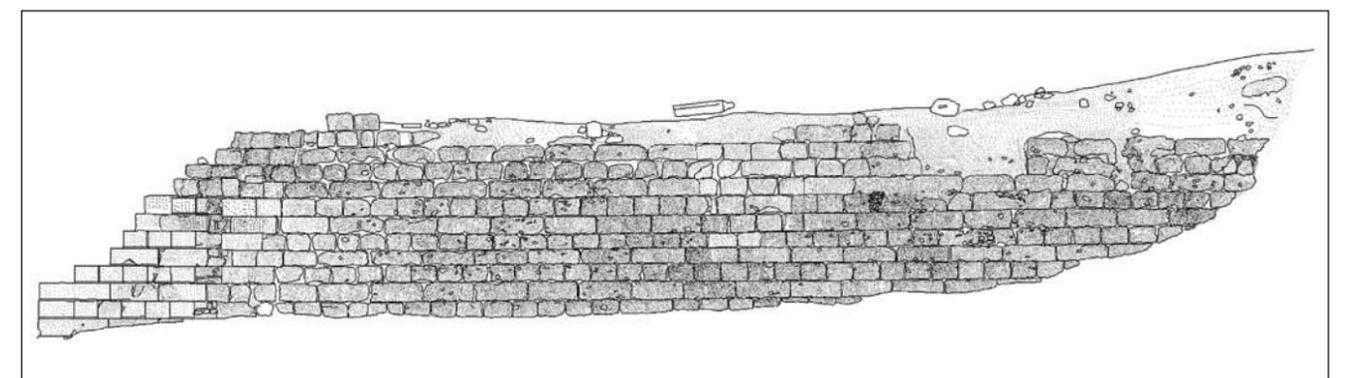
Fig. 5. Plan of the digital surface model of the elevation of the east side retaining wall of the cavea of the theatre of Dionysos. D. Mavromati, 2005.

Crucial for both geometric accuracy and optical quality of the final orthophotography is also the accurate description (modelling) of the surface of the object. This modelling is done with the breaklines and elevation points. Automatic collection of elevation points with the use of suitable software is in general unsuitable for applications used for the monuments because of the poor texture or great reflectivity of their surface, and because of the many occlusions. Usually, manual stereoscopic measurement is still the main mode of collection. If a commercial software is used, all the photogrammetrically collected elevation points and breaklines are typically intergraded by 2D Delaunay triangulation into a surface mesh

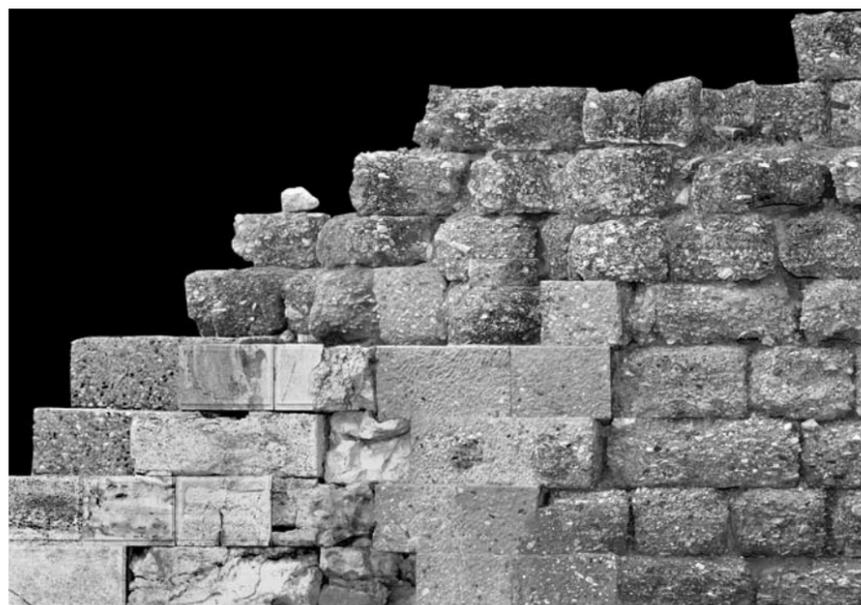
Fig. 6. Detail of the orthophotomosaic of the elevation of the east side retaining wall of the cavea of the theatre of Dionysos. D. Mavromati, 2005

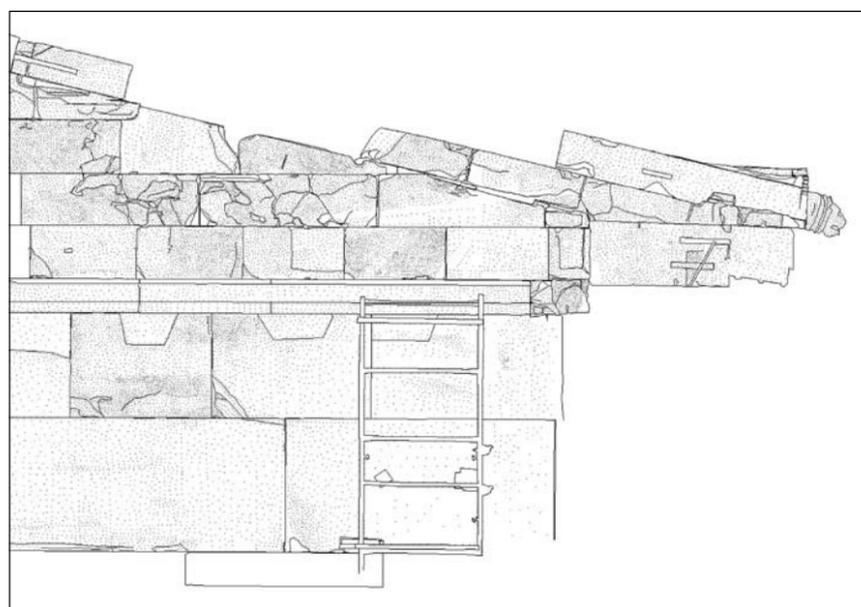
Fig. 7. Plan of the digital surface model of the north corner of the east elevation of the entablature and the pediment of the west side of the Parthenon. D. Mavromati, 2009

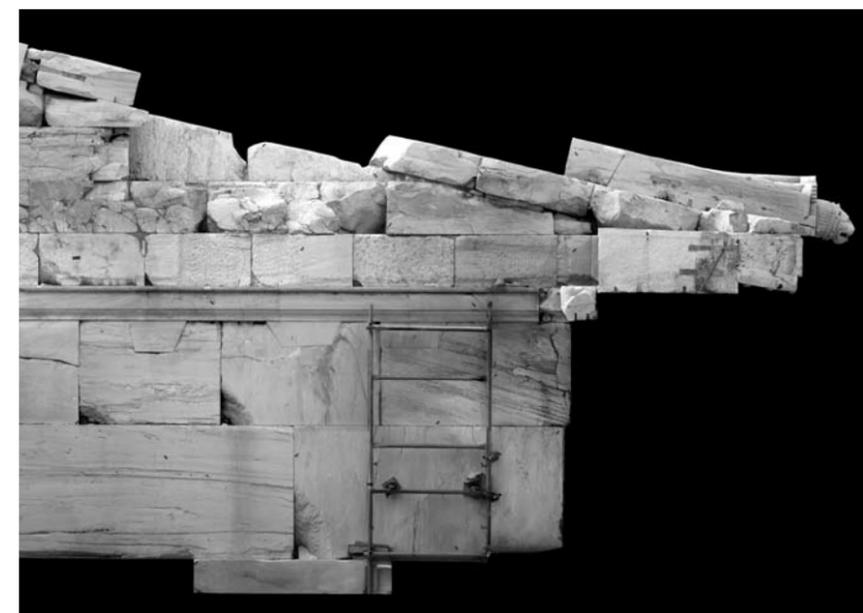
Fig. 10. Orthophotomosaic of the north corner of the east elevation of the entablature and pediment of the west side of the Parthenon, D. Mavromati, 2009

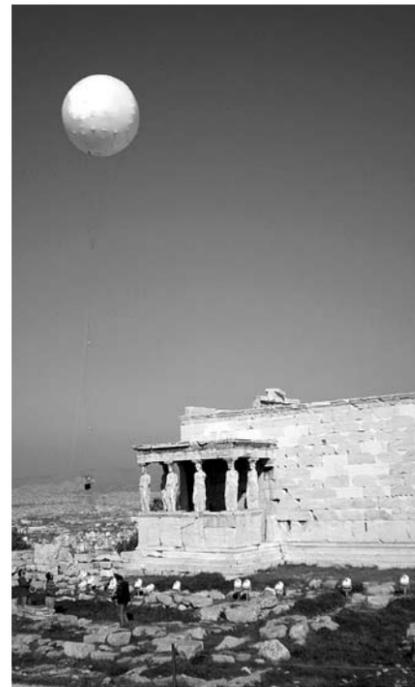
Fig. 1. The balloon system  
Photo V. Tsingas, 2009

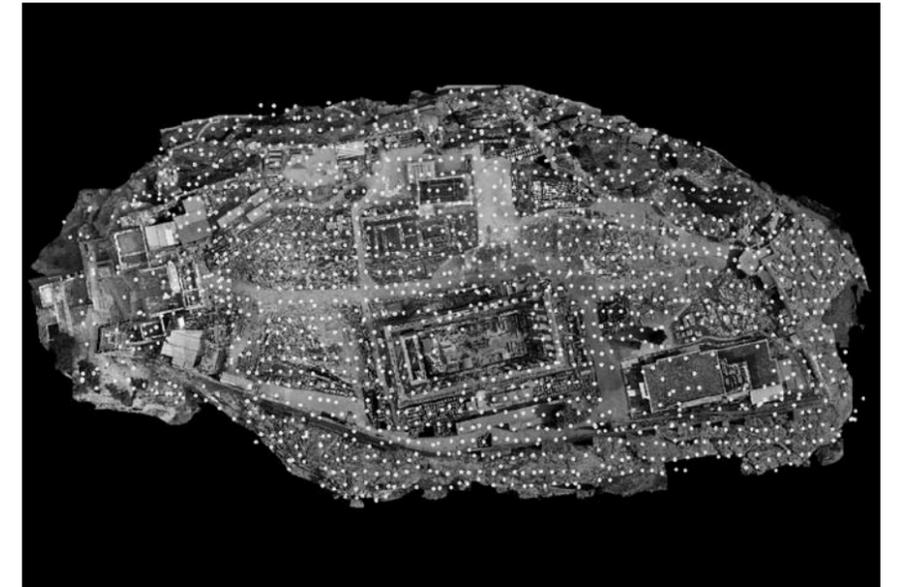
Fig. 2. Diagram (virtual centre) of the shots for the ground-plan

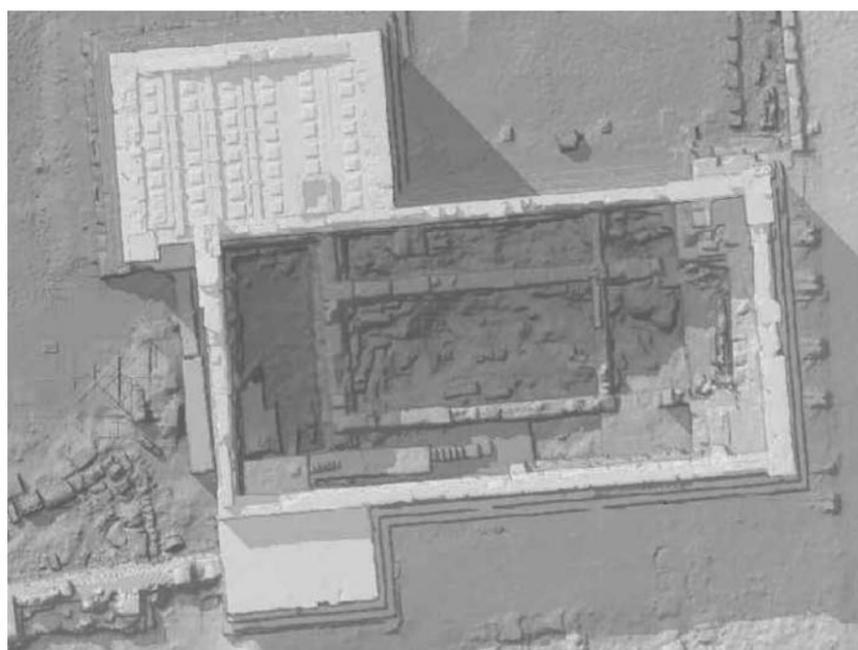
Fig. 4. Digital terrain model in the area of the Erechtheion

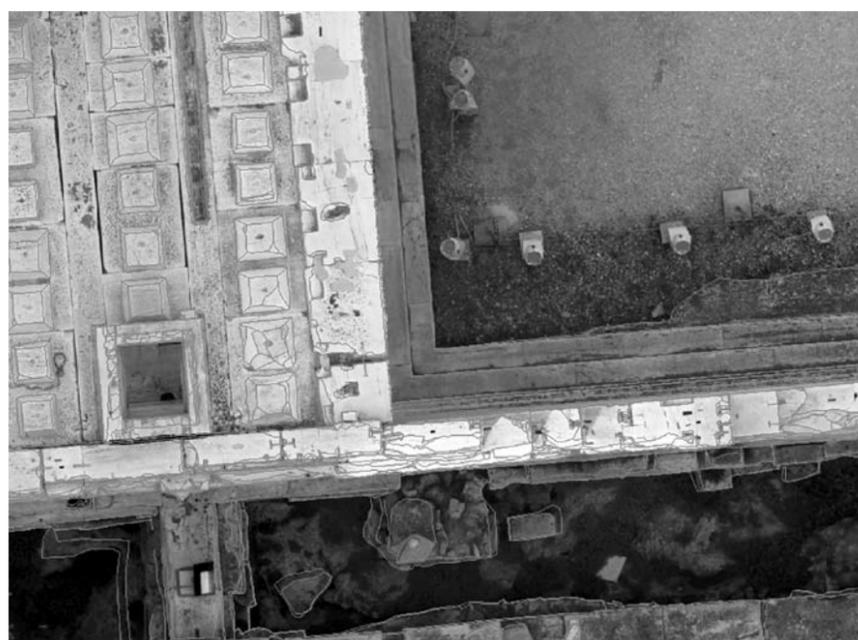
Fig. 3. Breaklines (lines of discontinuity)

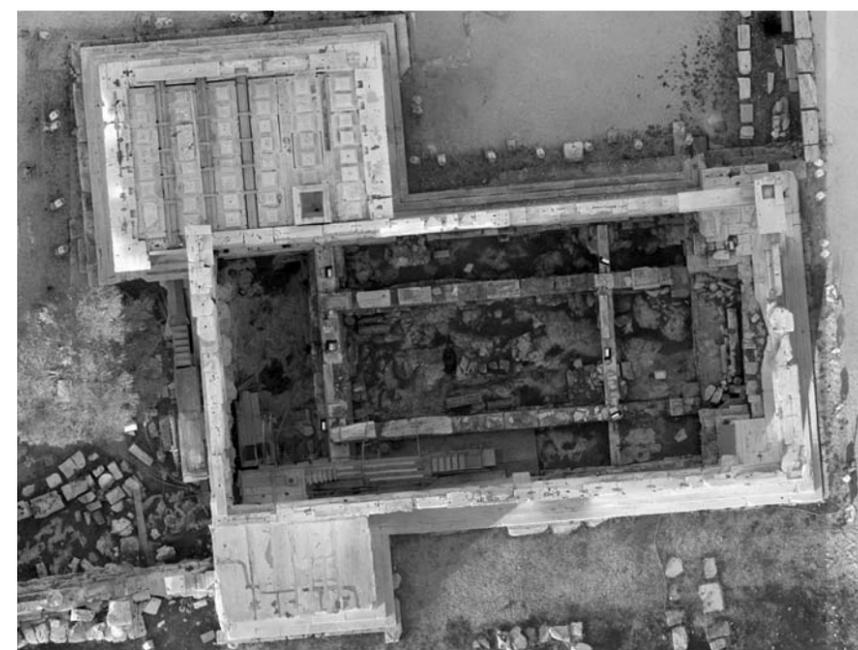
Fig. 5. Orthophotomosaic of the top view (Erechtheion).  
Study for the development of GIS on the Acropolis of Athens, 2009

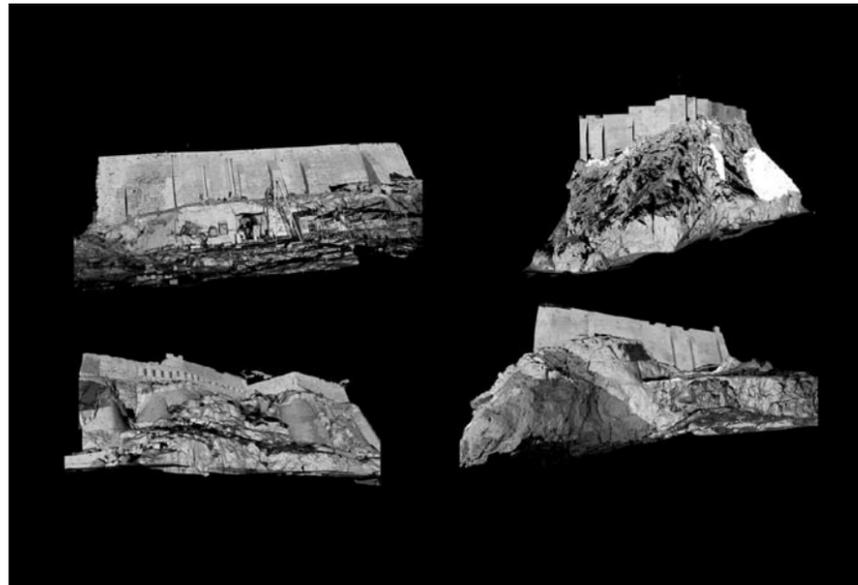
Fig. 5. Creation of a single model of point clouds

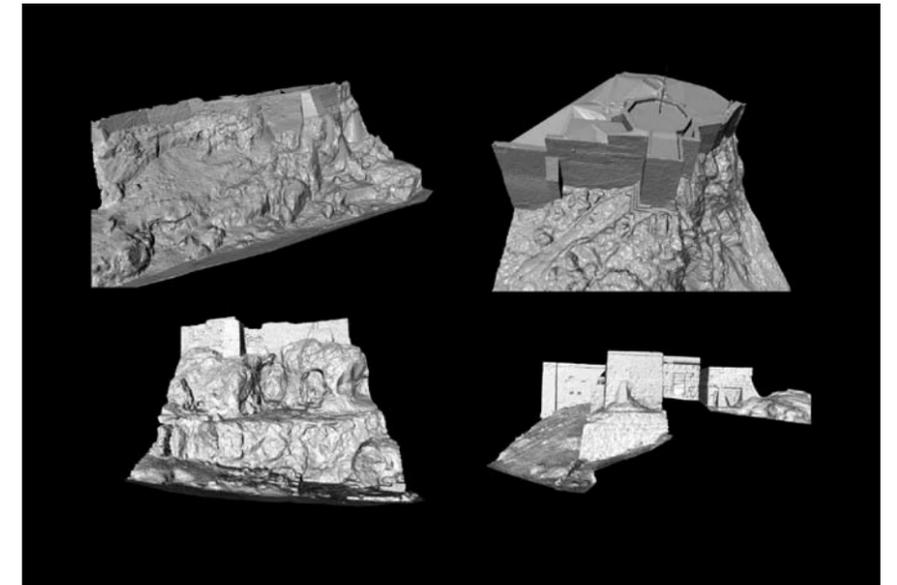
Fig. 9. Creation of surface models

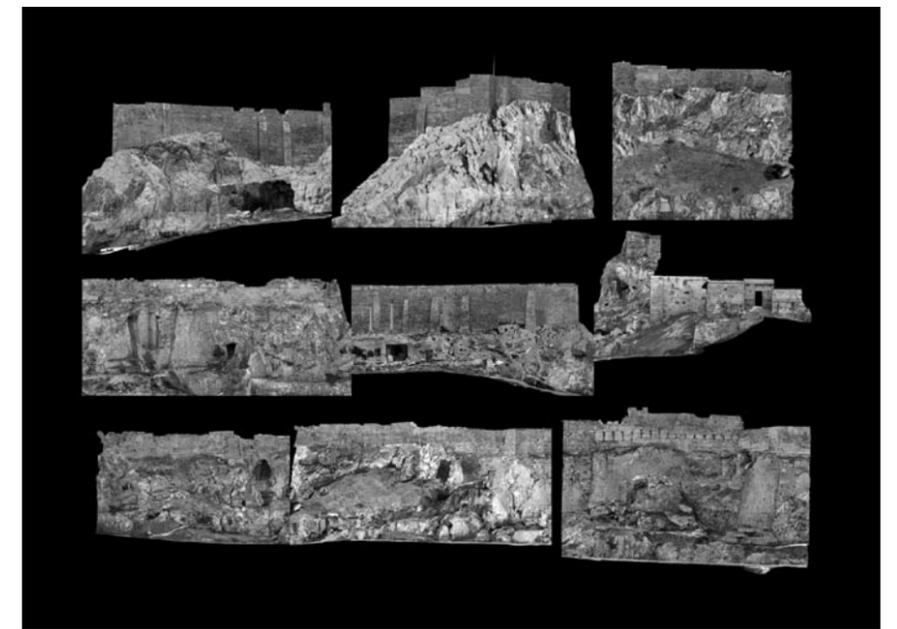
Fig. 10. Creation of final models with texture

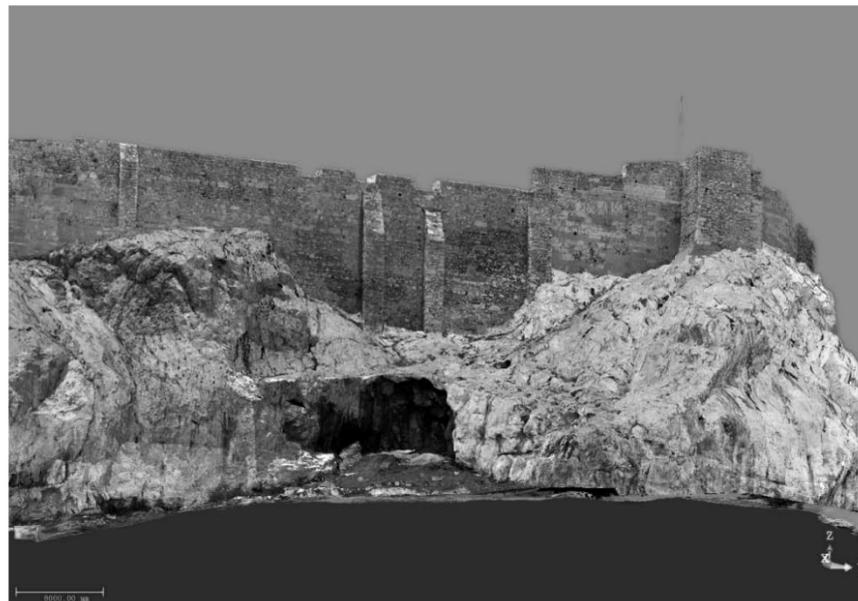
Fig. 11. View of the photorealistic three-dimensional model

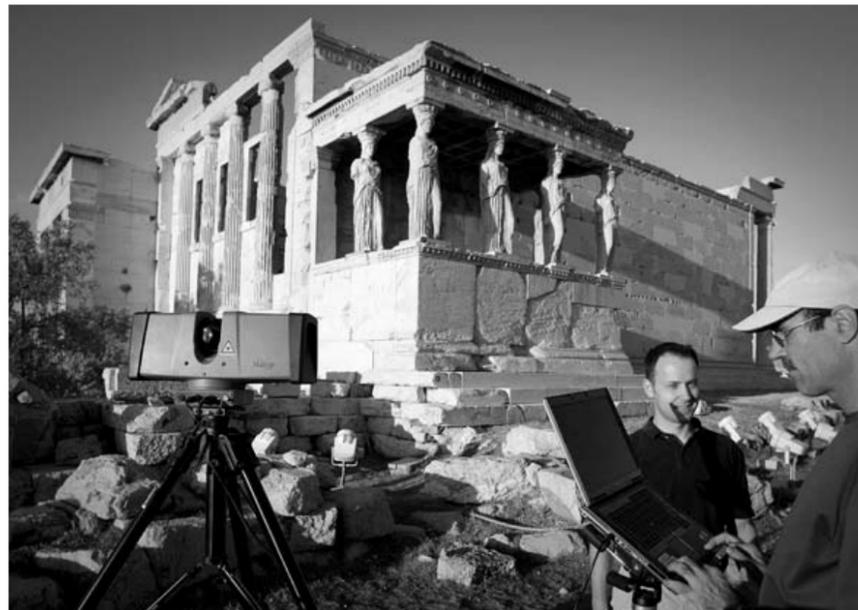
Fig. 3. Scanning with phase-shift scanner. Photo L. Grammatikopoulos, 2009

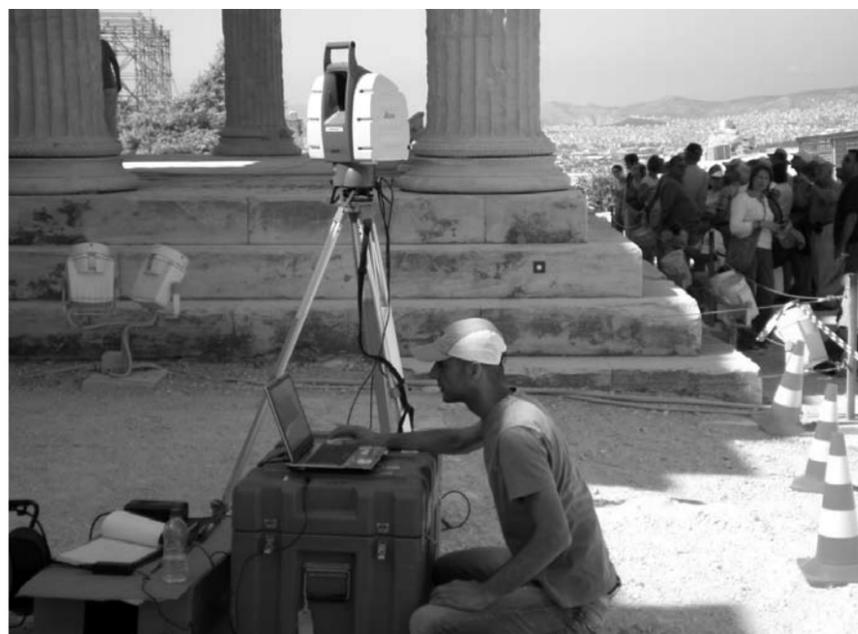
Fig. 4. Scanning with time-of-flight scanner. Photo L. Grammatikopoulos, 2009

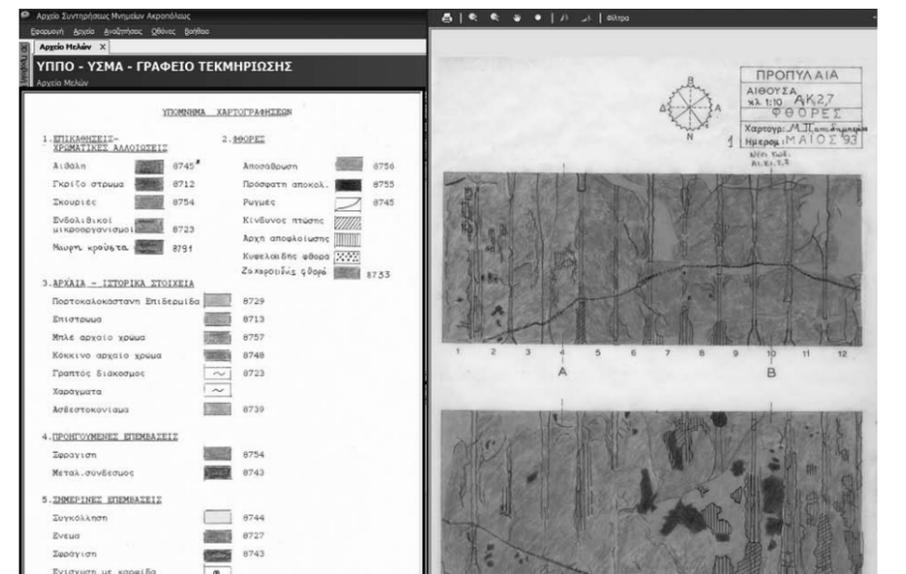
Fig. 4. Shown in colour at the left of the screen is the indication of the damage and interventions to the surfaces of the marble. Indicated in colour at the right is the damage to drum A.K. 2.7 of the Propylaea

The next point has to do with information about the ancient members that is provided by the mapping of damage and of interventions for the conservation of the surface of the marble. Over the years when the works were in process, eight successive improvements to the original chromatic annotations of the mapping have been used. The archaeologist Stelios Lekakis, who worked for a time on the Propylaea, arranged them in chronological order. These annotations were then incorporated in the new database in such a way that according to the date when a certain plan was composed, the chromatic annotations of the corresponding period can be viewed (fig. 4). Incorporated in the

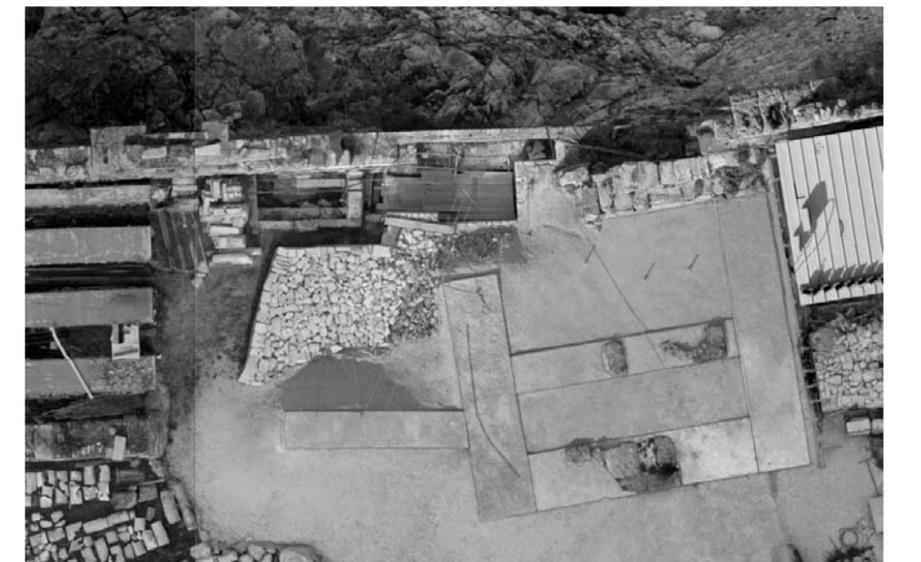
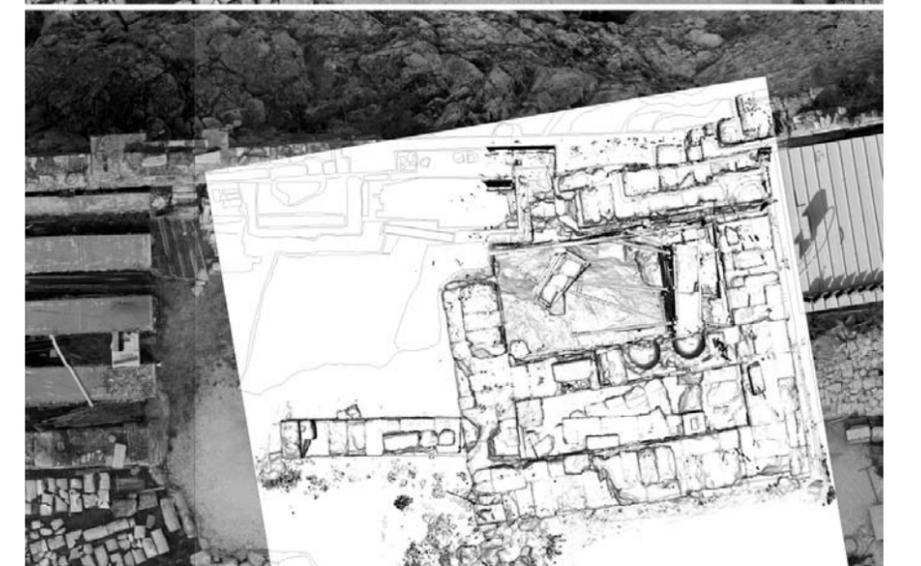
Fig. 1. The foundations of the Arrephorion after backfilling in 2007, in the photogrammetric documentation of the Acropolis (above). Three-dimensional scan before their backfilling and their inclusion in the photogrammetric plotting of the Acropolis (below)

Digital surveying of the Acropolis allows continuous addition of data including that from recent backfills, such as the filling of the Arrephorion foundations in 2007. The remains of the monument, now invisible, can be set with precision by suspending all the documentary material from the area of the foundations that is still visible (fig. 1). For full documentation of the monuments prior to backfilling, in addition to graphic survey, three-dimensional scanning at a density of 0.5 to 1 cm was carried out. Likewise full photography and topographical recording of all the surfaces was done using previously-marked points, that is, the necessary material was gathered for composing photogrammetric elevations and plans of all the foundations.

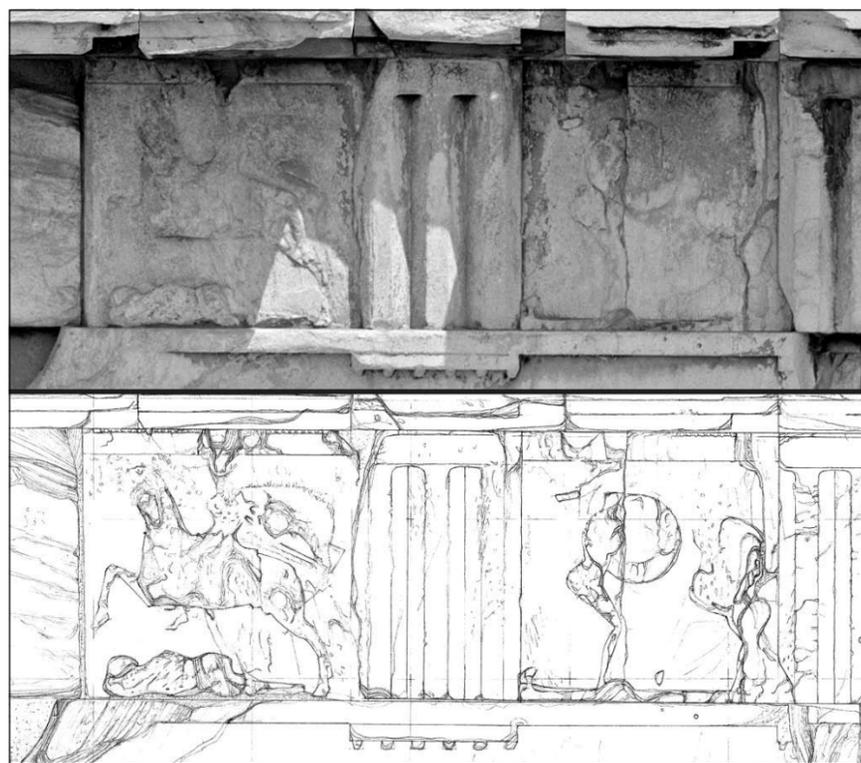
Fig. 2. The photomosaic of the west view as background in the architectural documentation for the recording of forms, such as the relief of the metopes, cracks and breaks in the marble. The figures show the 11th and 12th metopes of the west side of the Parthenon

tary information, such as cracks, damage of all kinds, the texture of the material or the type of erosion suffered by the surface. Since additional time is not necessary for its recording, it is of great help in reducing work in the open. For example, the architectural survey of the west end was used as a platform for recording forms, such as the relief of the metopes, cracks and breaks in the marble (fig. 2).

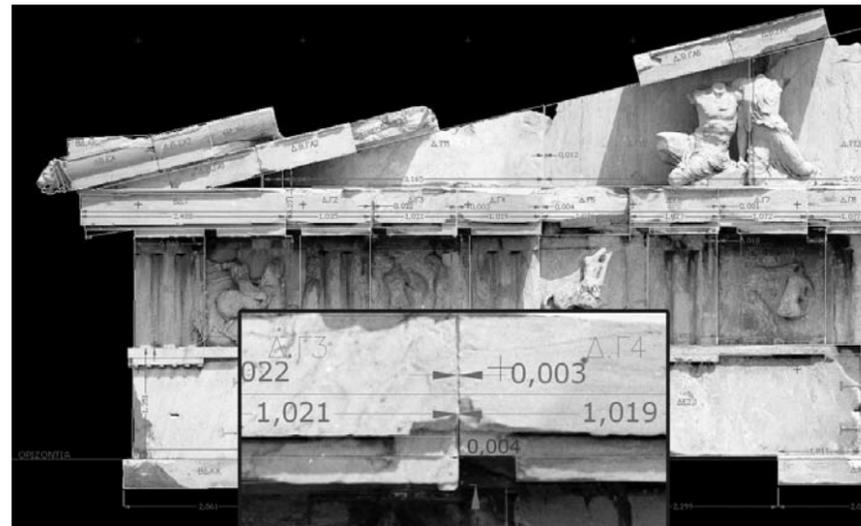
Fig. 5. North part of the west view of the Parthenon. Collation of the photomosaic of the exterior view (scale 1:20) with the corresponding linear drawing cad. Deviations at measurements 3 and 4mm are noted

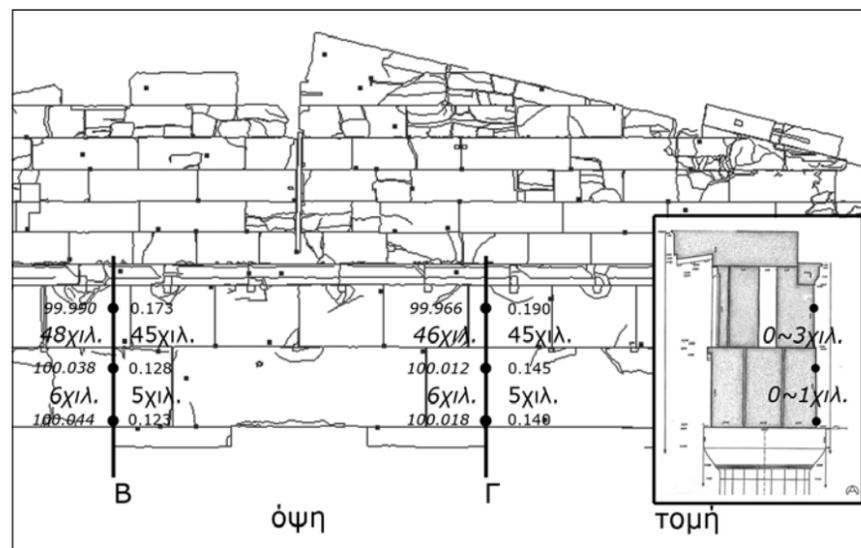
Fig. 6. Interior view of the west side of the Parthenon. Collation of background measurements in the photogrammetric model (scale 1:10) and direct survey with theodolite. The first are registered left of the positions of the measurements and the second right. Deviations of 1 to 3mm are noted

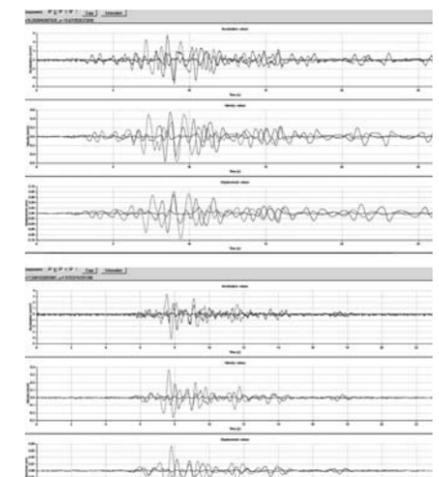
Fig. 1. Time-histories of ground acceleration, velocity and displacement for the earthquakes of Andravida (above) and Mantoudi (below)

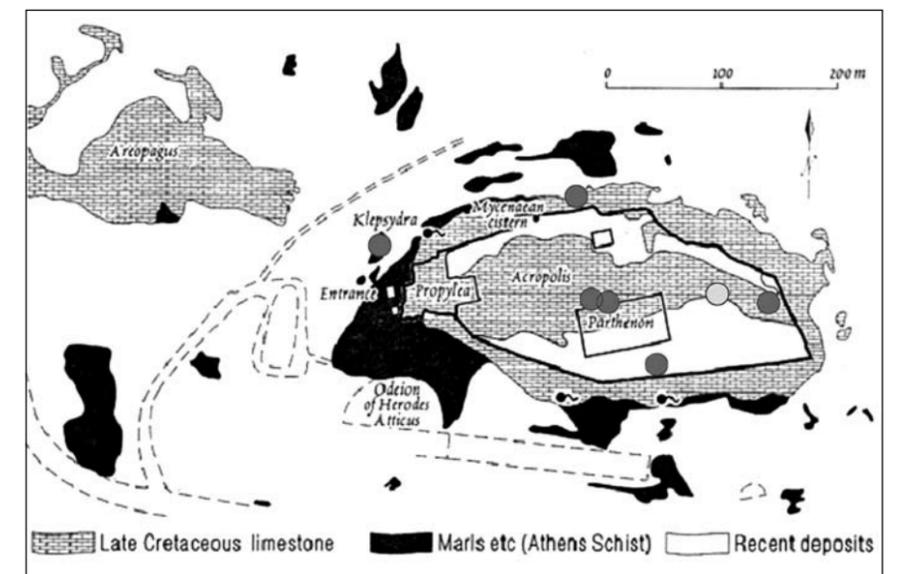
Fig. 2. Geological sketch of the Acropolis hill (by Higgins and Higgins, 1996), showing the installation sites of the accelerographs. The light grey circle indicates the first accelerograph installed in 2006, the dark grey circles show the positions of the new accelerographs installed by the end of 2008

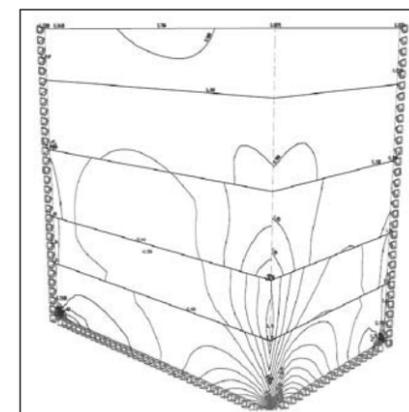
Fig. 1. Preliminary structural analysis of the SE corner of the Wall (isolines for tension and compression)

Specifically, in many areas of the Wall there are extensive cracks that are more numerous towards the end of the southeast corner of the Wall. It is not clear, in the beginning,

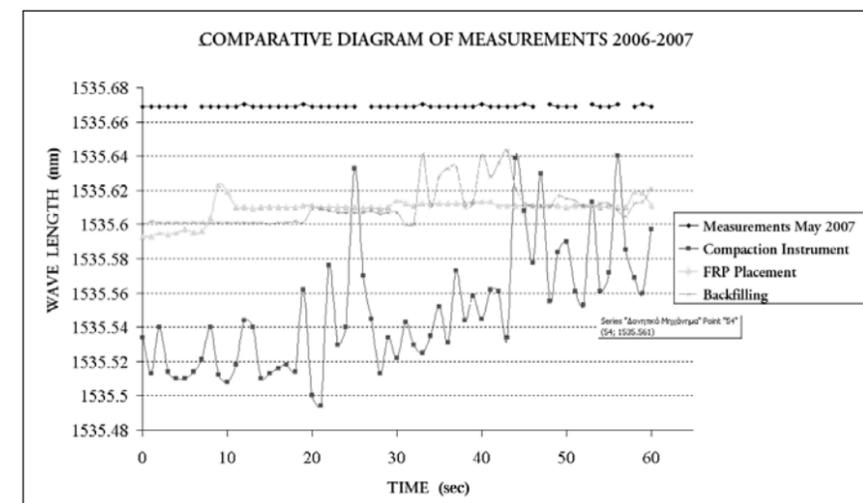
Fig. 2. Comparative diagram of measurements 2006-2007 [wave length (nm)-per unit of time (sec)]

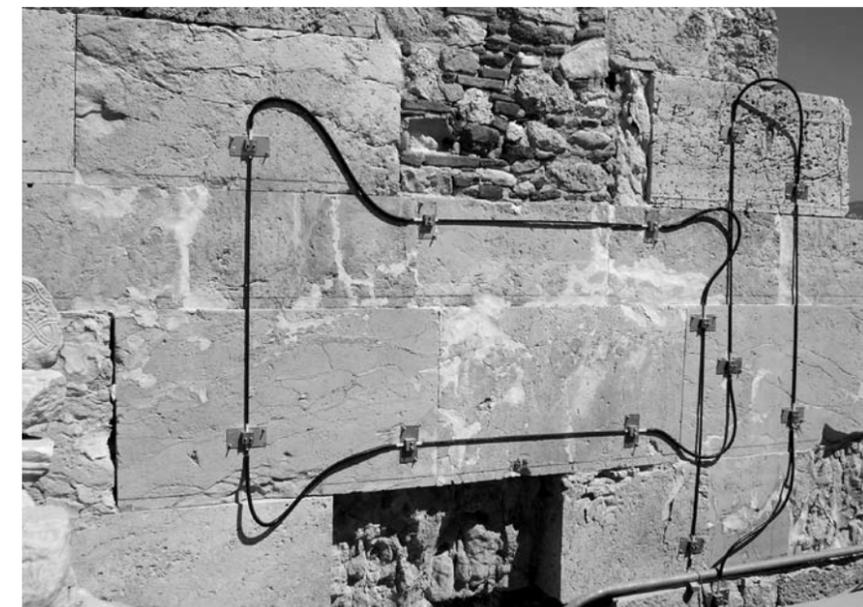
Fig. 4. North Wall. Position of the sensors on the interior of the Wall

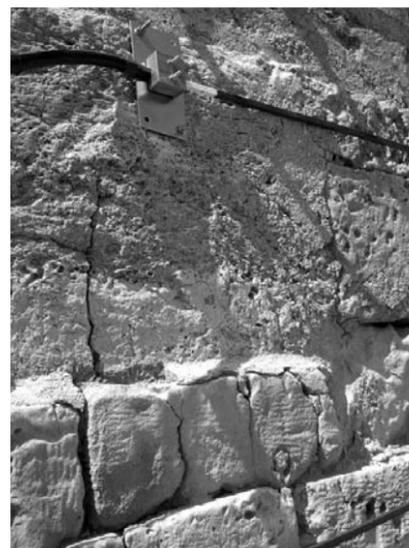
Fig. 5. End of sensor anchored near a crack

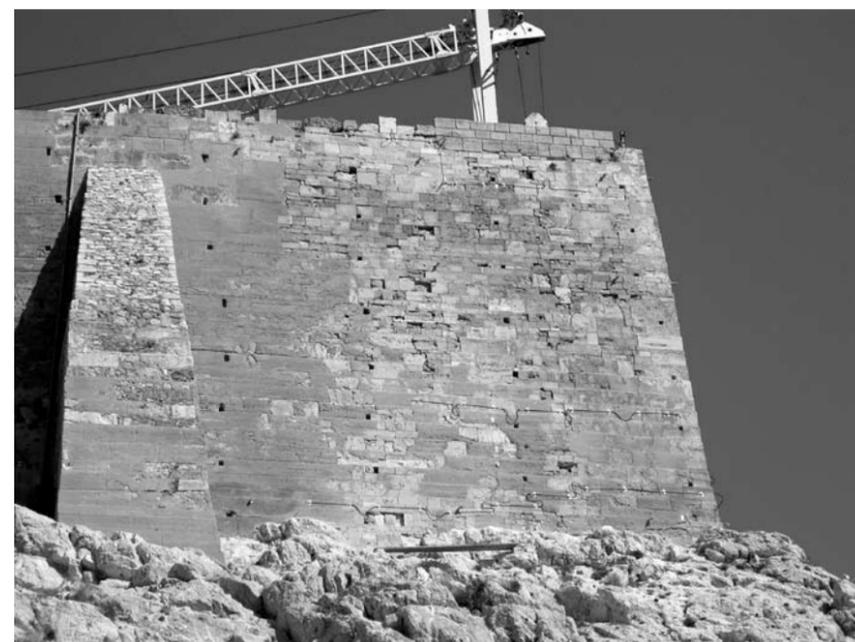
Fig. 6. Position of the sensors at the southeast corner of the Wall

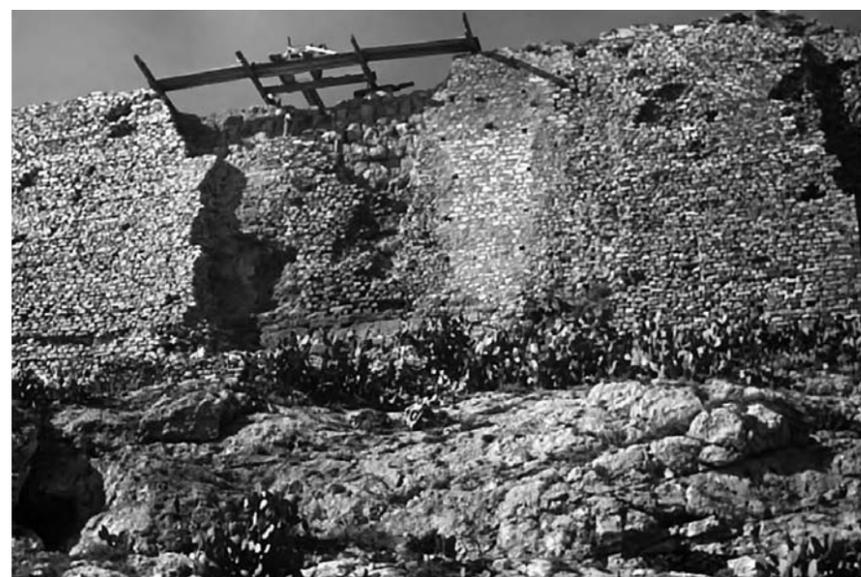
Fig. 2. Central area of the south Wall, significant detachment of parts of the later sheathing of mixed masonry. Photo Archive -1938

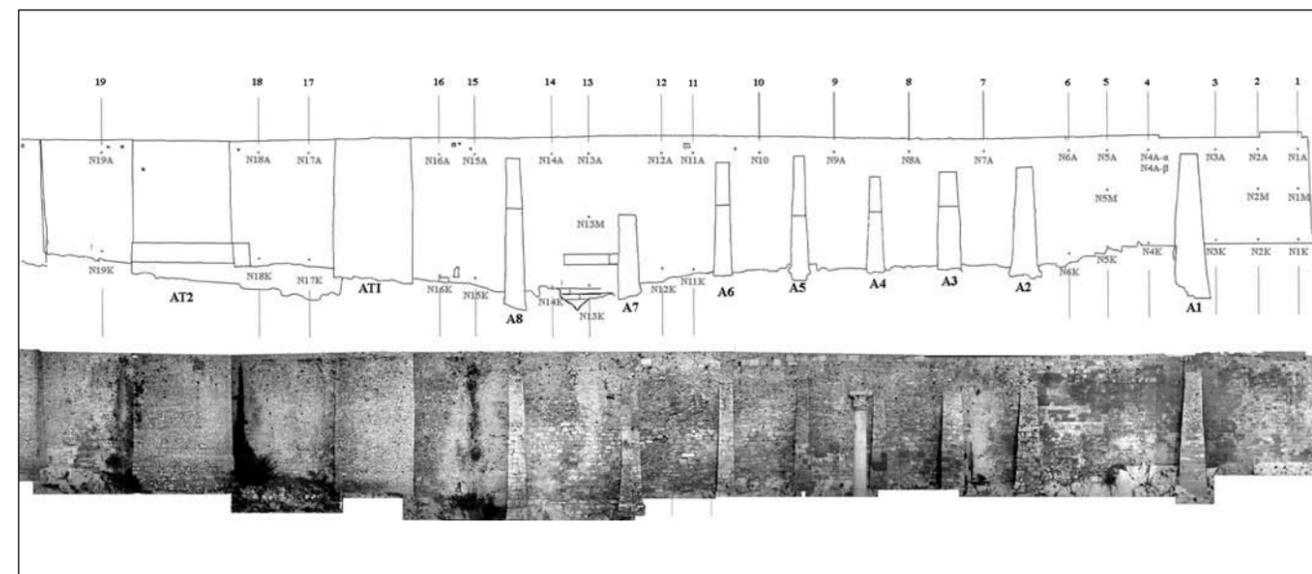
Fig. 3. Setting in three zones by height of 39 topographical prisms on the south Wall. Drawing V. Manidaki

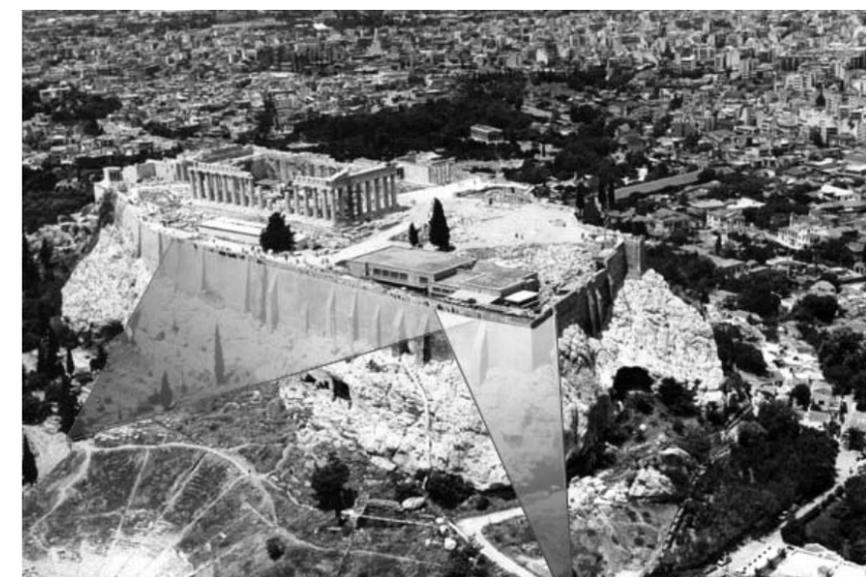
Fig. 4. The area being monitored on the Wall is extended to the east leg of the south Wall (around 155m from the SE corner of the Wall) and to a 12m section of the east Wall

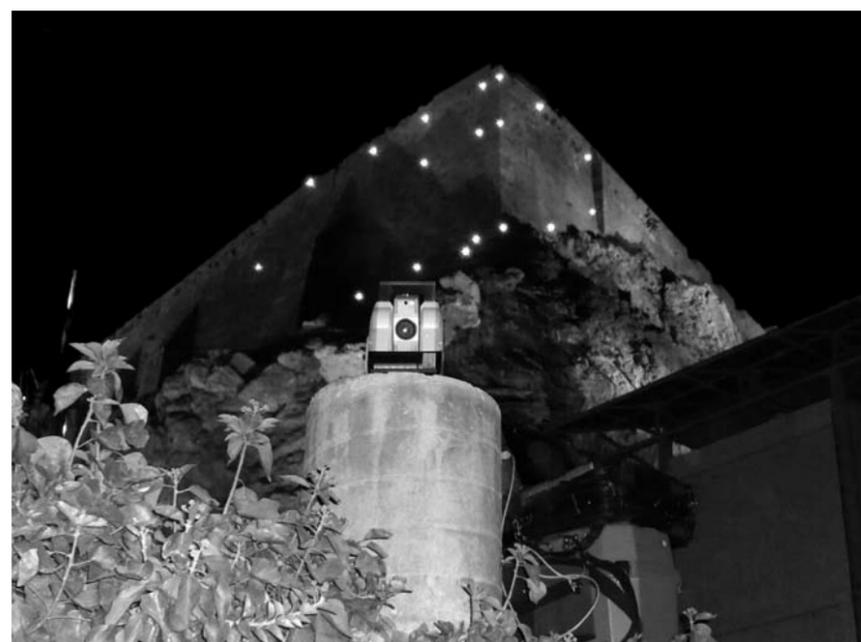
Fig. 5. Base B1: the bright spots indicate the position of the topographical prisms on the Wall oriented toward the base, and are the reflections from camera flash. Photo S. Leloudas

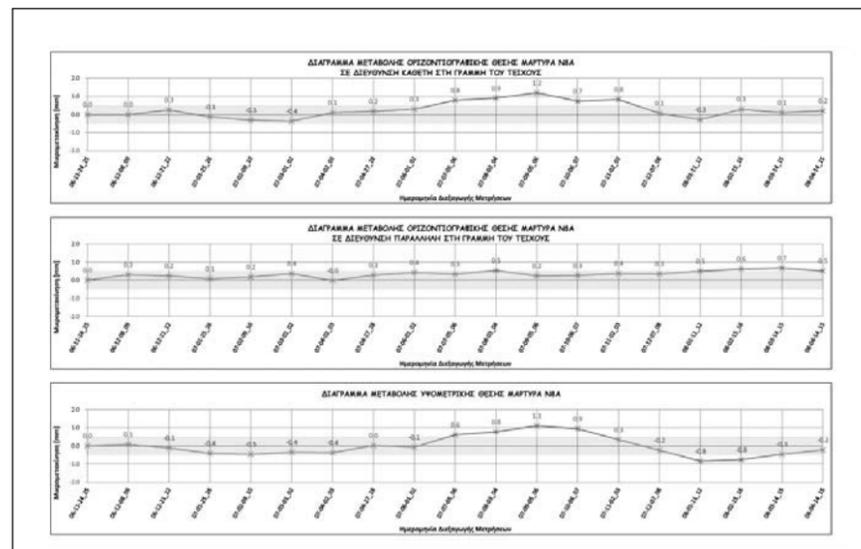
Fig. 6. Indicative diagram of diachronical monitoring of a target on which is marked the deviation from the original position by X, Y, Z. Processing of measurements: S. Leloudas and I. Partsinevelos
