PROCEEDINGS of a ONE-DAY CONFERENCE  
*Modern technologies in the restoration of the Acropolis*  
19 March 2010

### DIGITAL METHODS OF GEOMETRIC DOCUMENTATION OF THE MONUMENTS

### INSTRUMENTAL MONITORING OF DISPLACEMENT AND DEFORMATION

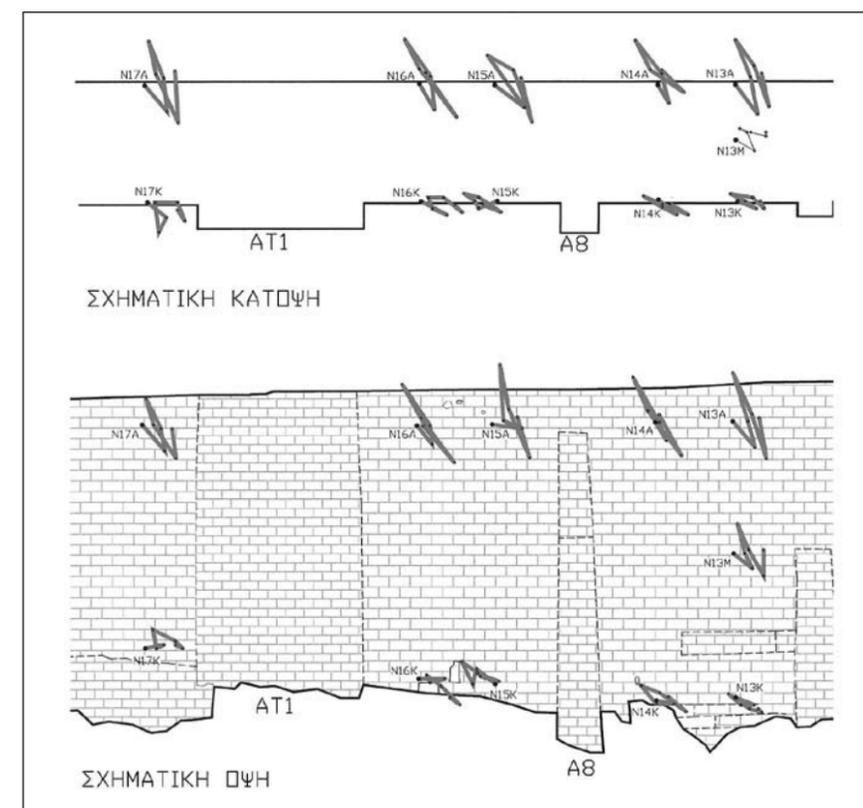
Fig. 7. Vectors of micro-displacement of the central part of the south Wall. Drawing T. Iliopoulos

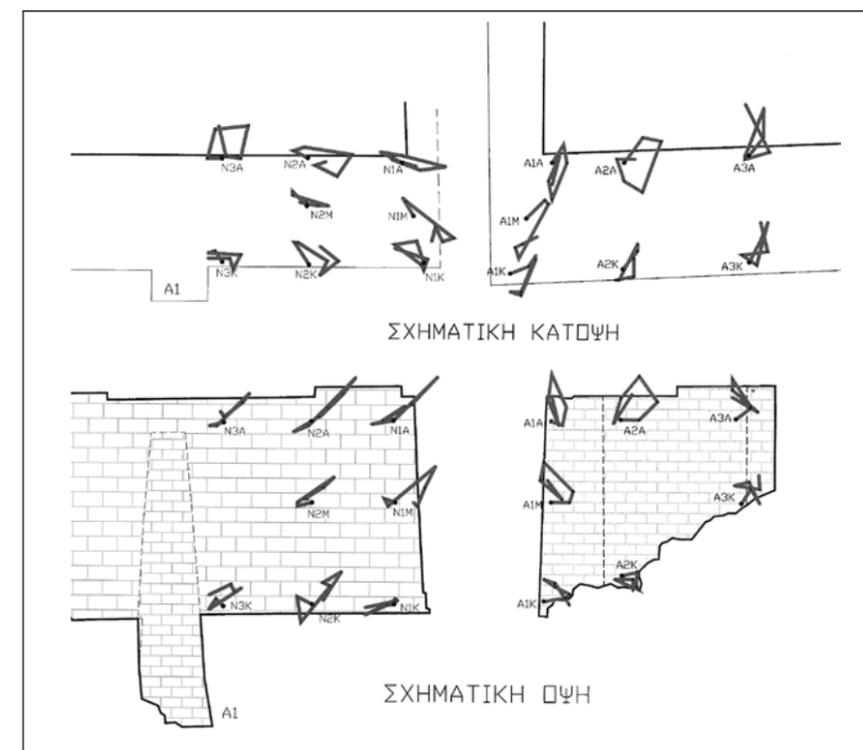
Fig. 8. Vectors of micro-displacements of the SE corner of the Wall. Drawing T. Iliopoulos

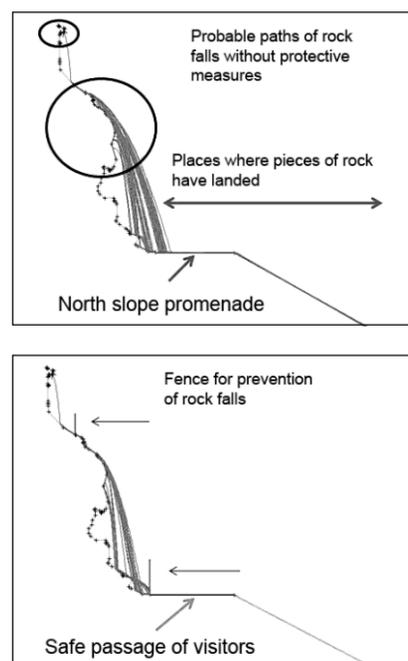
Fig. 3a-b. Rockfall paths in an area of the north Wall a: without protective measures, b: with protective measures. Diagram D. Egglezos

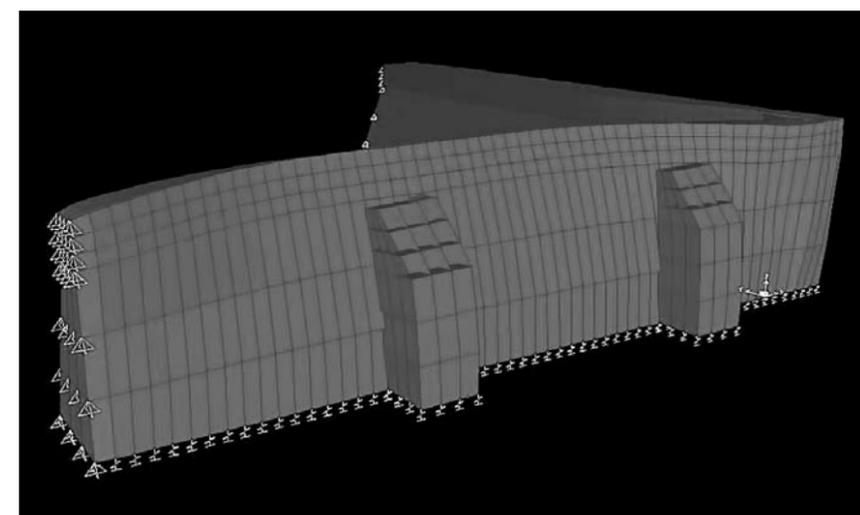
Fig. 4. Results of three-dimensional analysis with temperature load: strain field. Model (3D) D. Egglezos

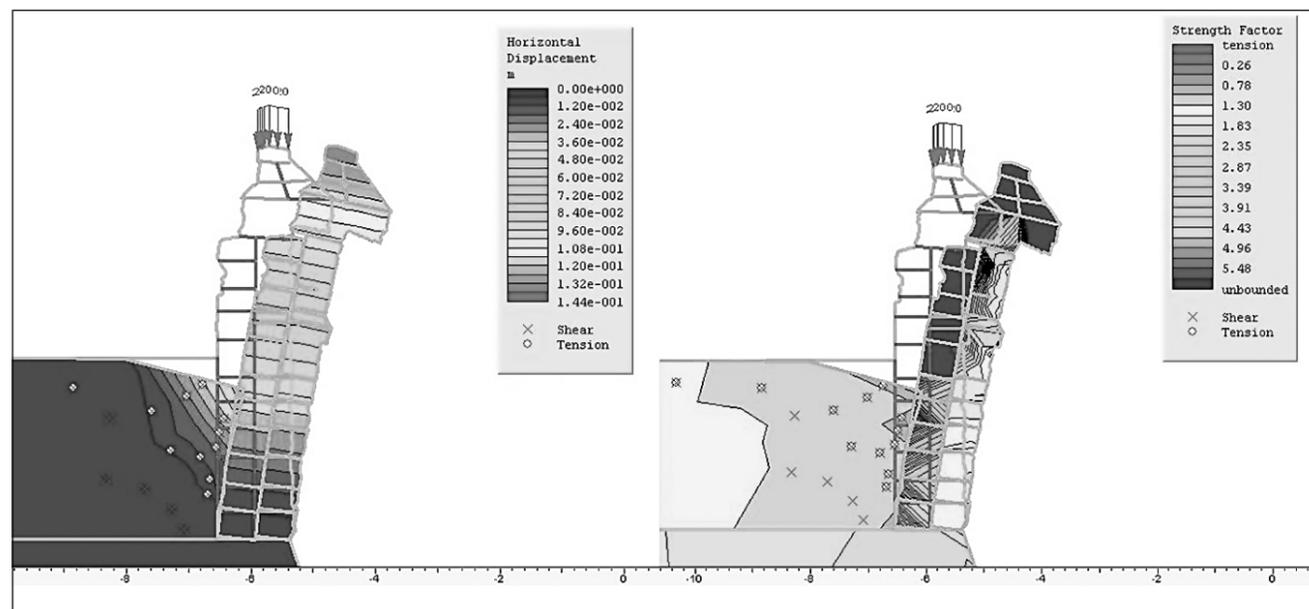
Fig. 2a-b. Results of the analysis a: Horizontal displacement, b: Strength gauge. Diagram D. Egglezos

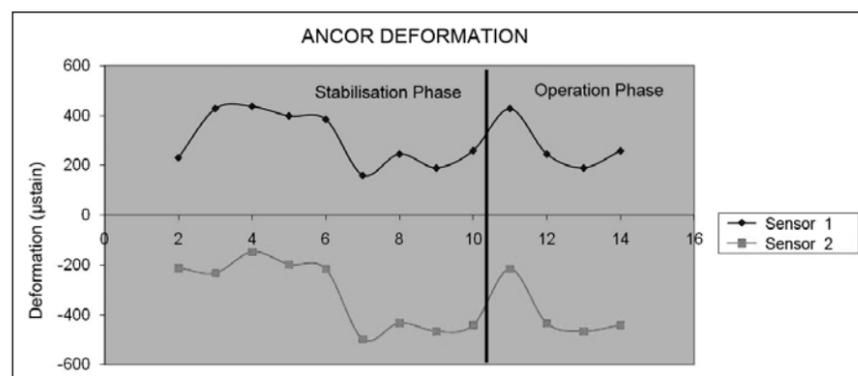
Fig. 6. Measurements of deformation of anchor with optical fibre sensors

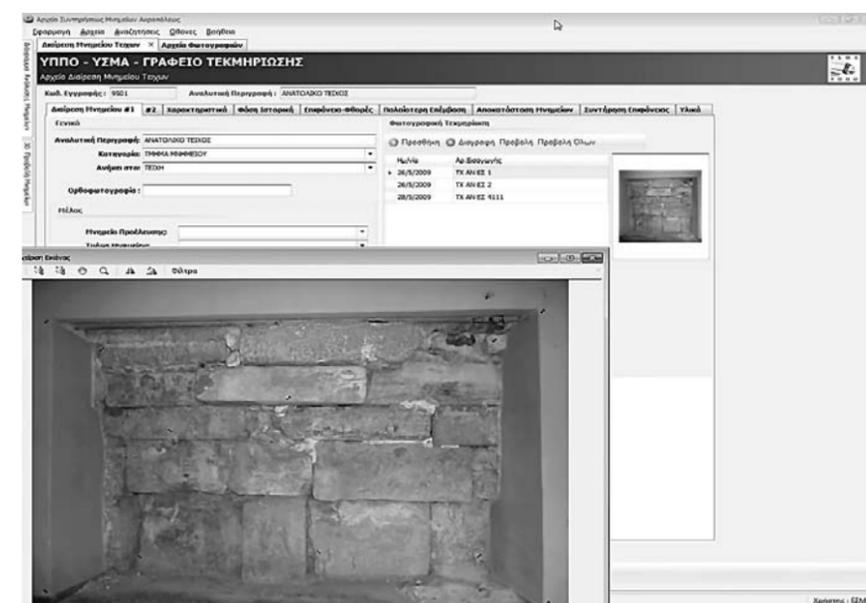
Fig. 7. Database card: record of repair to interior area of the east Wall

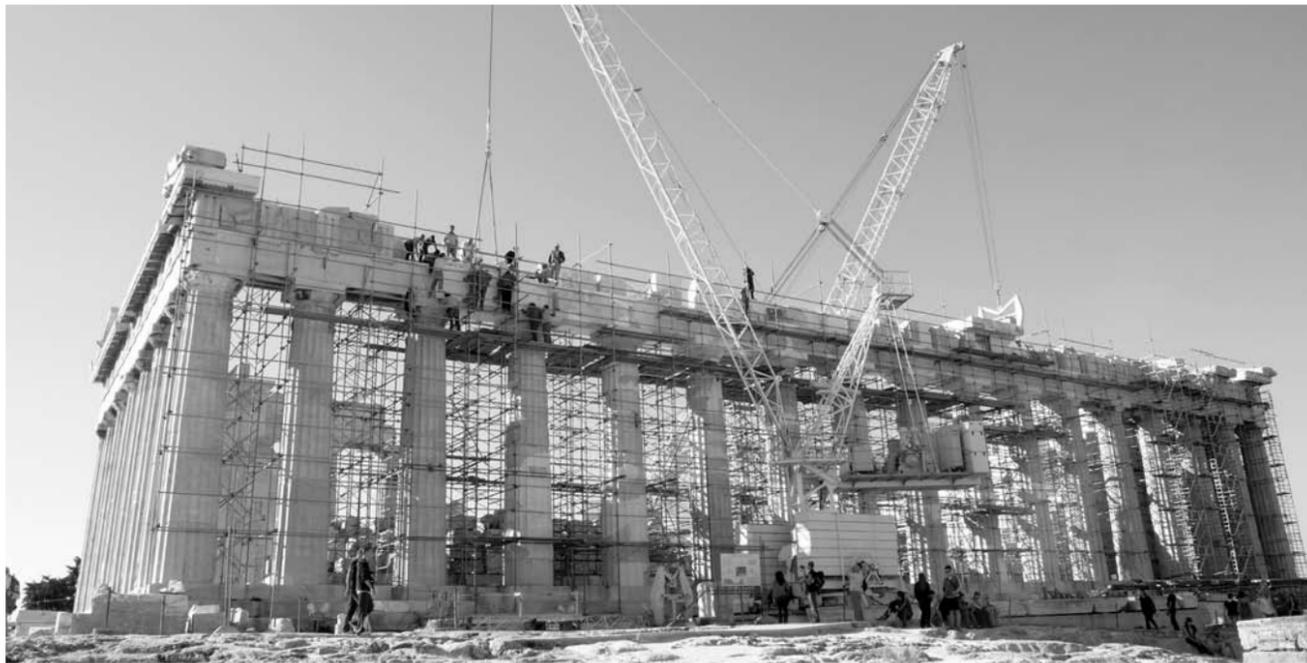
The north side of the Parthenon showing the resetting of the last architrave block. Photo V. Eleftheriou, 2009

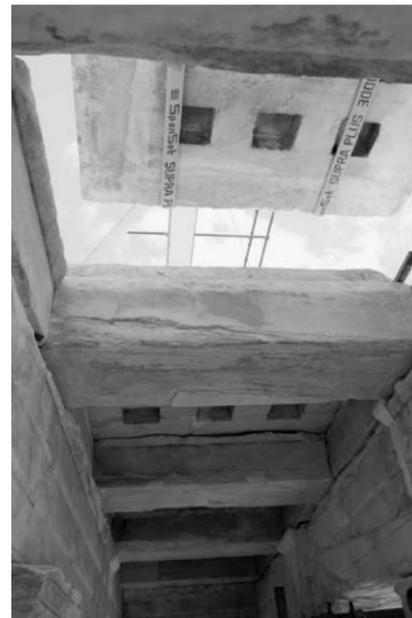
*Positioning a coffered slab in the ceiling of the temple of Athena Nike. Photo K. Mamalougas, 2010*

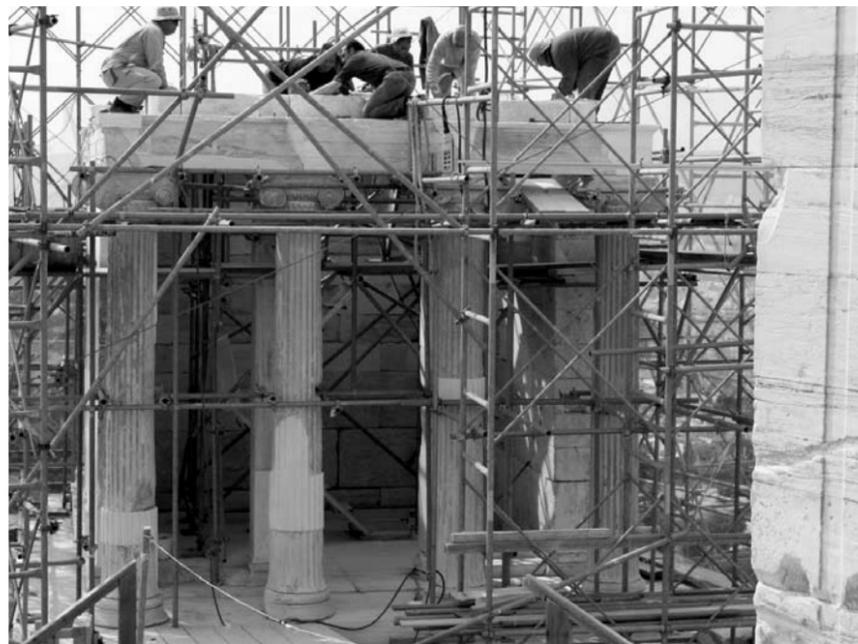
*View of the temple of Athena Nike from the east showing setting of the ceiling beams. Photo D. Michalopoulos, 2010*

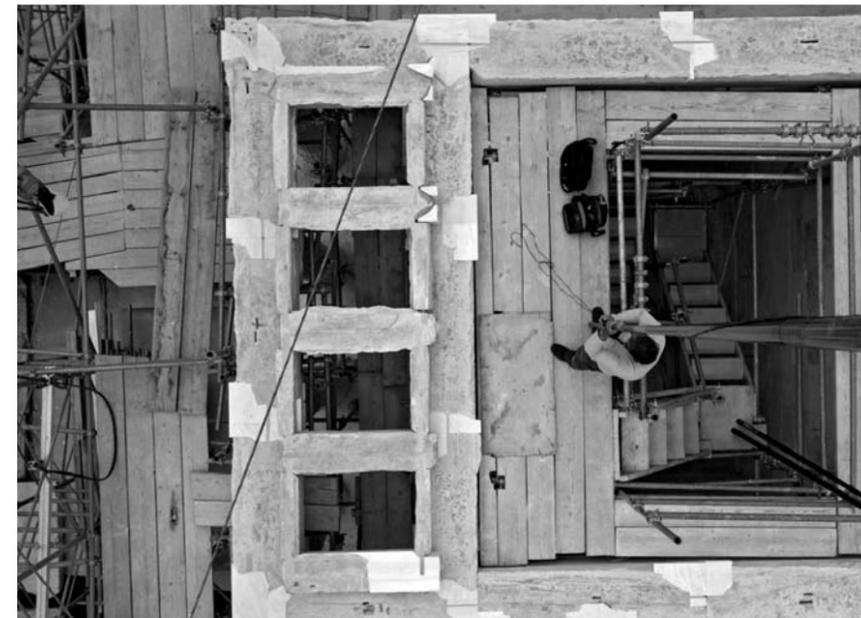
*View of the east section of the temple of Athena Nike from above after setting the architrave and ceiling beams. Photo S. Gesaphidis, 2010*

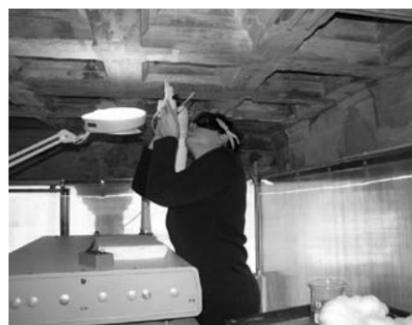
*Cleaning the coffered ceiling of the south porch of the Erechtheion using laser technology. Photo G. Frantzi, 2009*

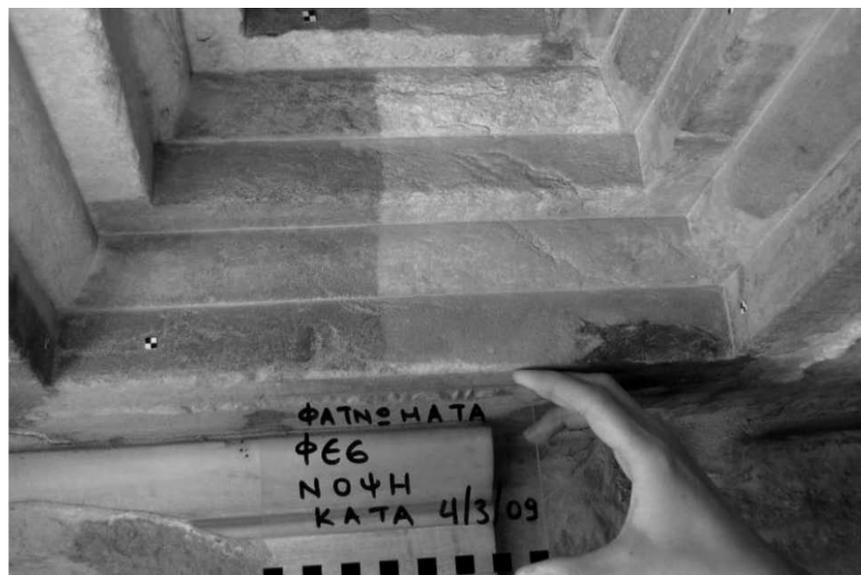
*A stage in the cleaning of the coffered ceiling of the Erechtheion south porch using laser technology. Photo A. Maridaki, 2009*

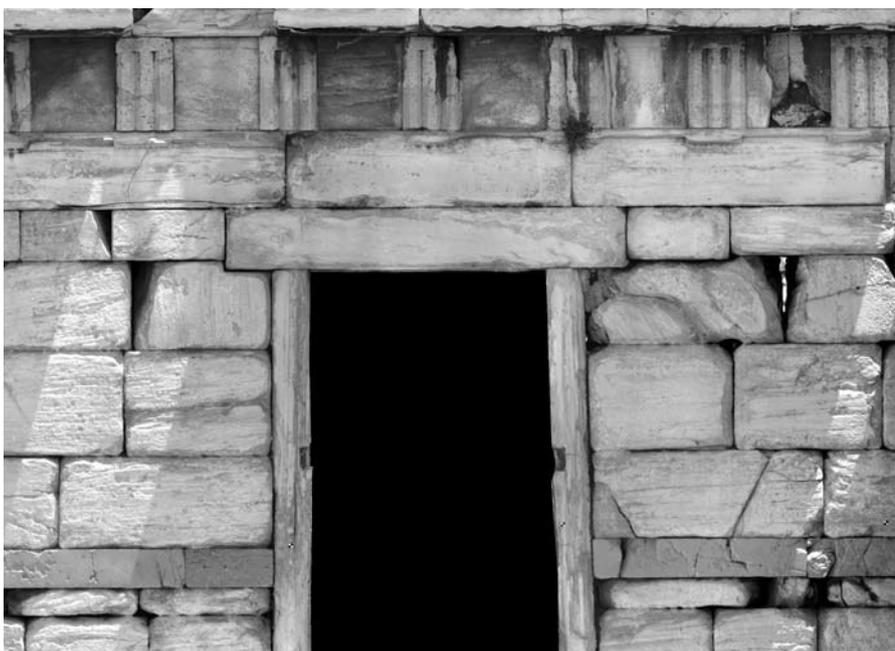
*Details of an orthophotomosaic of the Beulé gate.  
Study for the development of GIS on the Acropolis of Athens, 2009*

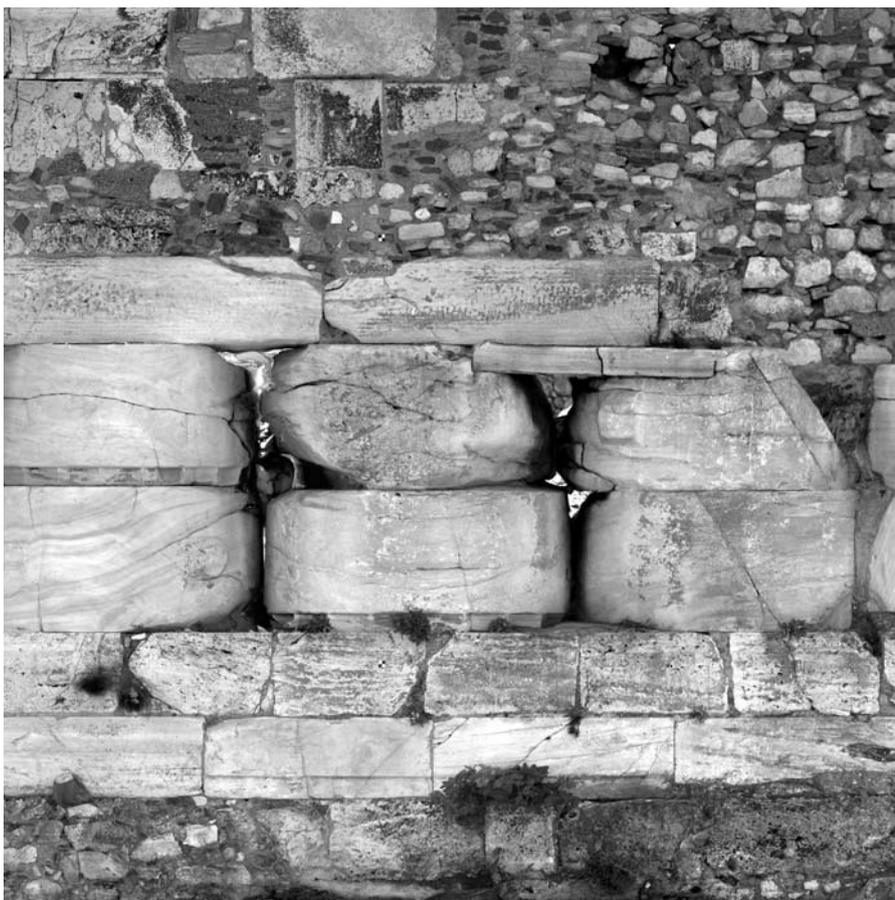
*Details of an orthophotomosaic of the north Wall of the Acropolis.  
Study for the development of GIS on the Acropolis of Athens, 2009*
