- M. Ioannidou, 2010 – 2011, The progress of restoration on the Acropolis
- D. Michalopoulou, K. Mamalougas, The restoration programme of the temple of Athena Nike: brief evaluation
- K. Karanasos, Restoration of the superstructure of the south wall of the central building of the Propylaia
- G. Frantzi, The gradual revealing of colour on the ceiling of the Porch of the Maidens in the Erechtheion
- V. Manidaki, The replacement of sculptured architectural members on the monuments of the Acropolis. Casts, copies and authentic members
- L. Lambrinou, The restoration of the Parthenon's pronaos: aesthetical matter or theoretical dilemma?
- C. Hadziaslani, E. Kaimara, A. Leonti, New activities and publications of the Information and Education Department
- E. Petropoulou, News from the Acropolis

2010 – 2011, The progress of restoration on the Acropolis

Athena Nike Restoration project

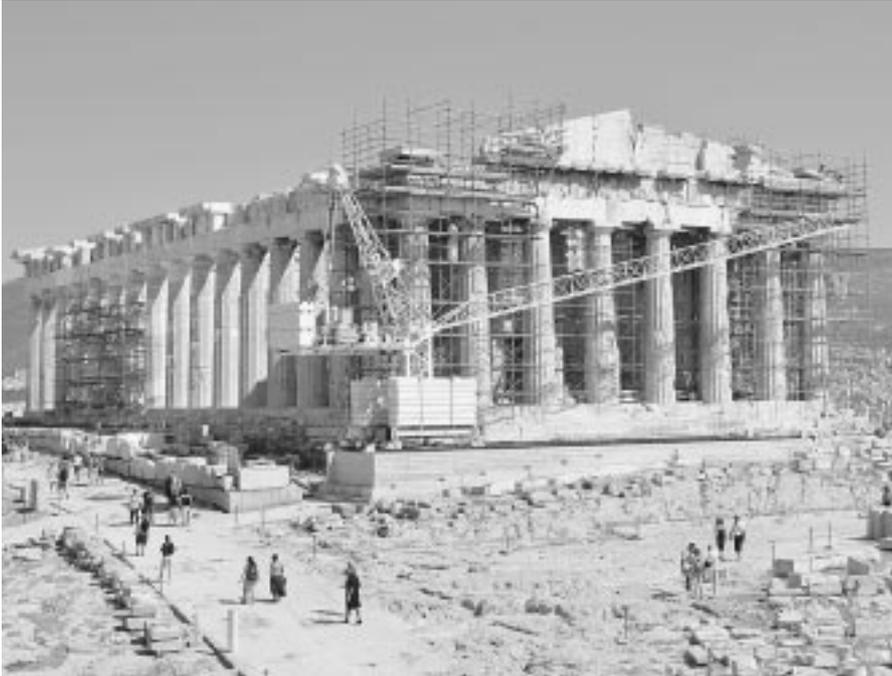
*View of the Parthenon after beginning the works of restoring the west side.
Photo M. Ioannidou, 2011*

The most important work on the Parthenon is the intervention on the west side of the monument, which was restored by N. Balanos during the first period of anastelosis of the Parthenon (1898-1902). The purpose of the new intervention is to cope with the serious structural problems and deformations in that part of the monument that are due to the destructions of the past, to the previous anastelosis, and also to earthquakes that have struck the monument. Moreover its purpose is the restoration of the monuments appearance by including in the monument a number of architectural members made of new marble. The study for this intervention has been carried out by the architects V. Eleftheriou and V. Manidaki. Included in the programme for 2011-

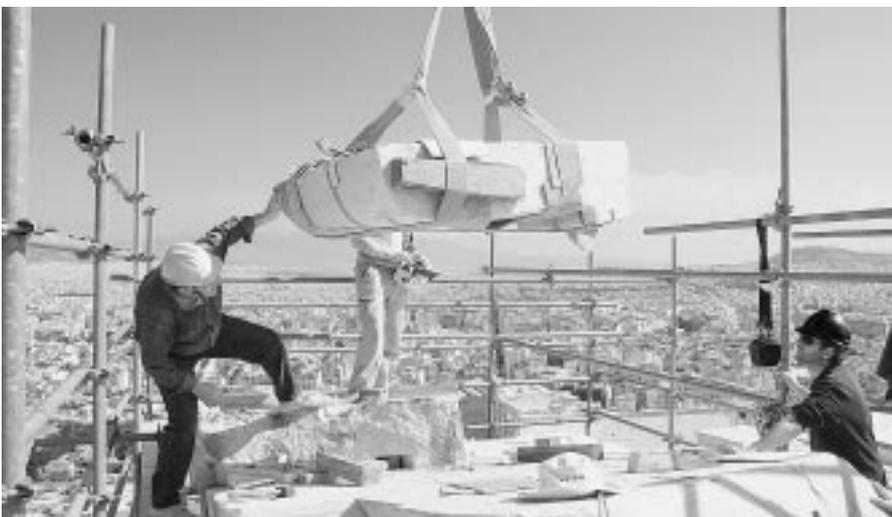
*Suspension of a section of the base of the northwest Parthenon akroterion.
Photo V. Eleftheriou, 2011*

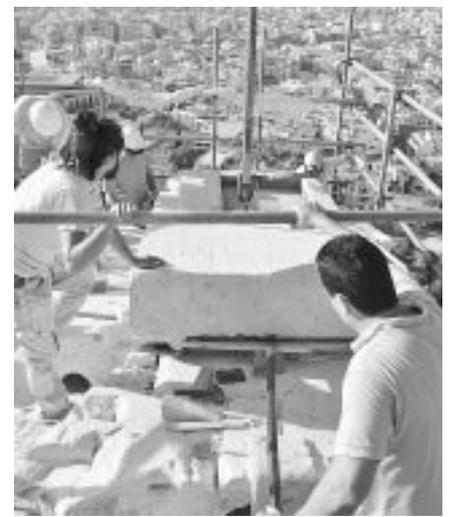
Dismantling the base of the southwest Parthenon akroterion. Photo V. Manidaki, 2011

2013 is intervention on the two corners of the west side, which includes, in accordance with the study, the dismantling of a total of 80 architectural members. To begin with, the dismantling will be carried out in the areas in which N. Balanos intervened in 1902. It will, however, be extended as far as the architrave blocks of the corner intercolumniation, the breaks in which were at that time repaired with large iron reinforcements that were placed on the façade of the monument. Programmed likewise is the structural restoration of the column capitals and one more architrave block. Planned also for this same phase is the dismantling from the two corners of the monument of a total of 6 metopes and their transport to the Acropolis Museum for their protection. Accurate copies of artificial stone will replace them on the monument. The addition of 6 new blocks in spaces that were left in the upper course of the two corners (cornices and tympanon blocks) are expected to strengthen the building structurally. Surface conservation will be carried out on all blocks to be disman-

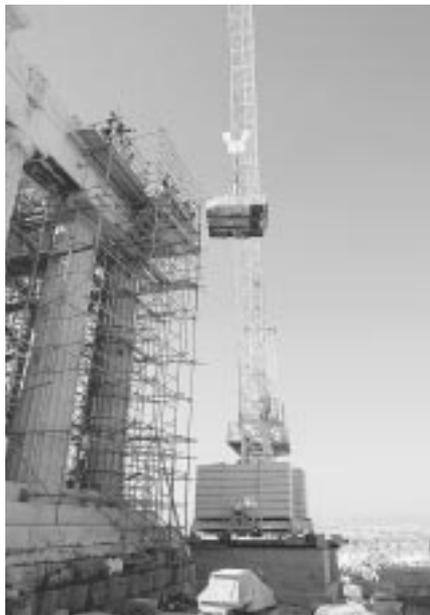
Lowering the northwest corner cornice block of the Parthenon. Photo V. Eleftheriou, 2011

The tasks of dismantling began with the NW corner of the monument on May 20 and, by the June 29, 17 blocks had been lowered (the acroterion base, the pan-tile with antefix, 3 blocks of the raking sima,

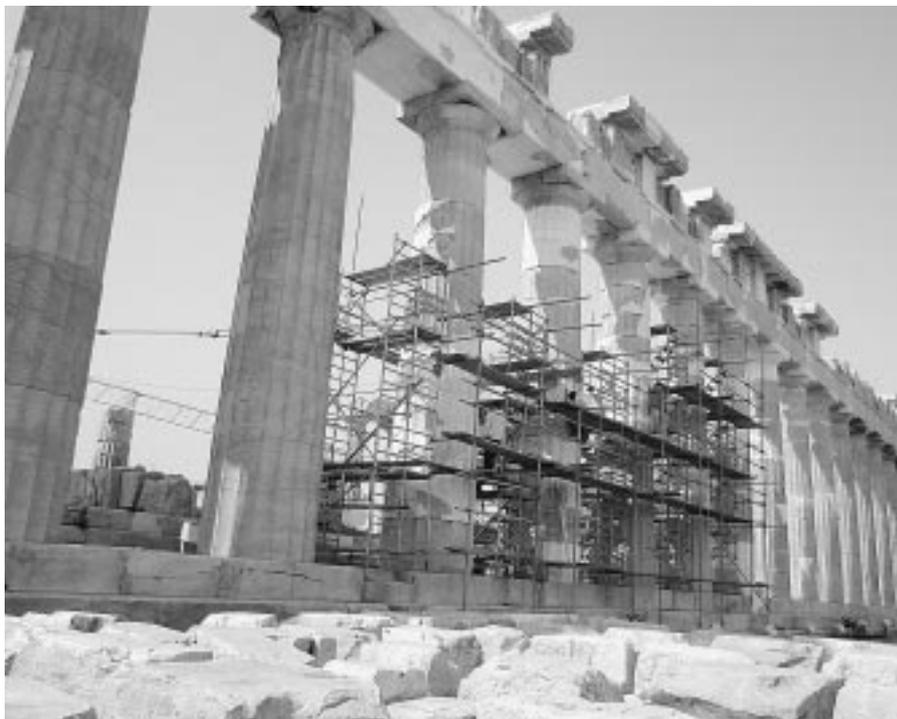
Carving the flutes of the columns in the north colonnade. Photo V. Vlachou, 2011

Included also in the Parthenon works is completion of the carving of the flutes in the new marble supplements of six columns of the Parthenon north colonnade. This consists of the final working of the surfaces of the new marble drums and

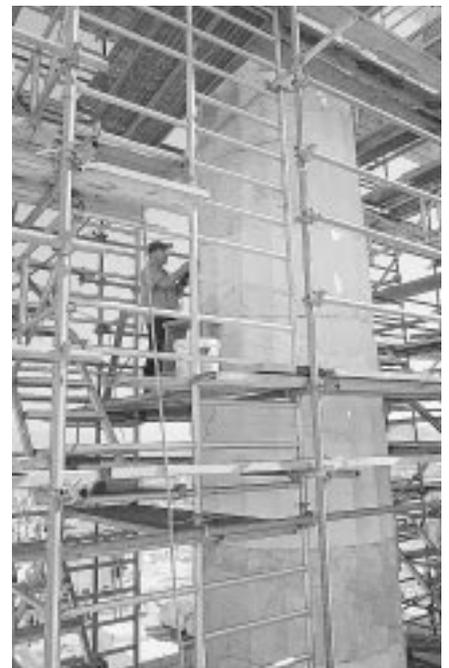
Working on the flutes of the fifth from E column in the north colonnade. Photo M. Ioannidou, 2011

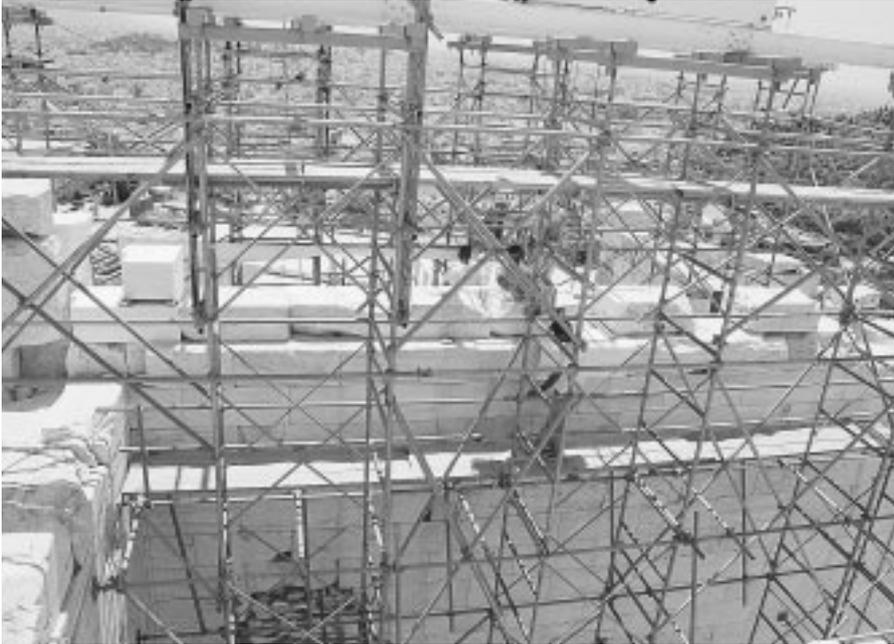
View of the south wall of the central building of the Propylaia, while resetting the blocks of the 19th course. Photo K. Karanasos, 2011

For the arrangement of the blocks of the 19th course, a total of seven wall blocks were examined. The block that is first from the east was not found among them. By analogy with the corresponding block of the north wall, it was indubitably L-shaped since part of the east surface of thrust entered between the wall-supported architrave of the south wall of the east portico and because it was set last in the series. In its place will be set a similar block of new marble. Finally, examination of the remaining blocks of this course showed that only one met the criteria necessary for including it in the anastelosis proposed at present. It also emerged that among the blocks reset on the wall, in-

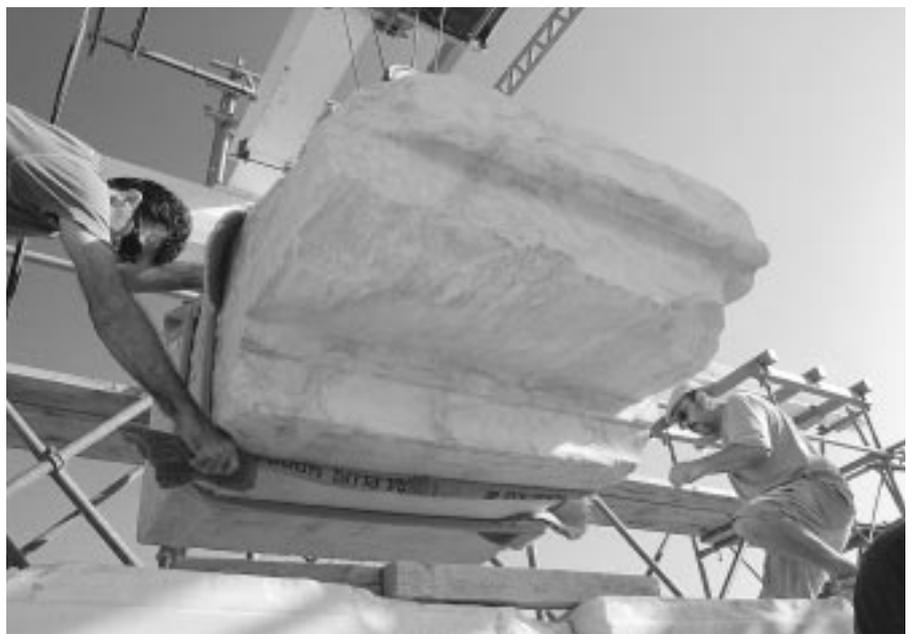
Resetting a cornice block on the south wall of the Propylaia. Photo K. Karanasos, 2011

Finally, the position of the only preserved cornice block of the south wall is at the east end, as is evident from its comparison with the corresponding cornice blocks of the north wall. It was found to have the same technical characteristics as the first from the east cornice block on the north wall, the only difference being that in length and in width it is larger. These characteristics are the L-shape face where the stone abuts the wall epistyle block of

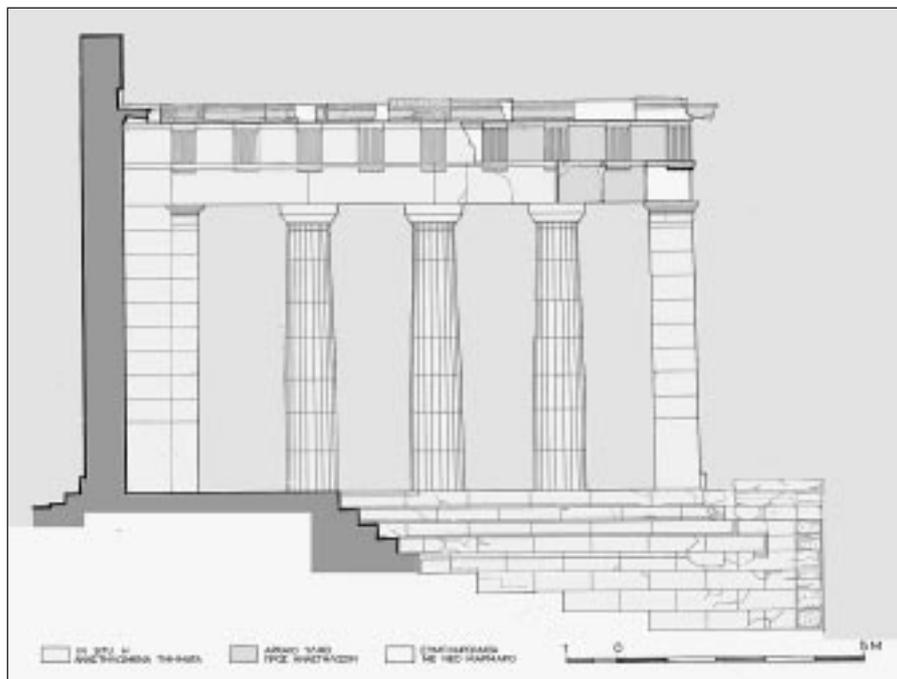
Proposal for the restoration of the south wing of the Propylaia: north side of the colonnade. Drawing T. Tanoulas, 2010

The architectural study for the restoration of the south wing was made by T. Tanoulas. The study called for the

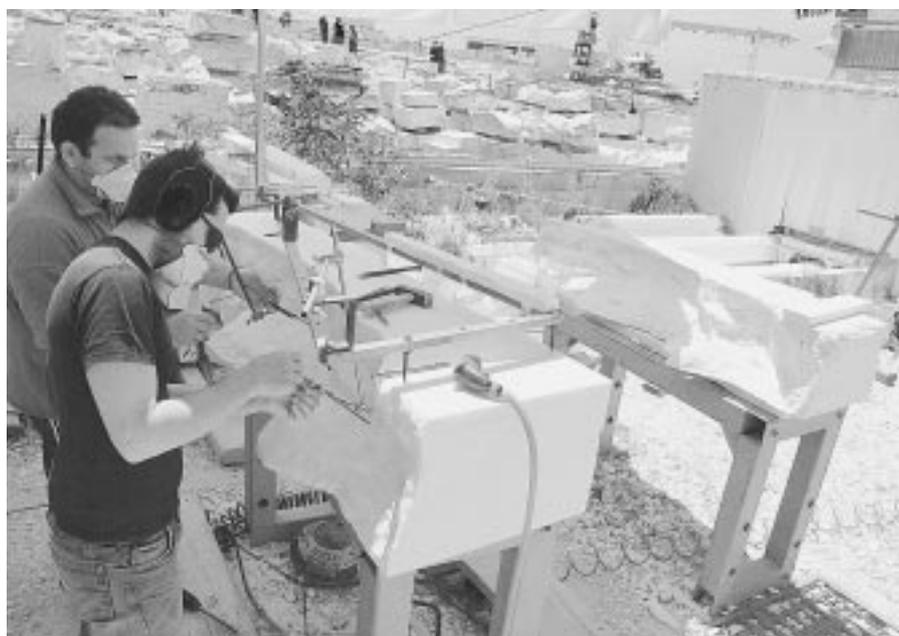
Working on a filler in a geison block of the south wing of the Propylaia. Photo K. Karanasos, 2011

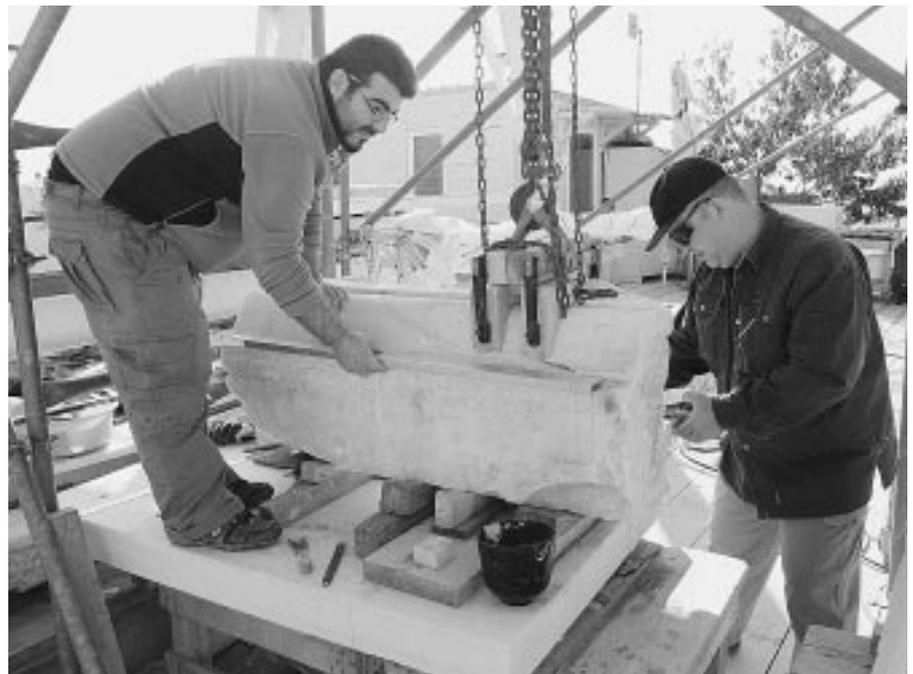
Joining belonging fragments to a member of the north crown of the Athena Nike bastion. Photo D. Michalopoulou, 2011

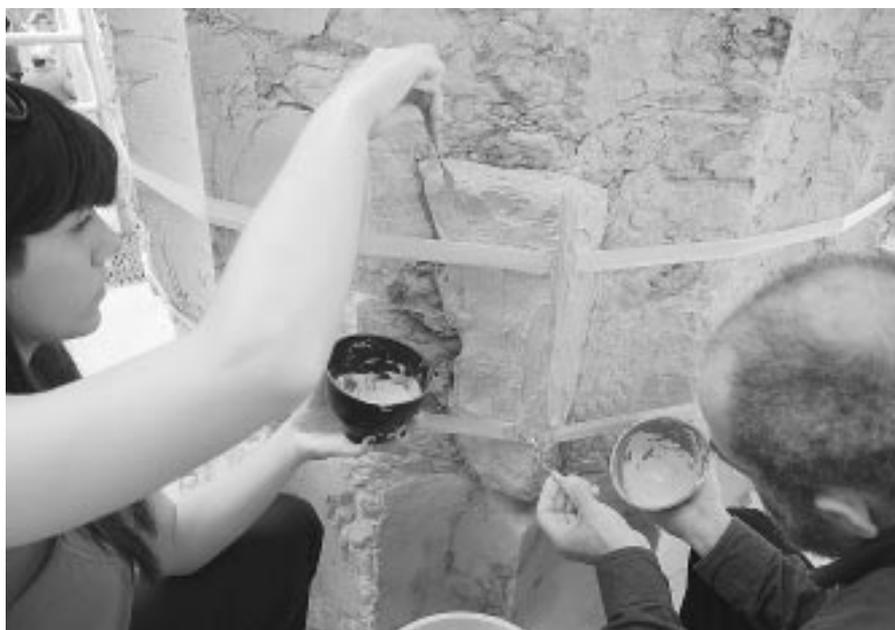
Surface conservation of the northwest column in the central building of the Propylaia. Photo K. Frantzikinaki, 2011

In the Propylaea, under the direction of the conservator K. Frantzikinaki, systematic conservation was carried out on the members of the south wall of the central building and the south wing, and also on the upper surface of 11 architectural blocks in situ, on which the blocks of the south wall are to rest. In addition, a drum of the first column from the north in the

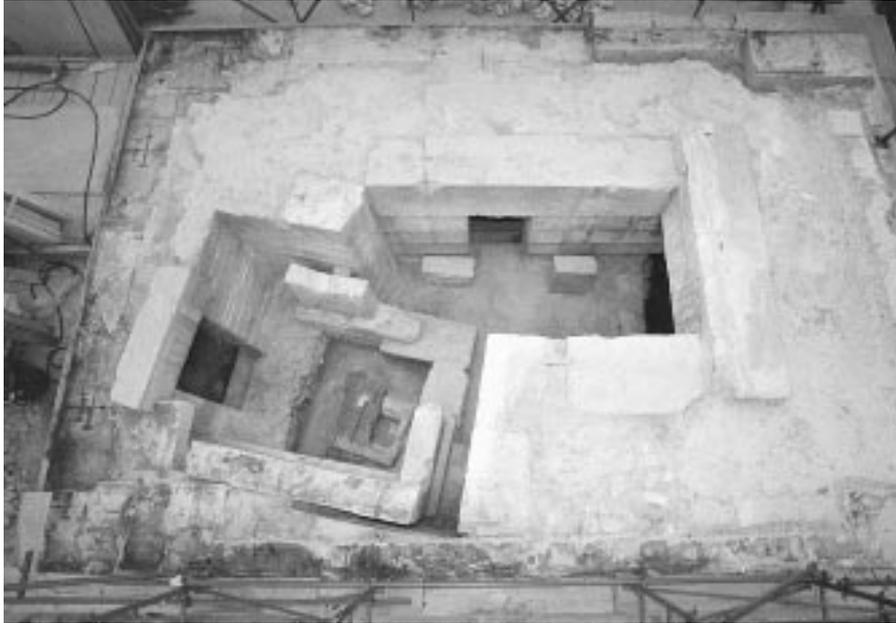
The subterranean space as it was found after dismantling the temple. Photo D. Giraud, 2002

- The existence of an underground space beneath part of the temple overthrew the basic principle of founding the monument on compact foundations and required the invention and application of entirely original solutions. These works, moreover, extended the area of intervention –beyond the classical temple– to include also the poros shrine and part of the bastion itself.

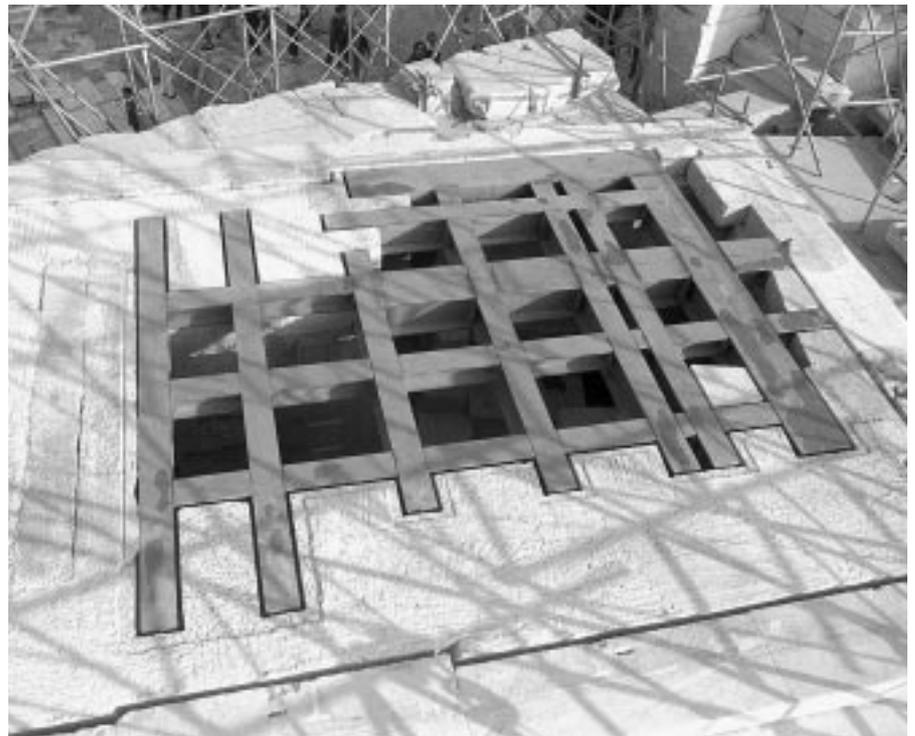
The metal grid beneath the floor of the temple. Photo K. Mamalougas, 2004

cracks in the concrete from oxidation of the reinforcements in the slab and corrosion of the iron beams. The method by which it was supported in the underground space, moreover, by building a little wall of non-reinforced compact stone mortar, which abutted the blocks of the poros shrine, had caused damage to the poros with the appearance of salts. The replacement of the reinforced concrete slab with a metal grid of stainless steel and the redesigning of the method for supporting it, was a work of great scholarly interest, because of the special behavioural requirements of the new construction and the limitations imposed by the available space to the dimensions of its structural members. The special conditions prevailing in the underground space, moreover, made the work arduous. The benefits obtained were, however, particularly significant since resistance of the monument to time was assured and the floor of the temple was now correctly and fully restored at the right level.

Redesigning the bearing structure beneath the floor of the temple yielded significant advantages both for the classical temple and for the preserved part of the poros shrine in the underground space. The composite construction, made up of reinforced concrete and steel beams, that was used in the previous anastelosis of the temple with the aim of making the underground crypt available for study of the poros shrine and other archaeological remains, showed clear signs of damage with

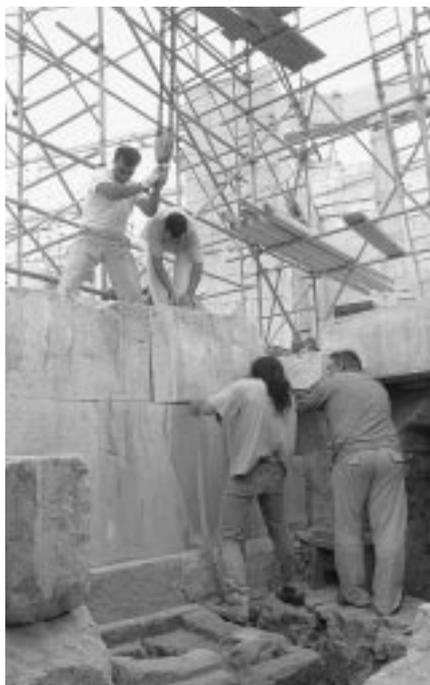
Dismantling the poros shrine. Photo K. Mamalougas, 2002

also to the preserved part of the poros shrine, which was dismantled in order to replace the iron clamps and dowels added in the previous anastelosis and to remove the salts from the stones. Furthermore, the redesigning both of the bearing slab of reinforced concrete and the method of supporting it with pillars of stainless steel,

improved the conditions of preservation and accessibility of the poros monument. This was accomplished with the removal of the aggravating elements of the earlier construction such as the iron support within the shrine and the non-reinforced cement found abutting the poros members. Waterproofing of the area was likewise improved.

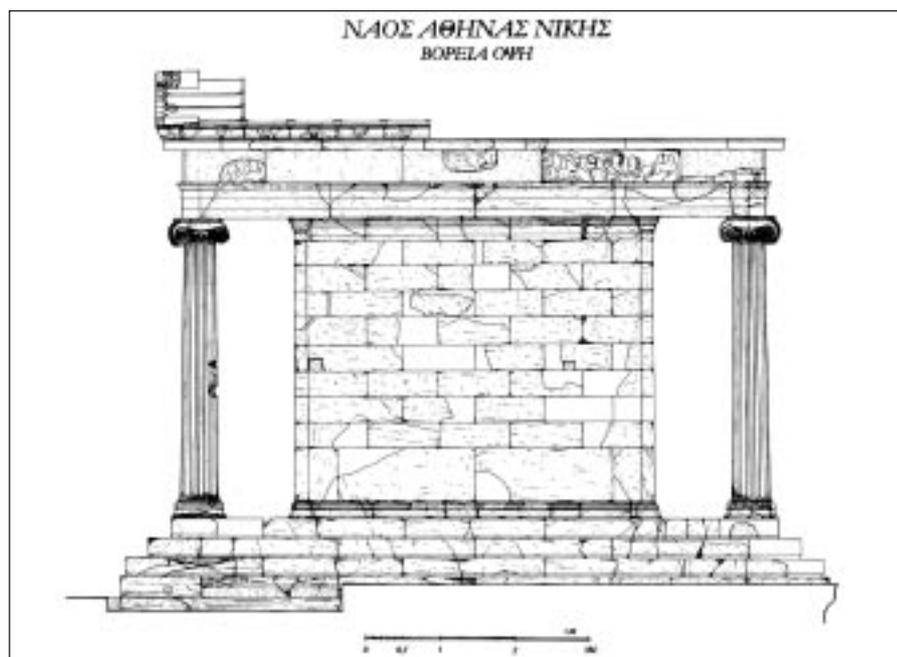
North facade of the monument after restoration. Drawing K. Mamalougas

Apart from the possibility of improving individual parts of the temple, the new restoration enabled us to correct problems that had been caused by the earlier anasteloses and had to do with deviations from the original geometry of the monument. The most significant of these was the 4 cm. incline of the crepis and consequently of the entire monument toward the west. This resulted in various distortions such as the inclination of the west columns toward the west rather than toward the cella wall. Similar corrections, on a smaller scale, invisible to the casual observer but important for the architectural consistency of the monument, were carried out on various different parts of the building, as a result of the study and rearrangement of the members.

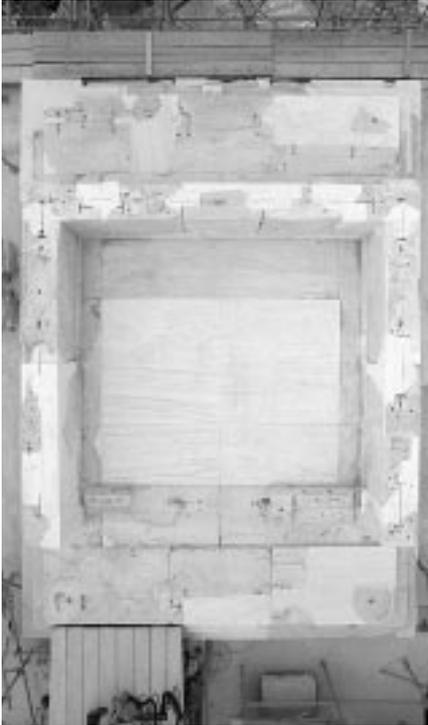
Restoration of the monument during the phase of resetting the members of the cella. Photo K.Mamalougas, 2006

Here it should be noted that, unlike the other large monuments of the Acropolis, the precise original measurements of the temple of Athena Nike were not given facts but had to be found through research, since no part of the temple is preserved in situ. Furthermore, a great many of the architectural members had lost their original measurements through the procrustean trimming they received in the previous anasteloses, made in order to place them on a deformed krepis or to “fit them in” to an incorrect position.

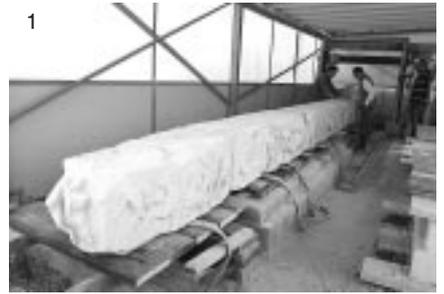
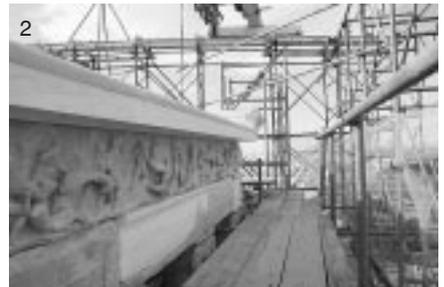
Replacing the authentic frieze with cast copies: 1. Trial setting of the south frieze in the laboratory.

In accordance with the current practice of moving the sculptural decoration of the monuments to the Acropolis Museum, the authentic members of the frieze have been replaced by cast copies made according to special specifications.

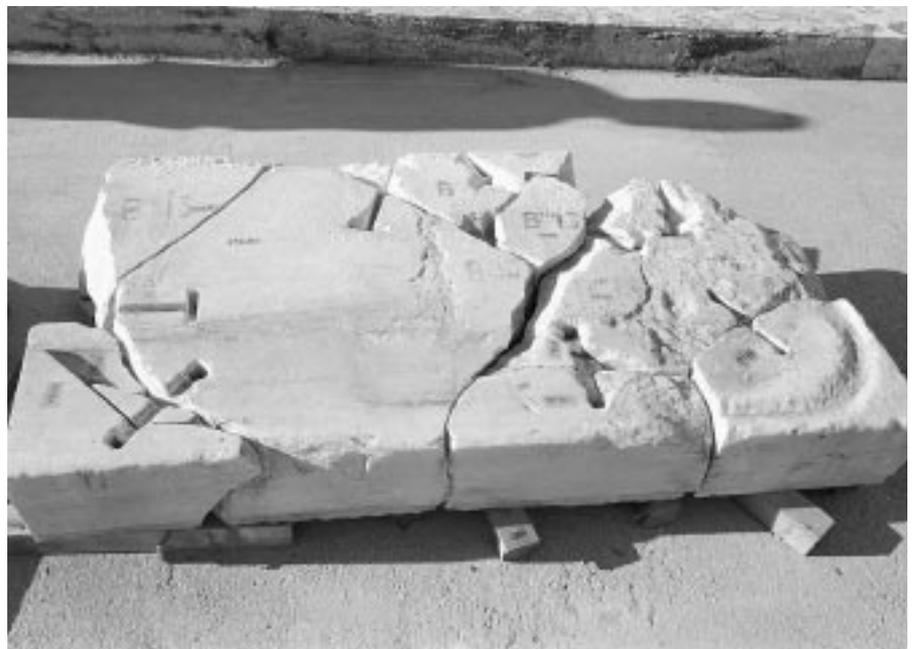
Fragmented architectural member of the crepis. Photo K.Mamalougas, 2003

The new restoration added a significant amount of ancient material to the building, in the form of both fragmentary and intact members. Part of this material was already known from the initial study. Other pieces were found either scattered on the rock or incorporated as ordinary inert material in the concrete filling inside the crepis of the temple.

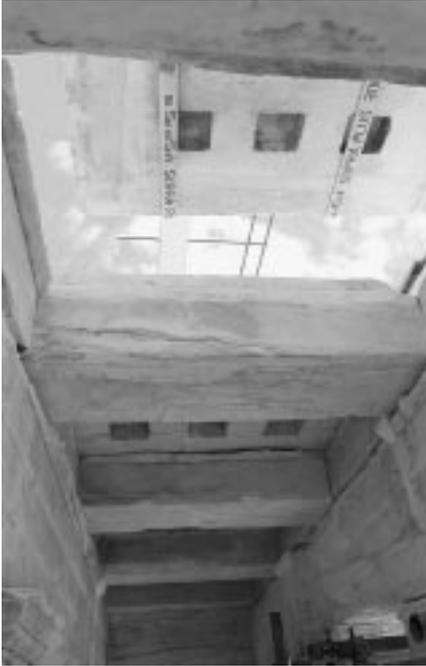
Resetting the coffered slabs of the pranaos.
Photo K.Mamalougas, 2010

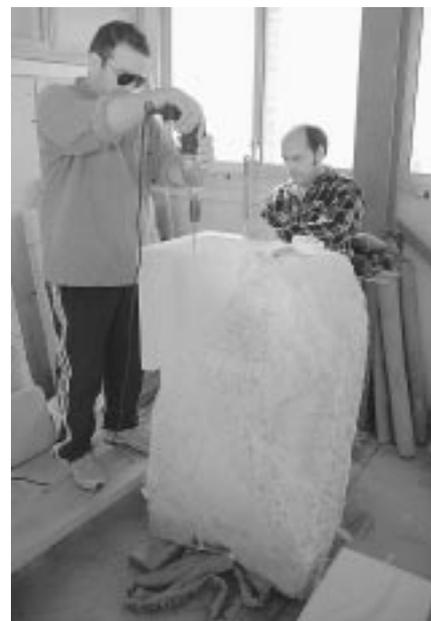
Drilling a hole in the filling of a block from the south wall. Photo K. Karanasos, 2011

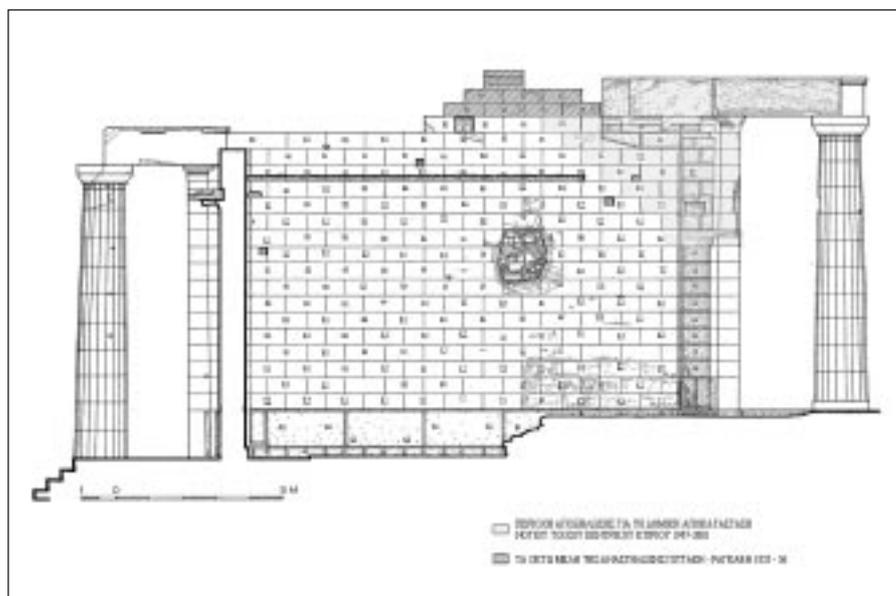
South wall of the central building of the Propylaia, from the south, on which the eight blocks of the anastelosis of K. Pittakis are outlined. Drawing T. Tanoulas

The two side walls, north and south, of the central building of the Propylaia have each twenty courses of blocks above the orthostate, which is composed of Eleusinian stone. Each course, in the section that corresponds to the west hall, is made up of nine or ten blocks. Up to the 18th course the blocks are set as stretchers and they take up the full width of the wall, which

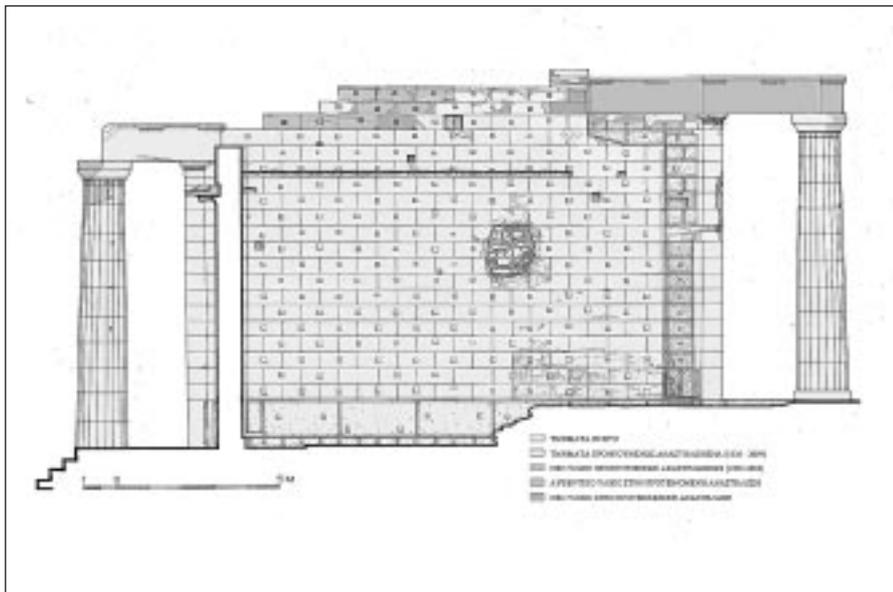
*The south wall of the central building, south facade, after its restoration.
Drawing T. Tanoulas*

Of the twenty blocks covered by the study, including the wrongly placed block of the north wall, sixteen were identified as belonging to the south wall. Eight of these are blocks that had not been previously restored. The condition in which they were found was in general good, so that they needed neither the joining of ancient frag-

setting three more blocks, which, as already noted, are to be made entirely of new marble, thus increasing the total number of blocks in the restoration to nineteen. These are the block of the interior cornice that replaces the block in the British Museum and the first blocks from the east in courses 20 and 19, necessary for the bedding of the cornice block.

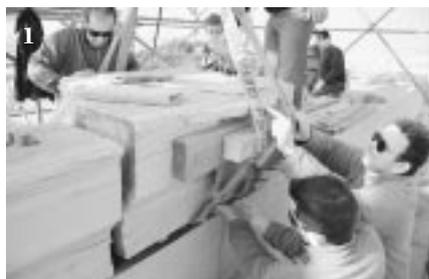
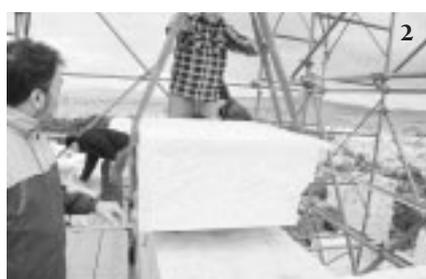
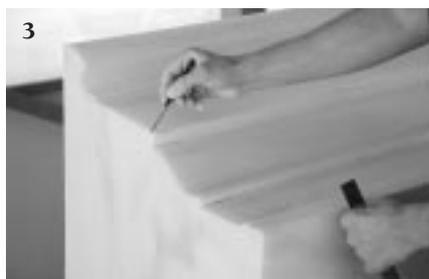
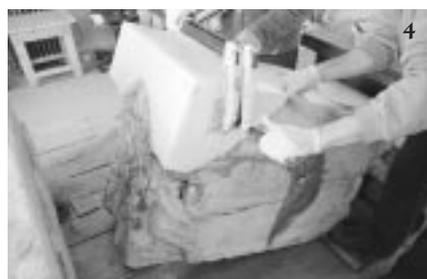
1. Dismantling the in situ block of the interior cornice of the south wall 2. Resetting the block of interior cornice made of new marble 3. Carving the final surface of the block of interior cornice made of new marble 4. Mending a new marble filling to one of the blocks of the 19th course.
Photo K. Karanasos, 2010- 2011

We note that for the needs of the restoration, it was necessary to dismantle the last in situ block of the interior cornice toward the west (AI.N.Θ.P.8), next to which the four blocks of the intervention programme are set.

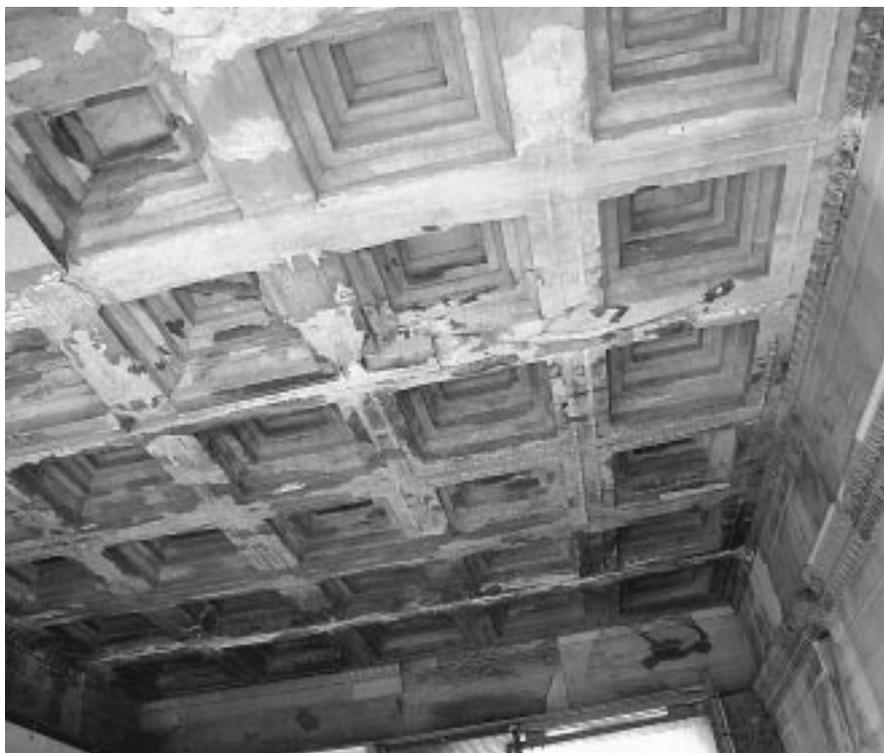
General view of the coffered ceiling of the Caryatid porch. Photo G.Frantzi, 2011

One of the programmes of the YSMA Conservation Section that is in progress today is the conservation and cleaning of the coffered ceiling of the porch of the Maidens in the Erechtheion. The cleaning of pollutants, the deposits of soot and black incrustation, with the use of laser technology, included in the conservation programme, is being carried out in collaboration with the Institute of Electronic Structure and Lasers of the Foundation for Research and Technology Hellas (IESL-FORTH). For this purpose, the interior space of the porch, behind the copies of the Caryatids, was closed off by a panel of polycarbonate sheets. A raised floor was constructed, providing access to the ceiling in order to do the work.

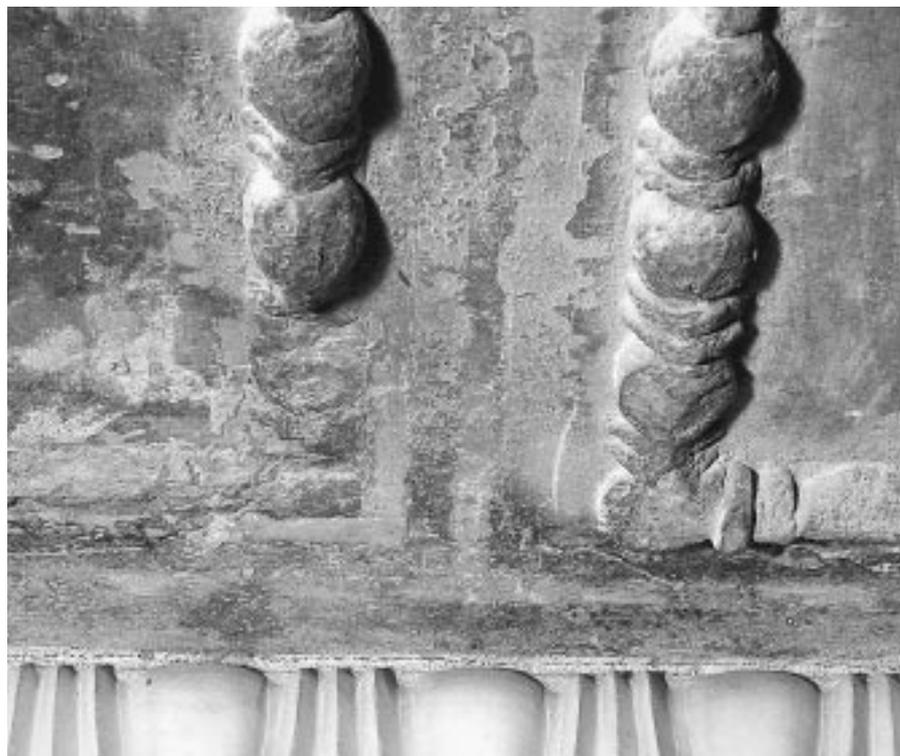
Traces of the two decorative bands on the lower surface between the coffers $\Phi 1\Gamma$ - $\Phi 1\Delta$. Photo S. Mavrommatis, 2008.

In the **2nd coffered slab** the deterioration is limited to surface sulphation. The lower surface on coffers $\Phi 2\Gamma$, $\Phi 3E$ has cracks and sulphated parts of the surface of coffer $\Phi 2A$ are flaking off. Damage to the relief astragals here too is extensive. In addition, a thin skin is observable beneath the black incrustation, which has pulled loose in a number of places, while here and there it

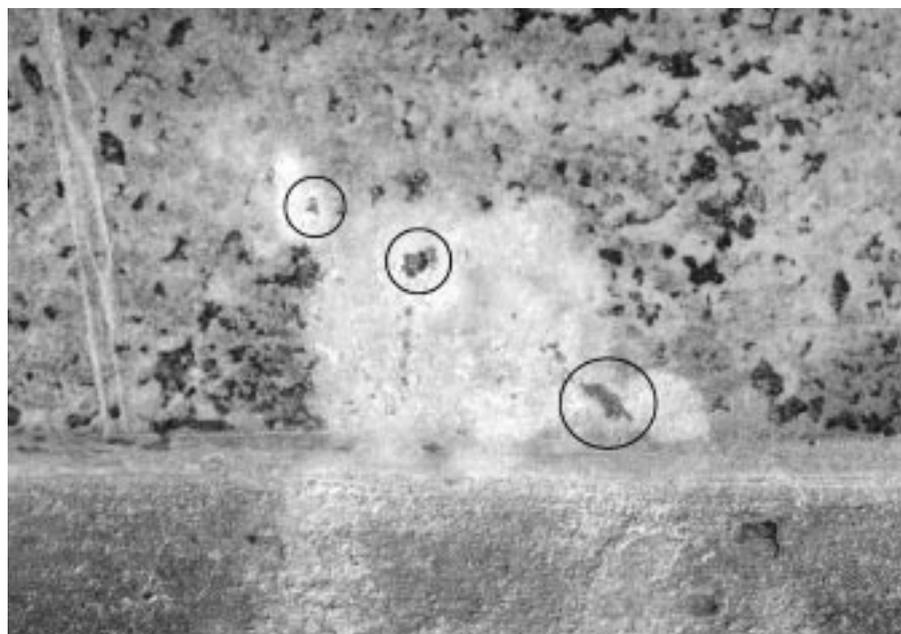
Detail of the first cymatium of the west view of the coffered slab $\Phi 1\Delta$ (coffer 1 West). The circles indicate the existence of blue colour. Photo T. Souvlakis, 2009

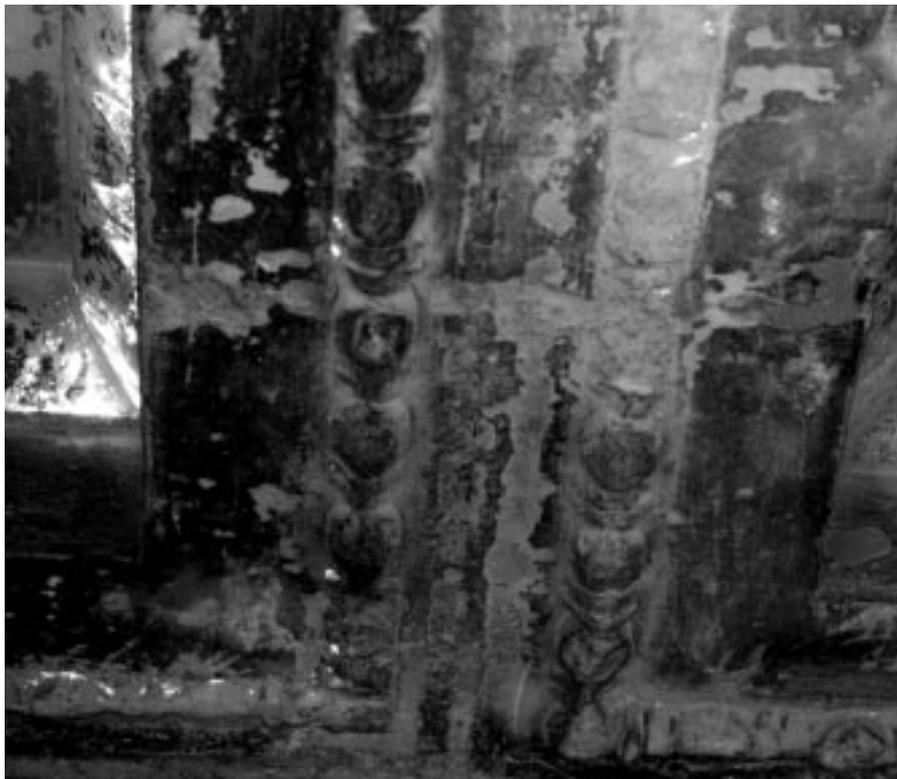
The Egyptian blue is mapped as a bright white using the VIL method. Photo G. Verri, 2009

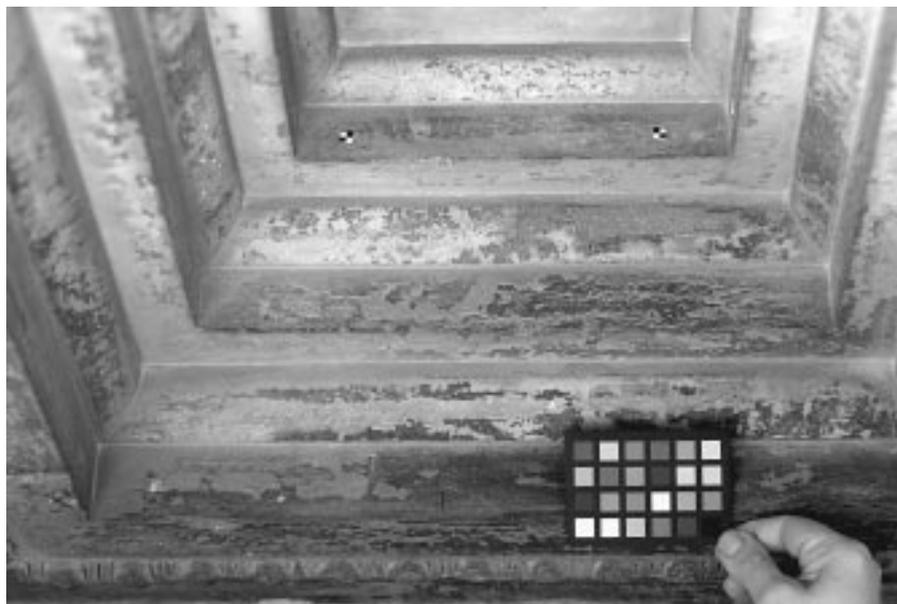
Visible in the west side of coffer Φ1Δ is the black layer on both the level and the curved surfaces. Photo G. Verri, 2009

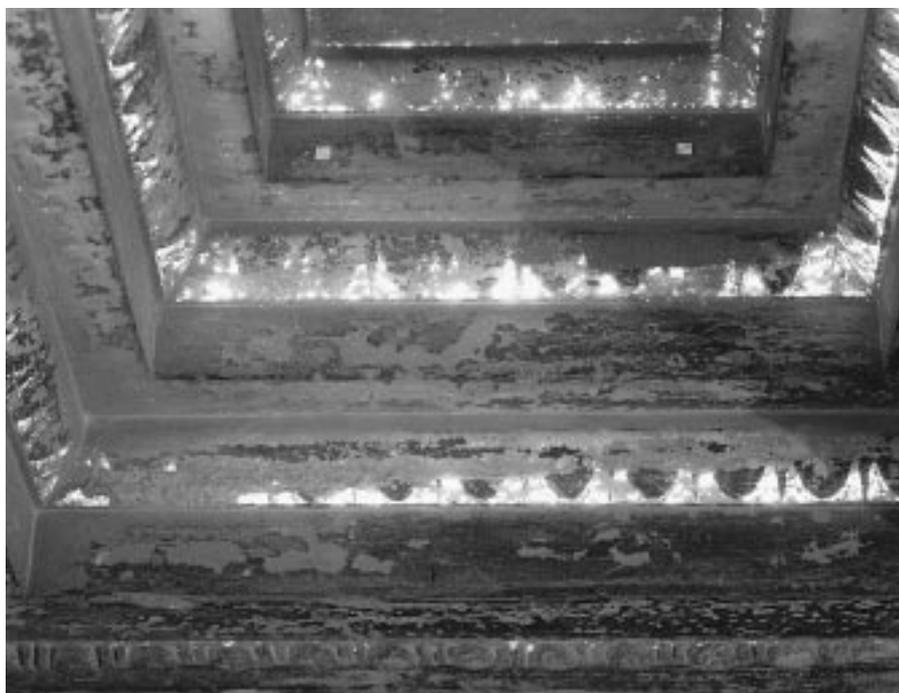
The Egyptian blue is mapped as a bright white using the VIL method. Photo G. Verri, 2009

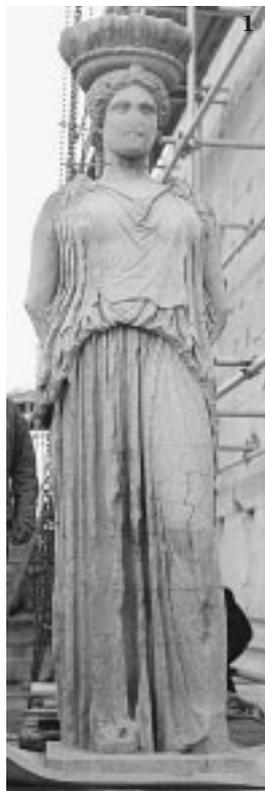
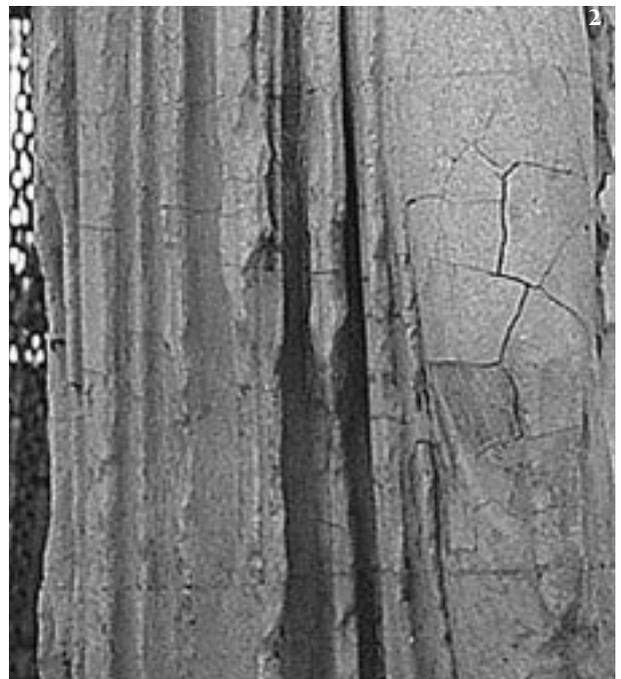
1. The 3rd Caryatid during its removal in 1979
2. Detail showing damage to the surface after 66 years of exposure (1913-1979)
Photo A. Papanikolaou, 1979

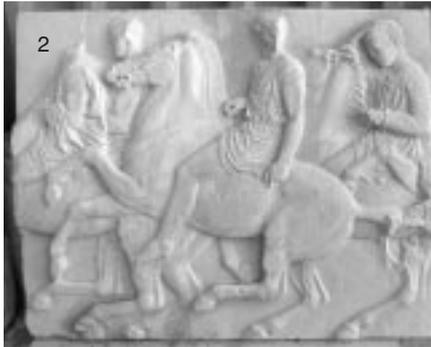
Cast copy from the Parthenon frieze (2) and a middle phase during its carving by means of a CNC stereopantograph (1)
Photo Venus Company, 2007

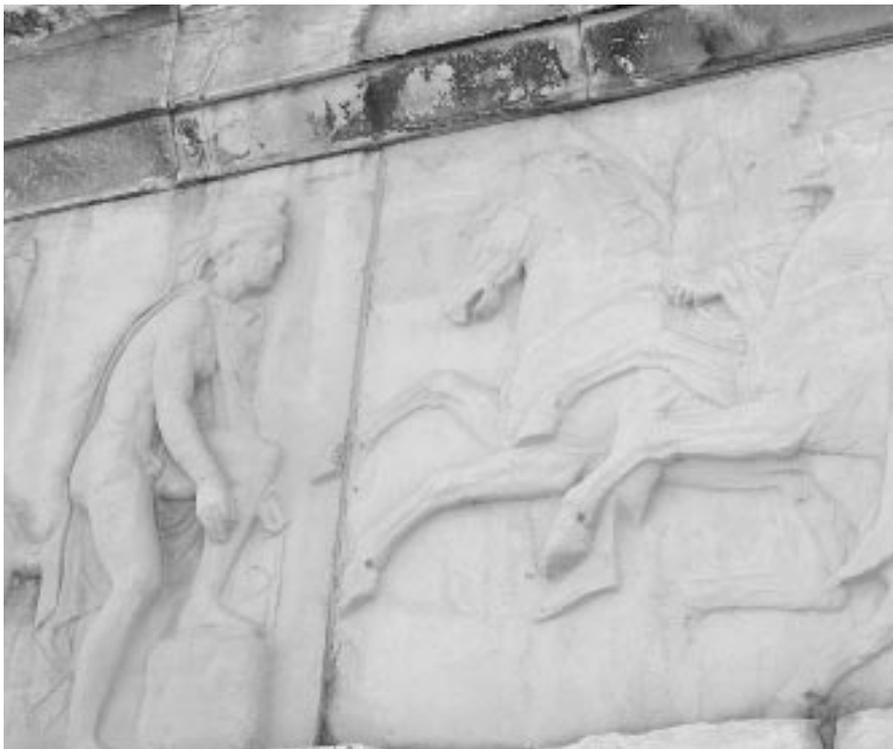
Detail showing the setting of two slabs of the west frieze. Photo V. Manidaki, 2010

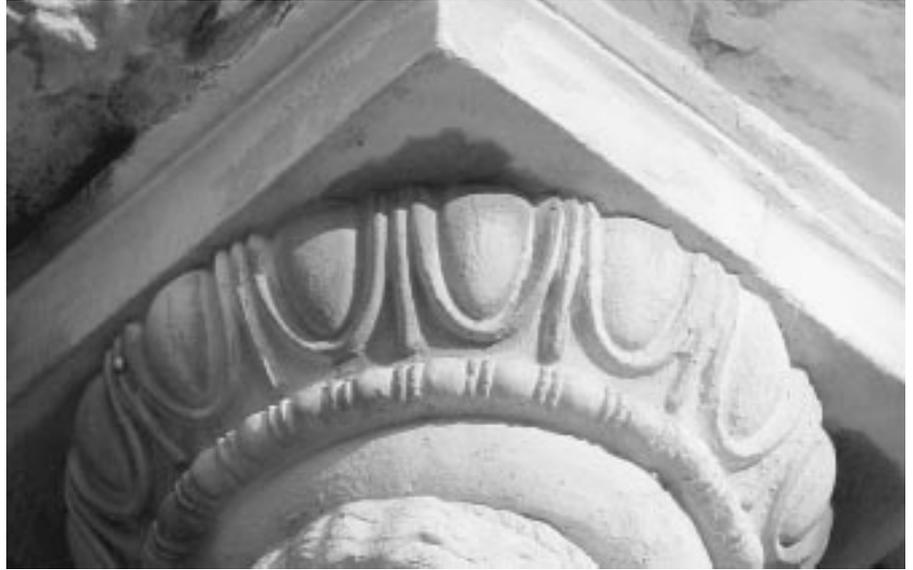
Cast copy of the reconstructed marble capital of the 6th Caryatid
Photo V. Manidaki, 2010

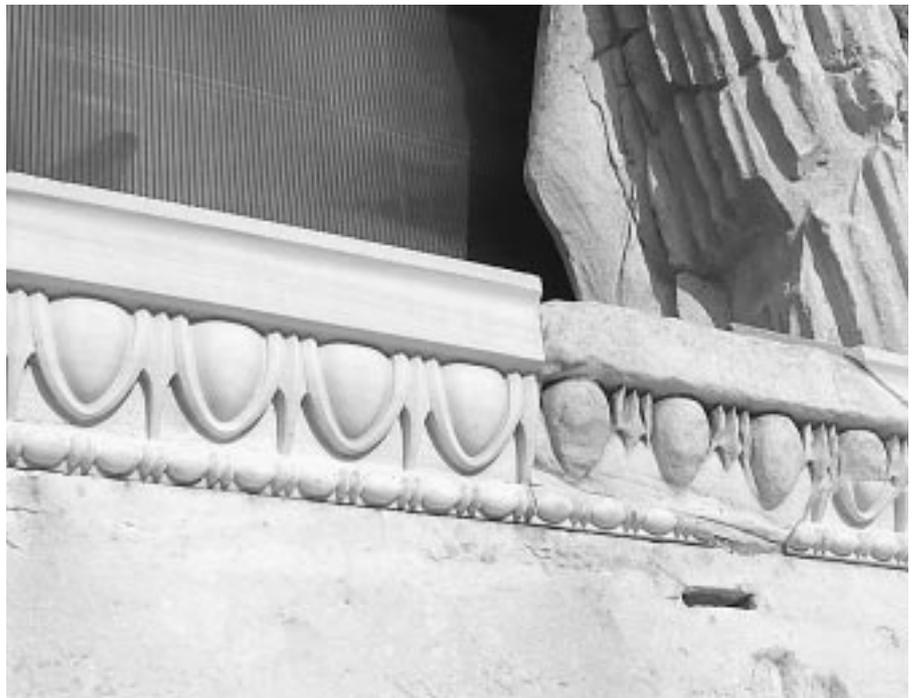
Marble filling in the sculptured decoration of the Porch of the Caryatids
Photo V. Manidaki, 2010

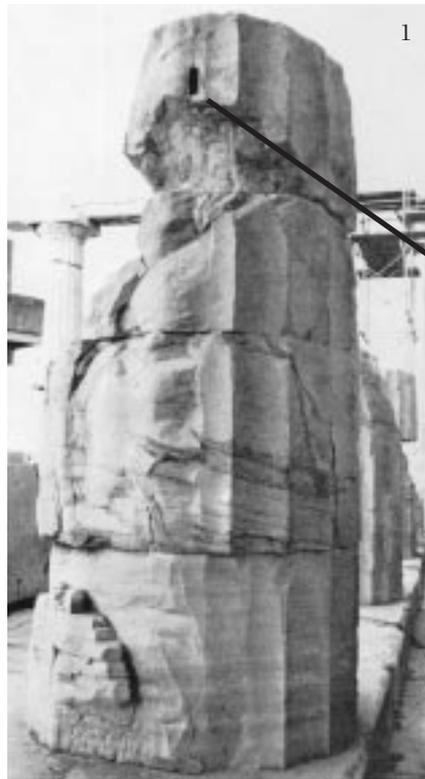
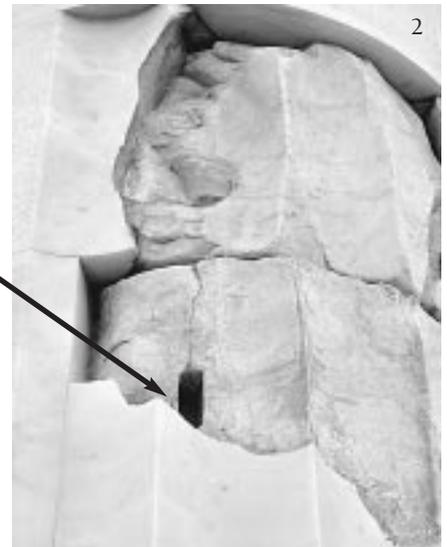
1. Pronaos column (4th from N) before restoration. Rectangular fence-cutting visible on upper, 4th drum.
