- M. Ioannidou, 2010 – 2011, The progress of restoration on the Acropolis
- D. Michalopoulou, K. Mamalougas, The restoration programme of the temple of Athena Nike: brief evaluation
- K. Karanasos, Restoration of the superstructure of the south wall of the central building of the Propylaia
- G. Frantzi, The gradual revealing of colour on the ceiling of the Porch of the Maidens in the Erechtheion
- V. Manidaki, The replacement of sculptured architectural members on the monuments of the Acropolis. Casts, copies and authentic members
- L. Lambrinou, The restoration of the Parthenon's pronaos: aesthetical matter or theoretical dilemma?
- C. Hadziaslani, E. Kaimara, A. Leonti, New activities and publications of the Information and Education Department
- E. Petropoulou, News from the Acropolis

2010 – 2011, The progress of restoration on the Acropolis

Athena Nike Restoration project

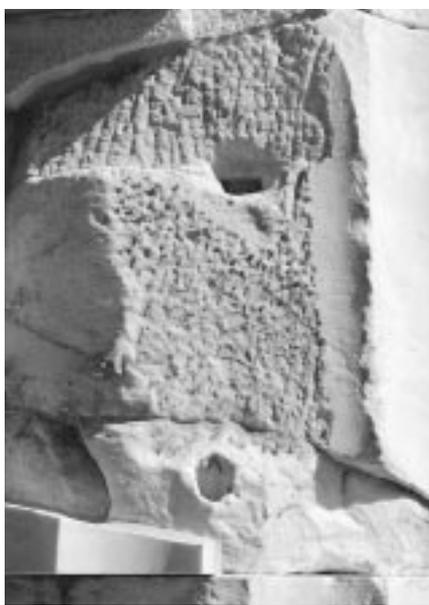
*Detail of 3rd column from N after restoration. Still visible are the traces for supports of ancient fences and Byzantine cuttings.
Photo L. Lambrinou, 2009*

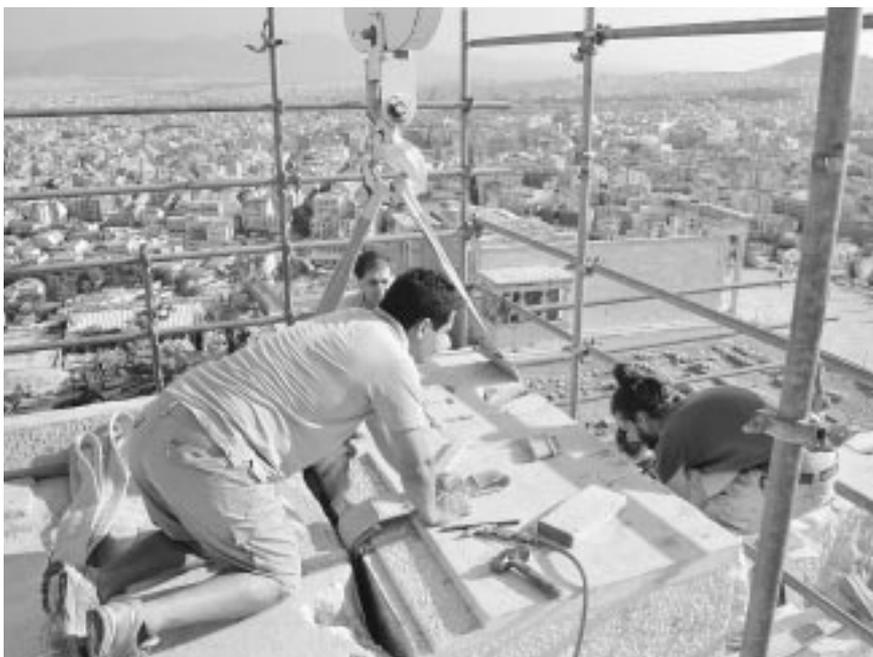
*Preparations for dismantling a cornice block from the north entablature of the Parthenon.
Photo V. Eleftheriou, 2011*

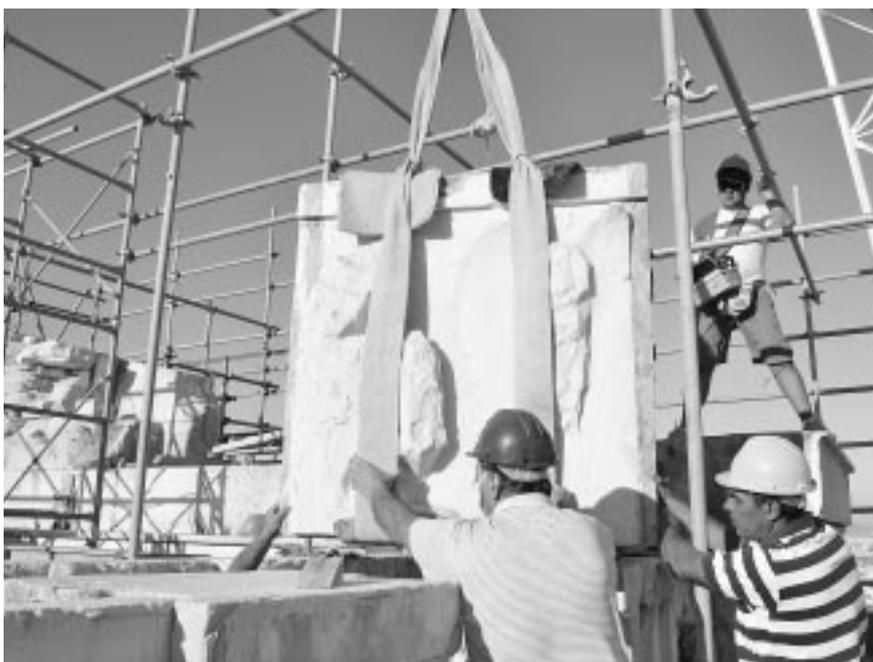
*Dismantling the second from the west metope of the Parthenon north entablature.
Photo V. Eleftheriou, 2011*
