- V. Eleftheriou, 2011-2012, The progress of the restoration works on the Acropolis  
A. Vrouva, The problem of the structural restoration of the capital ΔΚΚ2 of the Parthenon west colonnade  
K. Skaris, The architectural study for the restoration of the Parthenon west tympanum backing wall  
Y. Alexopoulos, M. Katsianis, Digital applications for projecting the Acropolis restoration works on the internet  
I. Kaimara, A. Leonti, S. Paraschou, C. Hadziaslani, Educational programme "A day at the Acropolis restoring its monuments"  
E. Petropoulou, News from the Acropolis  
E. Karakitsou, Nikos Skaris (1923 - 2012)

## 2011-2012, The progress of the restoration works on the Acropolis

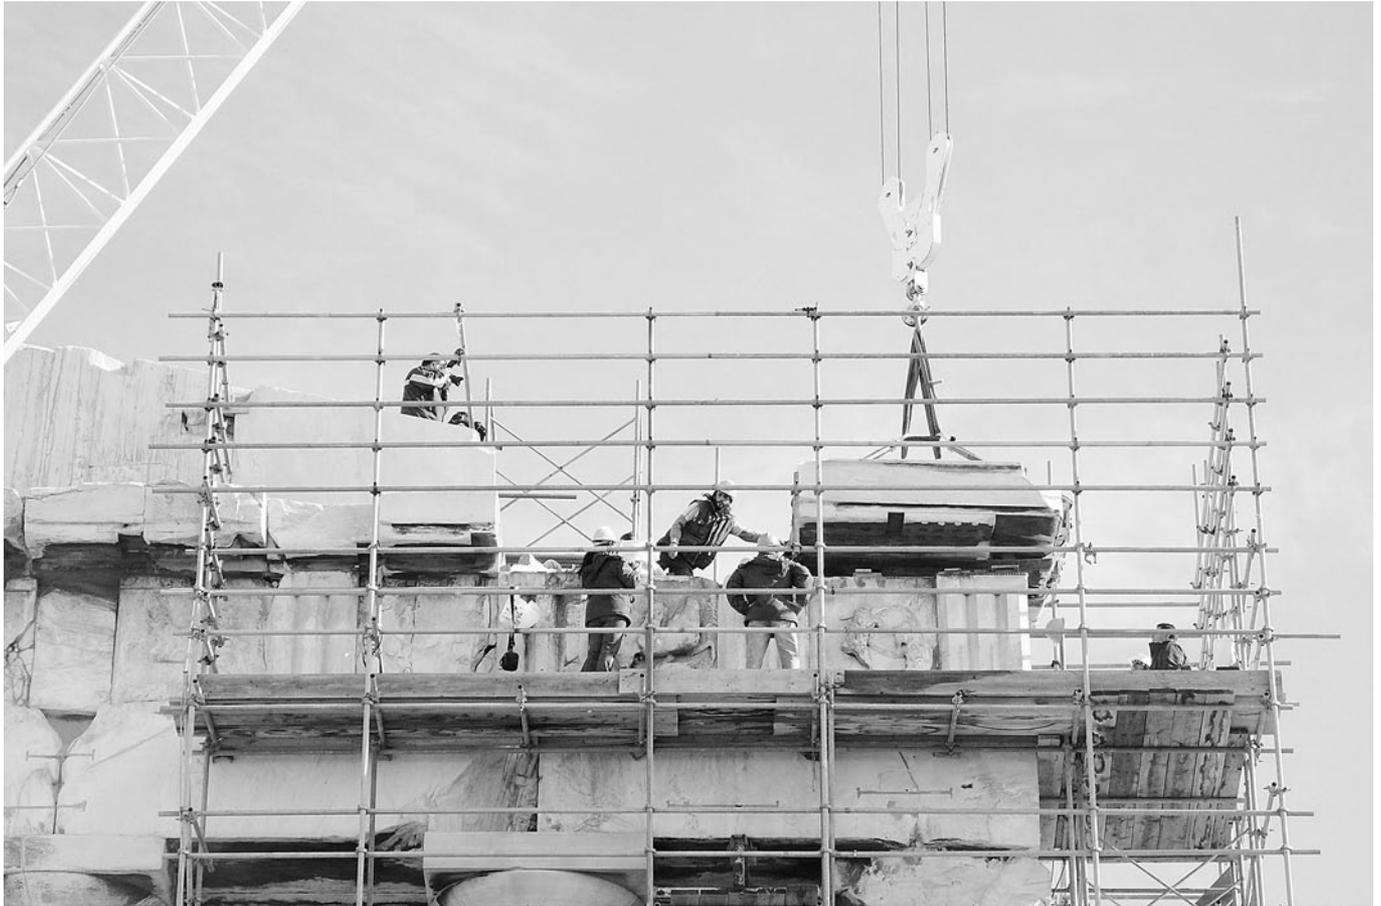
*Dismantling the southwest cornice block of the Parthenon. Photo V. Eleftheriou 2012*

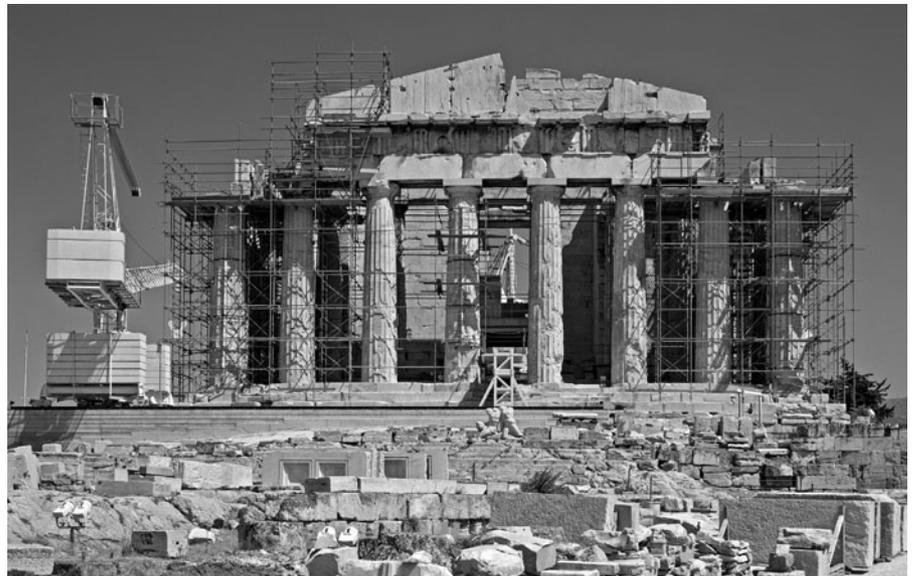
*The west side of the Parthenon after completing works of dismantling.  
Photo T. Souvlakis, 2012*

The works on the Parthenon proceeded on three fronts. On the west side the dismantling of architectural members, which began in May 2011, was completed. A total of 62 architectural members were dismantled from the northwest corner (original evaluation called for 47) and 49 from the southwest (original evaluation 37). The increase in numbers of dismantled members does not signify a planned extension in the area of intervention. It is due, instead, to the fact that only after dismantling can the precise number of blocks that have been used in the hidden sections of the monument be ascertained.

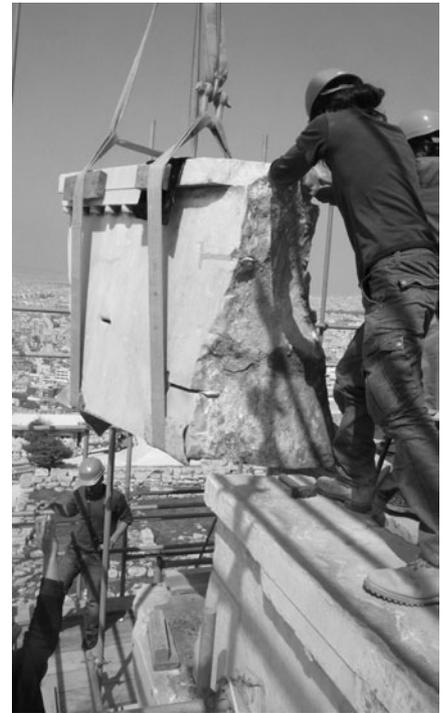
***Dismantling the first from north architrave block of the Parthenon NW corner.***

For example, it was found that the marble blocks used for the middle stone of the west architrave, on both the northwest and southwest corners were less in height than the blocks beside them and that the difference in level was compensated for by the addition of four or five marble slabs, 10 to 15 cm thick. Dismantling reached the level of the column capitals, in accordance with the relevant study of V. Manidaki, A. Vrouva and the undersigned. The greatest difficulty lay in the extremely heavy architrave blocks, up to 8.5 tons. Of the twelve that were dismantled, five were already broken, while three more had structural problems to a lesser degree. This necessitated special arrangements for their support before moving them. After dismantling the architrave blocks, it was evident that the column capitals were in worse condition than had been expected. The condition of the second from north column capital of the west side was judged to be especially problematical. The action of the dowels of the overlying architrave blocks caused cracks, which had been dealt with in the past by the addition of exterior metal clamps. After removal of the architrave blocks, more cracks were discovered, invisible on the outer surface, that made the restoration of the members difficult (details in the next article of the present Newsletter). A final decision as to how to deal with the problem will be

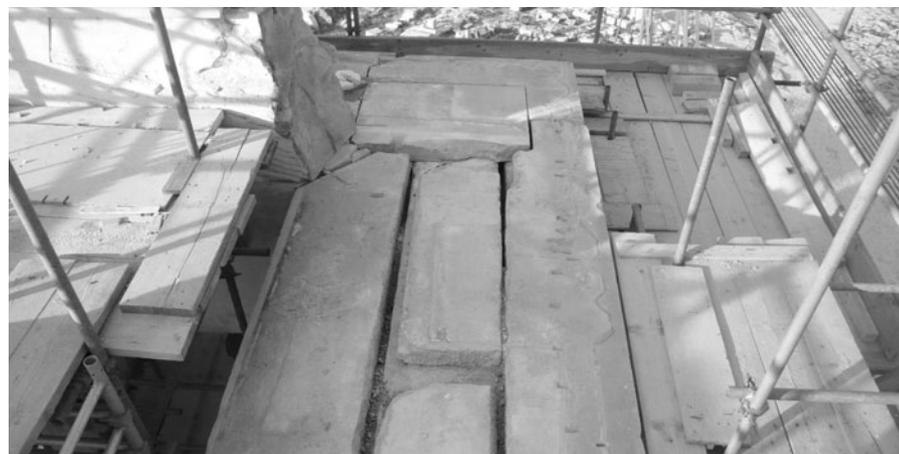
***The upper surface of the NW corner architrave block of the Parthenon after removal of the overlying members. Visible are the supporting posts of the middle architrave blocks.***

made when the southeast broken section of the column capital has been removed and the exact state of preservation has been determined. It will be necessary, however, to install a special construction (carrier) to support the entablature at the area of the 2nd intercolumnar space of the west side. This has been studied by the civil engineer A. Vrouva and is to be installed in the autumn.

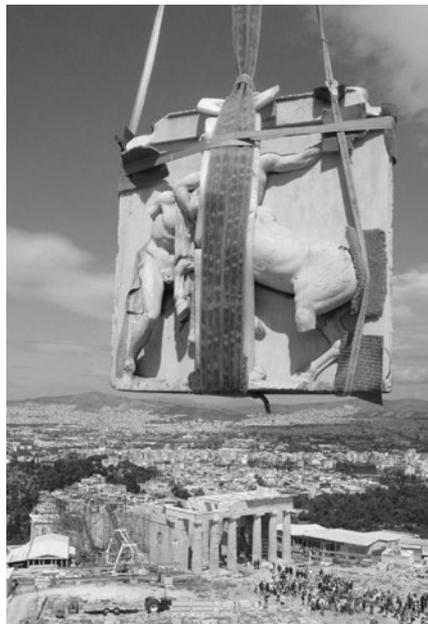
**Lowering the SW metope of the Parthenon with a scene from the Centauromachy. Photo V. Eleftheriou, 2012**

Seven metopes, four from the northwest corner and three from the southwest corner were dismantled and transferred to the Acropolis Museum. These metopes are the last of the sculptural decoration that is being removed from the Acropolis monuments. Ten ancient metopes will remain on the Parthenon where they will receive conservation in situ. Likewise removed were the copies of the two pedimental sculptures of the west side, Kekrops and Kallirrhoe, which had replaced the originals in 1976. Set in place of the metopes and the pedimental statues will be copies made of a cast material, the

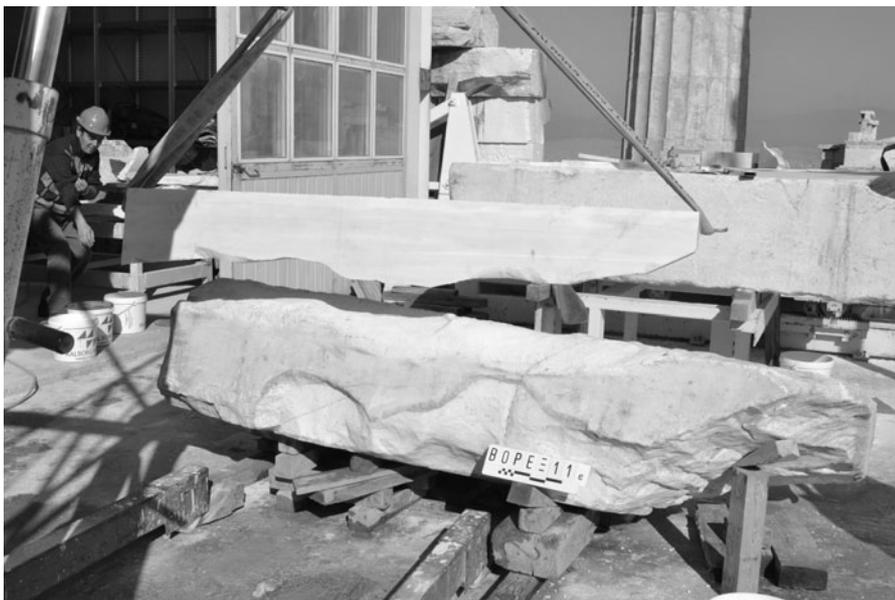
**Adjusting a filling to a north orthostate block. Photo R. Christodopoulou, 2012**

The anastelosis of the north side of the Parthenon was completed in 2009, and the final surface of the flutes remains to be worked in the areas filled in on the drums of six restored columns. The carving of the flutes, a work requiring high accuracy, has been undertaken by the most experienced marble technicians of the Parthenon team and over 50% of the work has been completed.

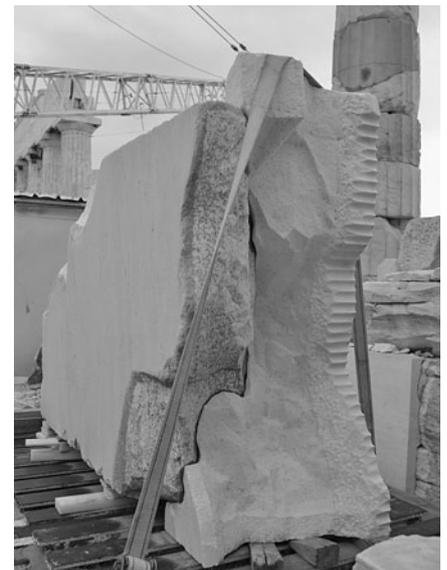
**Attaching a filling to a north orthostate block of the Parthenon. Photo R. Christodopoulou, 2012**

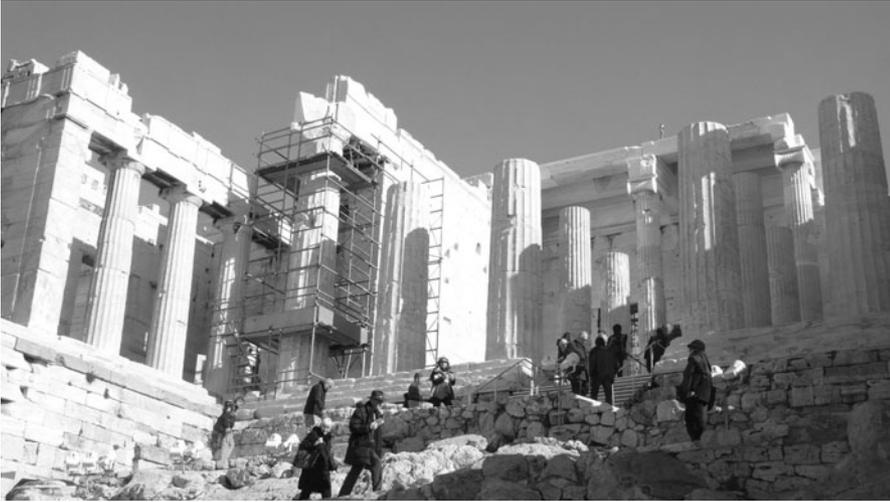
**View of the west façade of the Propylaea showing the scaffolding supporting the NW column of the central building. Photo V. Eleftheriou, 2012**

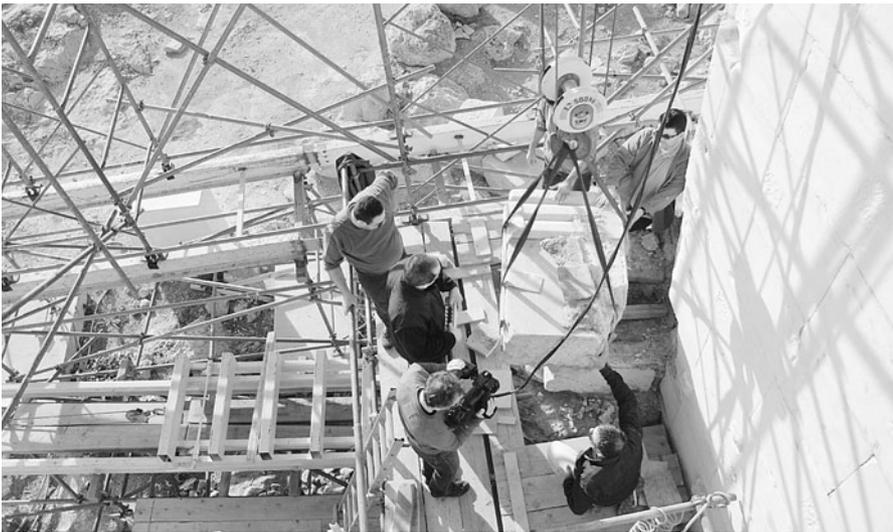
**Dismantling a frieze block from the SE corner of the south wing. Photo K. Karanasos, 2012**

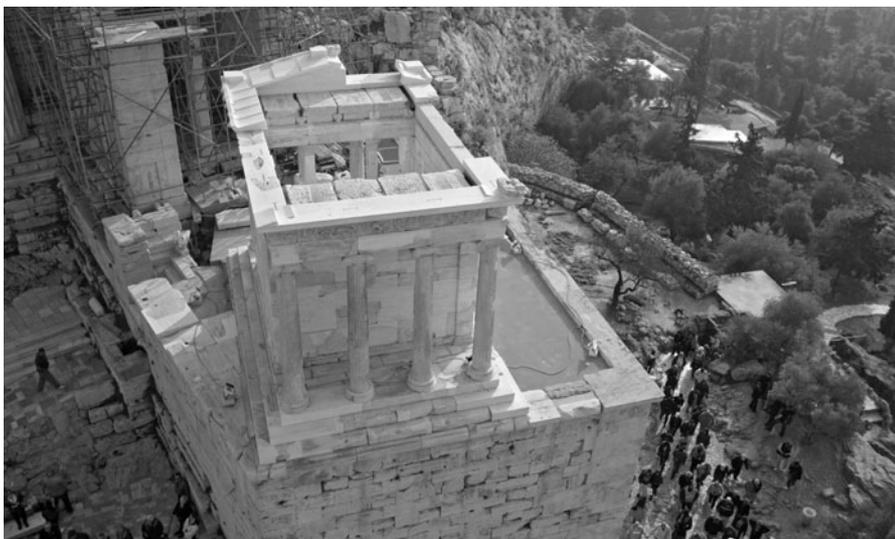
**View of the temple of Athena Nike after completing the restoration of the north crown of the bastion. Photo S. Gesaphidis, 2012**

In the temple of Athena Nike the restoration of the crown along the north side of the bastion and the arrangement of the subterranean space, where the poros temple is preserved, were both completed. The replacement of the reinforced concrete slab originally planned, was finally avoided and, instead, the existing slab was reinforced with sprayed concrete and

additional metal reinforcement. With the completion of these works, the worksite installations were removed and the area of the Brauroneion was cleaned, exposing again the base of the Chairedemos dedication in the centre. A study for the arrangement of the site and access to a view of the Temple of Athena Nike is to follow. Head of the marble technicians team, which has already moved to the teams of the Propylaia and the Parthenon, was L. Zacharopoulos.

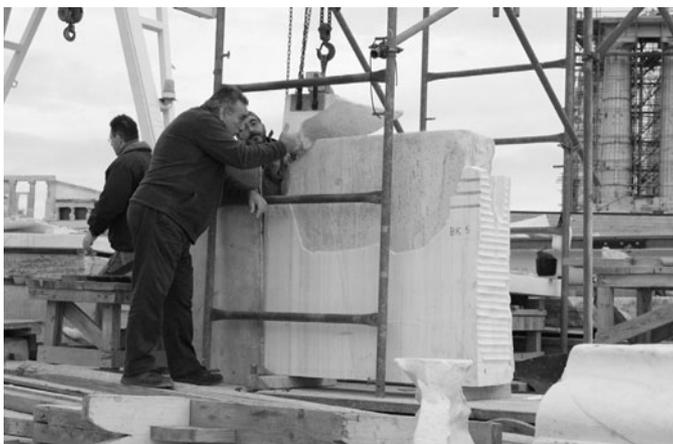
**Adjusting a filling to a north crown block of the temple of Athena Nike. Photo D. Michalopoulou, 2012**

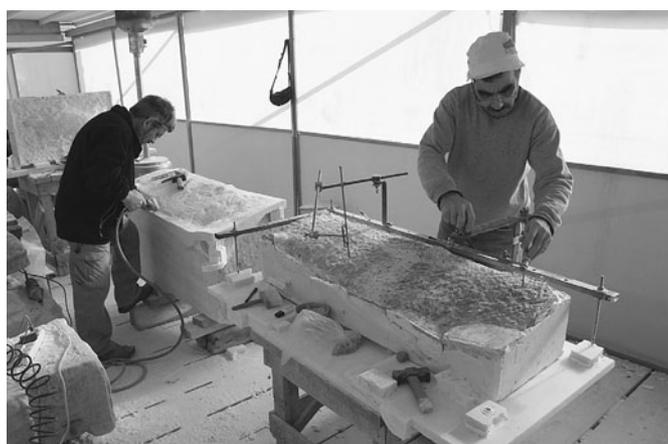
**Carving a filling for a north crown block of the temple of Athena Nike. Photo D. Michalopoulou. 2012**

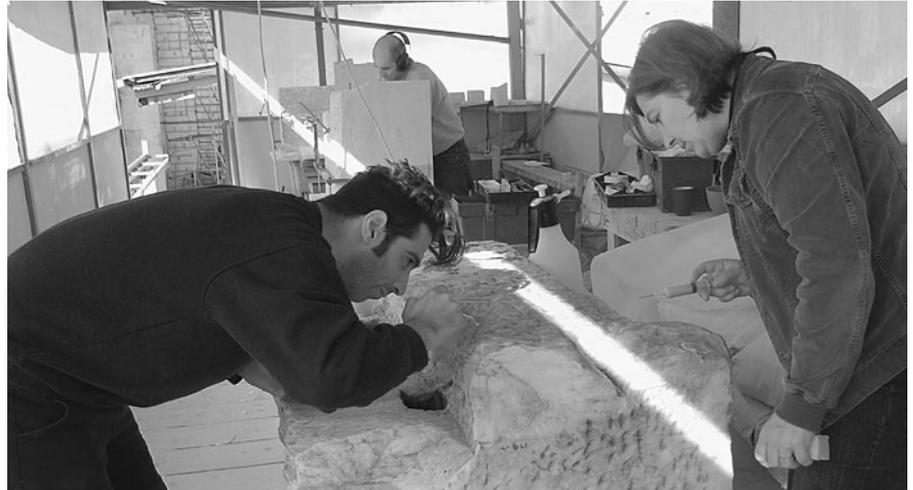
*Application of injections into a block of the south wing of the Propylaia. Photo E. Frangiadaki, 2012*

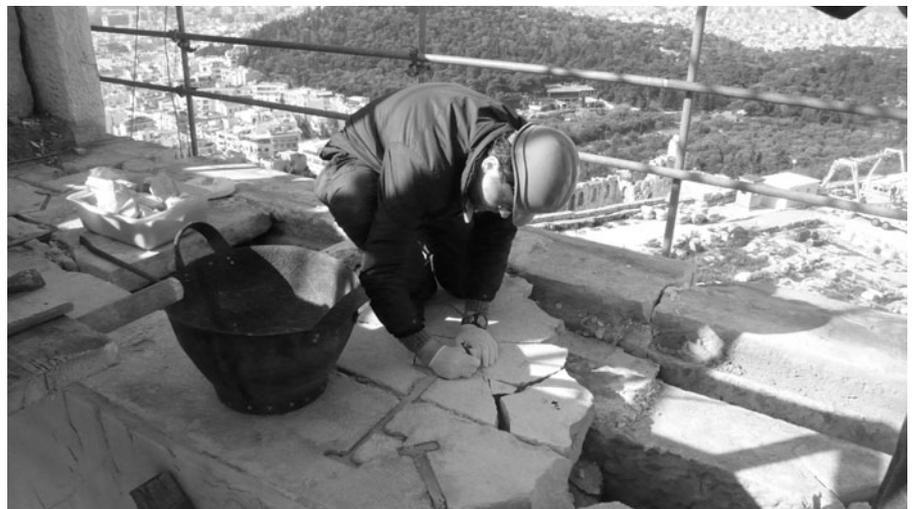
*Mapping fragments of an architrave block of the Parthenon NW corner. Photo V. Eleftheriou, 2012*

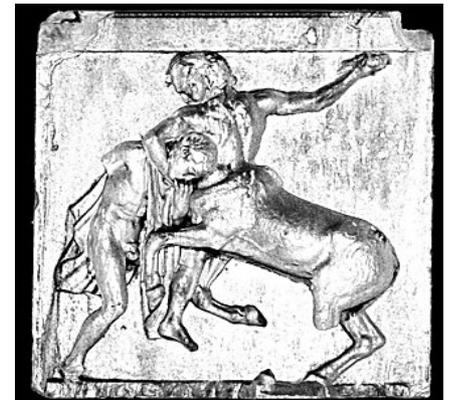
**3D models of the surface of Parthenon metopes. Scanning and elaboration: A. Valani**

by the rural and surveying engineer D. Mavromati. So too, select architectural members such as the corner blocks of the raking sima, the acroteria bases and the metopes of the Parthenon, and five archaic column capitals were surveyed with three-dimensional scanning by the rural and surveying engineer A. Valani. The two above mentioned engineers also prepared the contract for the work “Photogrammetric surveying of the Acropolis monuments” after international tenders were made. The procedure began in October 2011 and consignment of the work went to the partnership “Geoanalysis S.A. - Elpho - Fotopo S.A”. The work comprises the production of orthophotomosaics, at a scale of 1:10 to 1:25, of the ground plan of the north side and corners of the west side and the view of the entablature of the north side of the Parthenon. Included also are the ground plan and views of the walls of the south wing of the Propylaia. A photogrammetric survey will also be made of the wider area of the Propylaia and the temple of Athena Nike, at a scale of 1:100. The survey will be incorporated in a previous survey, which was carried out in the context of the work “The Development of Geographical Information Systems on the Acropolis of Athens”.

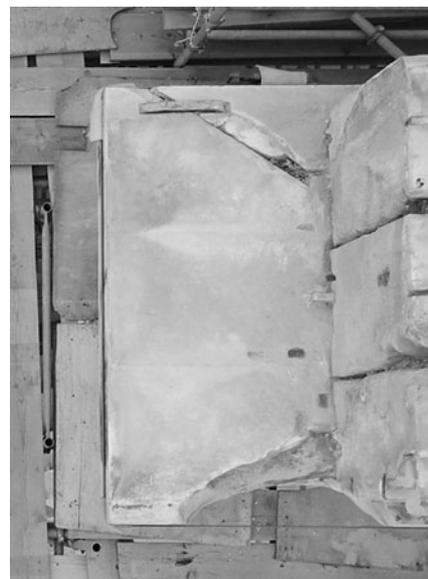
*Plan view of the capital ΔKK2 after dismantling the first span of the west colonnade. Photo A. Vrouva, 2012*

The dismantlement carried out on the northwest corner of the temple revealed the structural problems of the capital ΔKK2 to their full extent. The state of preservation in which it was found necessitated systematic survey of its pathology. A thorough investigation made for the intervention posed serious questions about selecting the most appropriate solution for its rehabilitation. It was clear that the conventional methods that have until now served the purposes of restoring the Acropolis monuments and have been established as formal restoration practice, are not able to provide the required safety factor for maintaining this particular architectural member in its original bearing position. Presented here are the problems encountered in the study and the proposals introduced and studied. This is a very distinctive example in which the various contradictory values in the restoration project had to be carefully weighed.

After dismantling part of the northwest corner new evidence came to light for the structural stability of the capital. It was thus possible to make an overall estimation of the severity of the damage as well as to determine the factors that provoked it.

It was evident that the fractures had been well estimated in terms of form and that they can be attributed to a weak inner stratum of the marble within its volume that was incited by the presence of the dowels. Another fracture was also ascertained, for which there was no external indication prior to the dismantling.

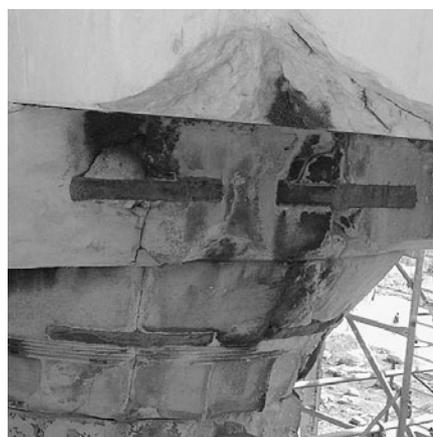
*The column capital ΔKK2 before dismantlement. View from the S. (left), from the W. (center) and from the E. (right). Photos A. Vrouva, 2012*

The problems of the capitals were described as thoroughly as external observation allowed since the initial study of the state of preservation of the west colonnade was made. Even then it was obvious that the second capital was one of the most severely damaged members, as

during the Balanos restoration a systematic effort had been made to secure the obviously loose fragments.

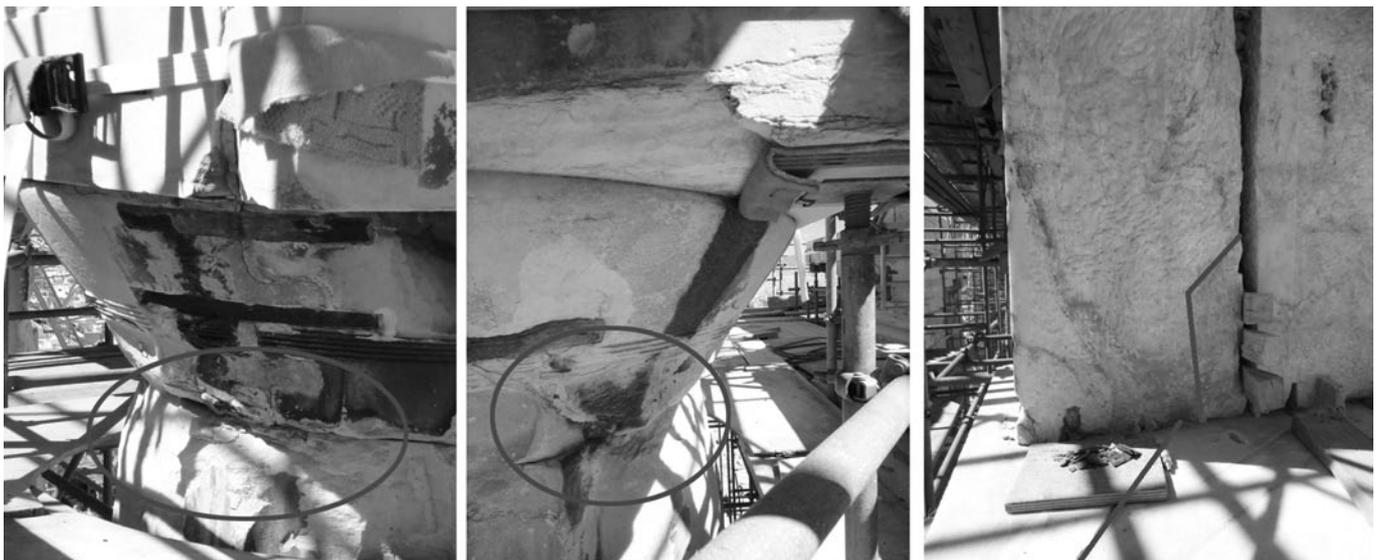
**The SE fragment rests on an area with extensive mass loss in the underlying drum (left, center) and fracture attributed to stress concentration in the lower NW corner of the inner east block of the architrave of the second span (right). Photo A. Vrouva, 2012**

The risk due to specific damages is increased in view of the observations which concern the seating of the SE fragment on the drum beneath and the seating of the inner east block of the second architrave.

The fragments show a clear recession in comparison to the upper surface of the capital. This means that the load of the architrave blocks is carried through their seat on the capital no matter how small a part remains intact, excluding the area of the fragments. This indicates stress concentration in a small area of the architrave. The restoration of the SE fragment of

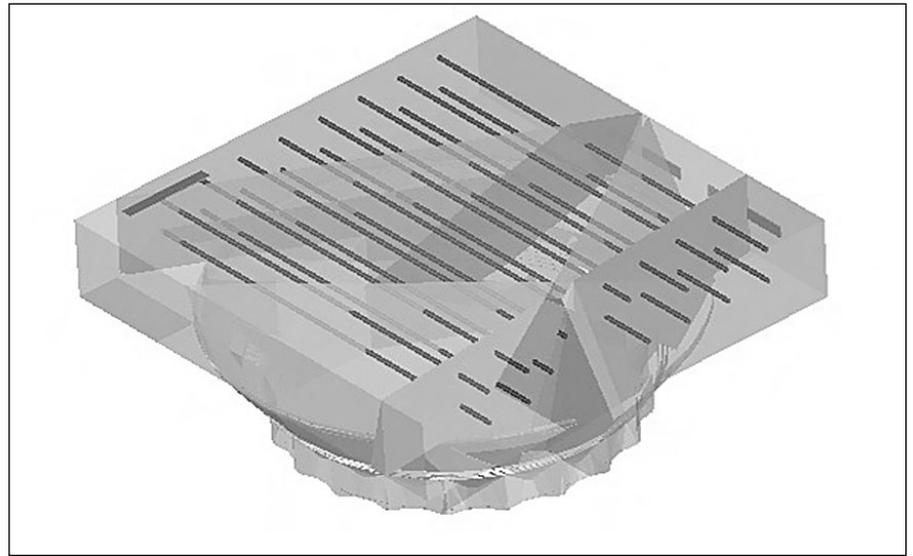
**Suggested positioning of the titanium bars inside the abacus of the capital for joining the fragments together**

The use of internal titanium reinforcement bars in all the fractured surfaces was an alternative the purpose of which was to ascertain that the bars would have the best inclination, thus maximizing their effectiveness for adjusting the fragments. This kind of intervention required that the fragmented capital would have to be moved to the worksite in order to manipulate it properly. The deformations could then be completely restored. The method, however, was to be preferred only if the safety factor thus provided was much greater than in all the other reinforcement methods. This was because removal of the capital from its original position was a significant decision with various implications.

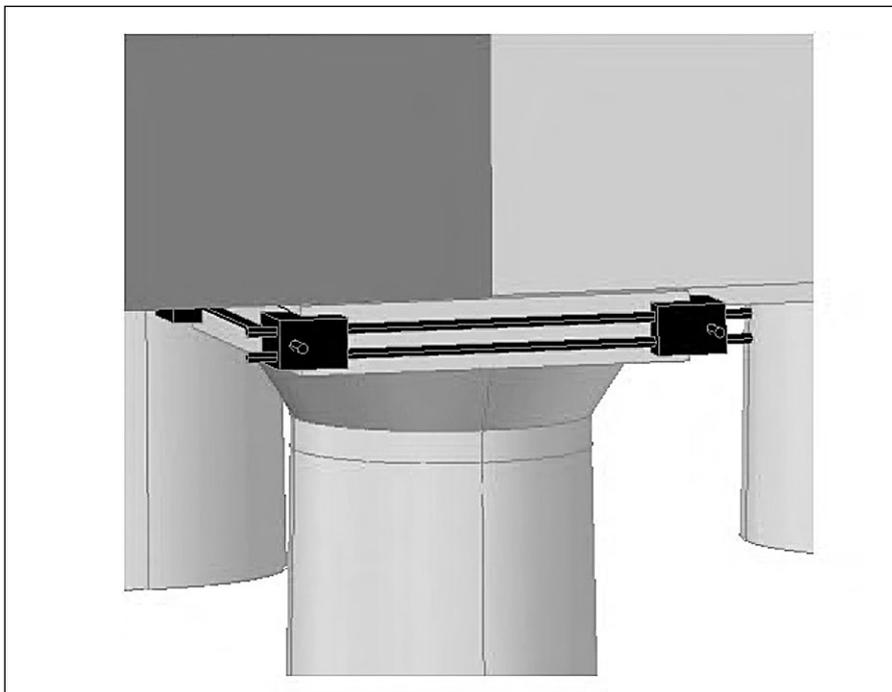
**Schematic representation of the solution with pre-stressed tendons**

The use of exterior pre-stressed tendons was an alternative to the first solution, proposed in order to avoid visible per-

The study excludes in addition the solution with external pre-stressed tendons, since the shear of the fractured surface could not be assumed by the reinforce-

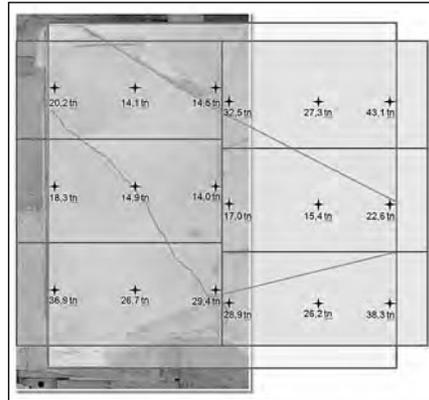
**Possible location for the architrave supports on the upper surface of the capital and the respective loads**

the beam remains in place. The condition of the capital would thus be consolidated in its present state. This solution meets the requirements for the static loads, yet further and in-depth study is required on seismic response.

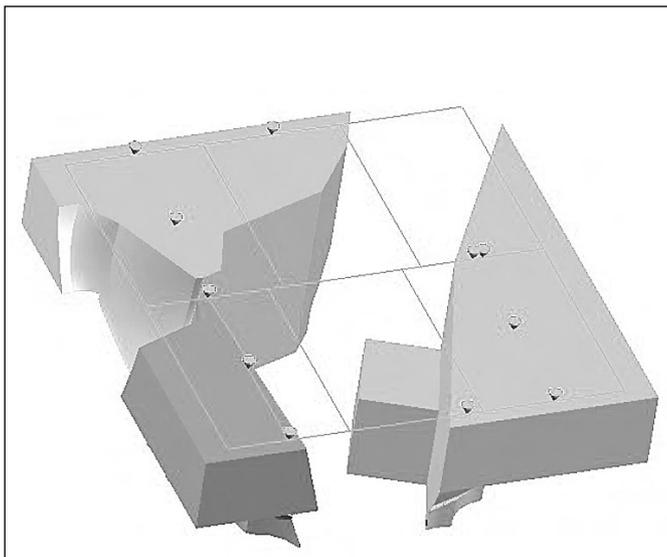
**Schematic representation of the solution with incorporation of a new complement with a shear protrusion**

The replacement of the SE fragment with a new complement of different shape would require the construction of heavy scaffolding in the area. The functionality and safety of the intervention were doubtful since the core of solid marble has been diminished by the fractures. This is an intervention with significant loss of ancient material. Among the advantages of the method are a well assured seating of the fragment on the drum and the restoration of the deformations.

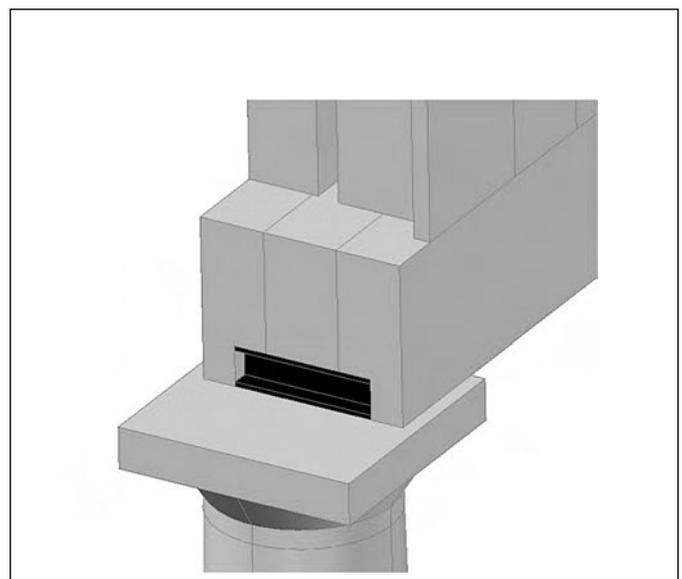
**Schematic representation of the solution with nested beam**

The final decision in favour of a nested titanium beam in the architraves (solution 6) was made at the ESMA meeting 14/6.12.2012. This solution avoids the function of the fragment which cannot be adequately secured on the rest of the column capital so as to bear the load it was

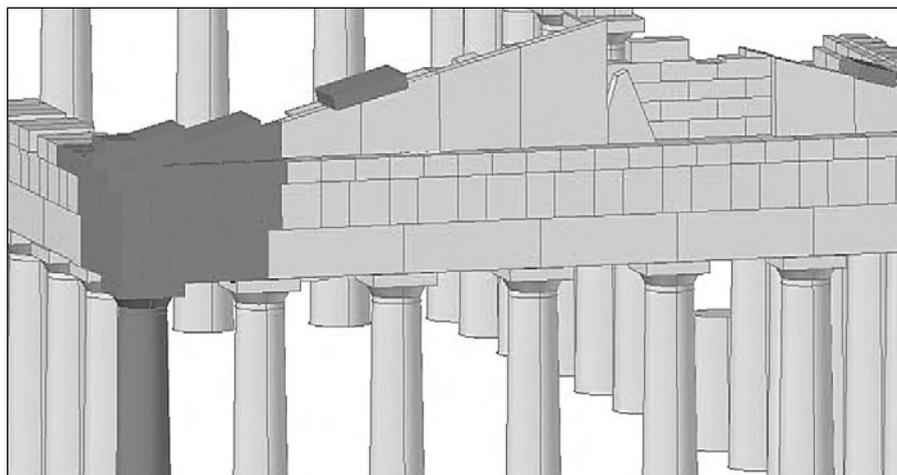
**Replacement of the fractured capital with a new one – west view**

Considered as a scheme of last resort was the replacement of the capital, because of its severe problems and its critical position in the whole construction. How to remove the capital and to replace it raised serious discussion. Again, two solutions were considered: raising the entablature and dismantling the intercolumnar blocks. To raise the entablature was considered risky because of the difficulty of assuring a precisely level elevation; even slight inclinations could imperil the entablature. This procedure called for a strong and heavy splint, which, given the geometrical characteristics of the entablature would be difficult to construct. The scaffolding required for the works, a heavy steel structure, was studied. It necessitated the construction of an enormous base of reinforced concrete. The overall project was neither time nor cost effective compared to the dismantling of 25 ancient architectural members. Yet the decisions to be made

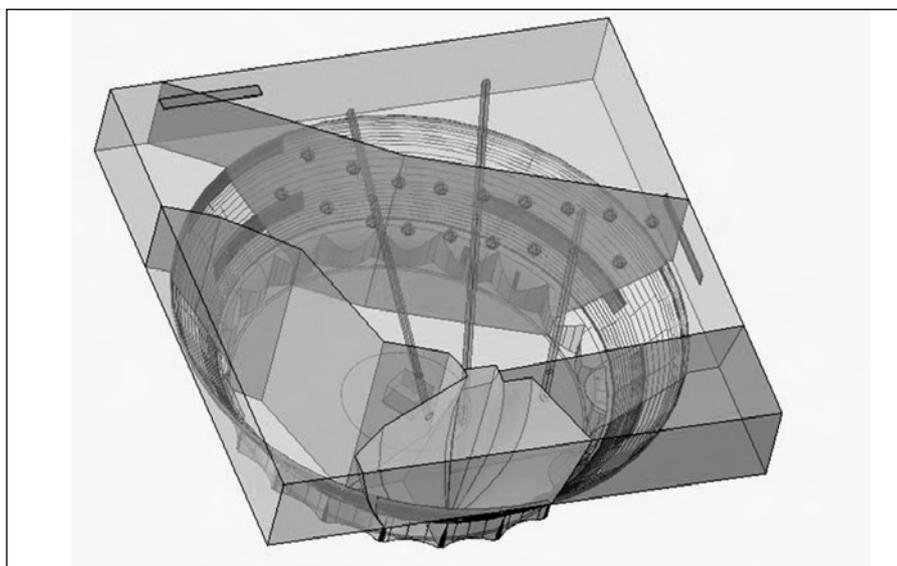
**Schematic representation of the solution with the insertion of spheres and tendons**

This original solution was proposed by Professor M. Korres, fellow member of the ESMA, at the meeting 13/16.11.2012. The proposal was the detachment of the SE fragment, the insertion of small spheres in the fracture-surface and the adjustment of the fragment in place with three pre-stressed tendons to secure it. Study of the proposal showed that the solution was weakened by the existence of the other fractures in the area where the tendons would have to be anchored. The ESMA requested experimental research on the method and verification of its effectiveness before its adoption.

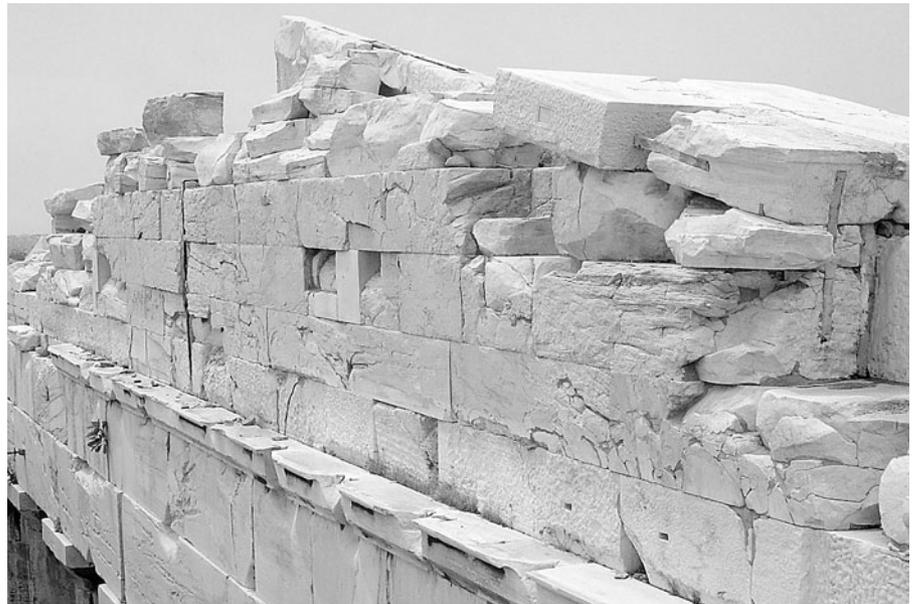
*General view of the east side of the backing wall of the west tympanum from the northeast. Photo YSMA Archive*

set from the centre towards the edges. Along the length of the slanting surfaces of the east side of the backing wall seven beam casings were cut to hold the west ends of the roof beams. The great destruction of the blocks around the beam holes by fire suggests that the beams here were wooden. Yet the precision with which the horizontal surfaces of the beam cases are carved and the measurements of the beams leave open the probability that the beams were in fact of marble.

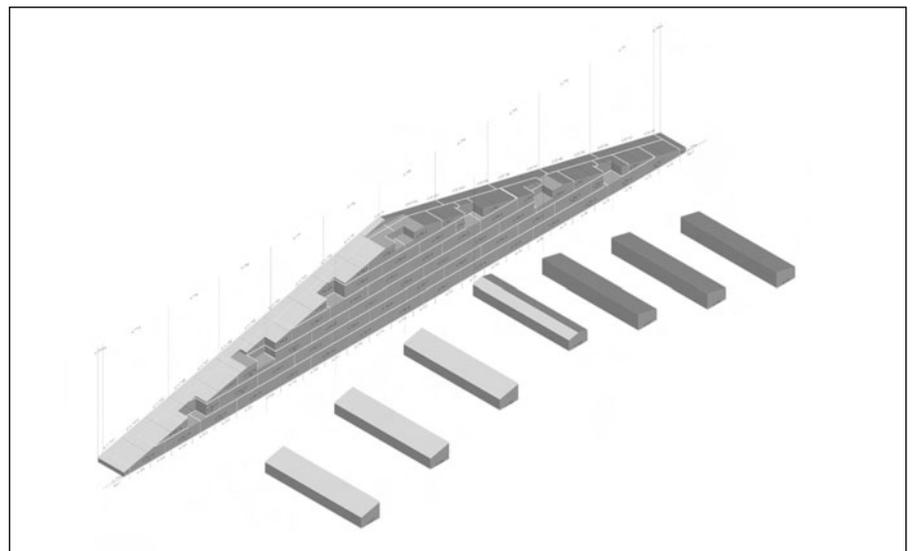
*General perspective reconstruction view of the backing wall, the orthostates of the tympanum and the roof beams*

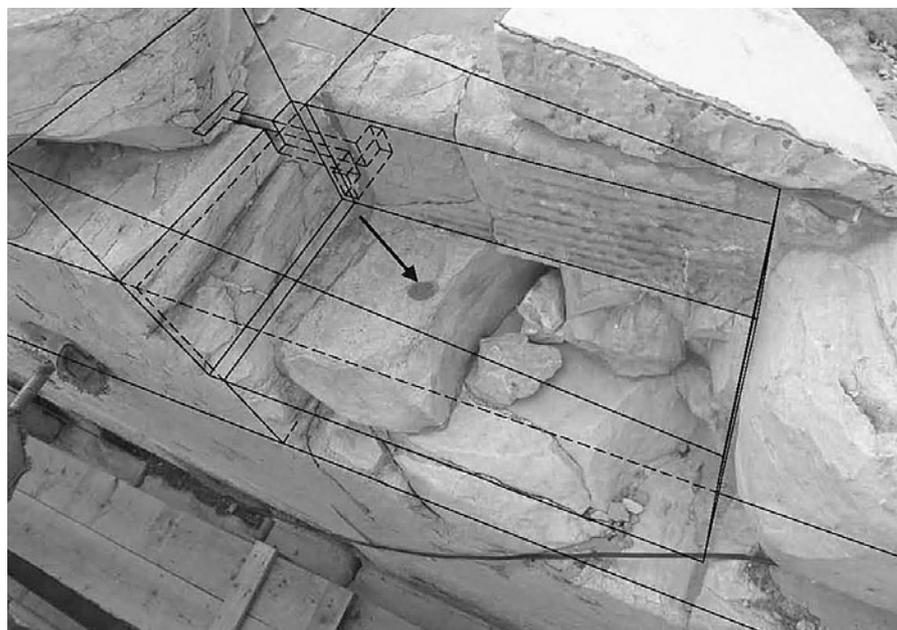
**View of the beam case for the second beam from the north. A broken line shows the edges of the blocks before cutting the beam case and the dowel that was rejected. The arrow marks the location of the black crust, probably left from the fire.**

Examination of the material in place shows clearly that the main problem concerning the condition of the wall is the catastrophe inflicted by the fire. Contributing to the damage was probably the fact that second-rate material had been used for its construction. In other words, a considerable number of natural faults and weak courses in its construction as a whole will have made it all the more vulnerable to the fire. In the beam cases and generally in the areas closest to the roof, extensive destruction is recorded and absence of material that presupposes the burning of the wood of the roof very close to, or even in contact with, the marble. In the other areas indeed, while the loss of material is limited and a great part of the original outer surface preserved, numerous

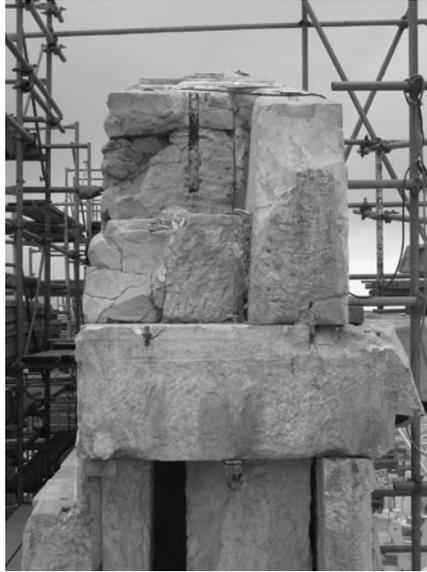
*View of cornice block A.F.5 and the overlying members of the antithematic wall and the tympanum from the north, after dismantling the NW corner. The depth to which the cracks caused by thermal fracturing of the blocks of the antithematic wall appear to extend is characteristic*

thermal breaks, changes in colour, small surface cracks and crumbling of the surface layers of the material are apparent. These areas have retained their mass, even though fragmented, since their exposure to the fire was probably at some distance and the fragments formed were held in place by the remnants of the upper courses. Consequences of the fragment-

ation of the blocks by the fire and by the powerful stresses they were subjected to later on, are the significant relative shifts and turns between the blocks or fragments of blocks. Apart from the breaks and cracks caused by the fire, recorded in addition is a crack almost vertical in direction, north of the symmetrical axis, that runs through the courses of the blocks and continues as significant openings of the joints in the members of the underlying entablature. The interventions of N. Balanos in the backing wall, as in all the other parts of the west side of the Parthenon, have given rise to problems associated with the placing of joining elements between the members in locations other than those used in antiquity and also with the rusting of the metallic elements that he used. Problems of interpretation are created by the use of fragments of ancient material for filling spaces or for supporting blocks of the upper courses, together with an extensive use of cement plaster for filling in joints and cracks. Another observation is that the corner blocks of the fourth course project slightly beyond the sloping levels of the cunei. This is probably because the fragments that make up the blocks of the course have not been correctly adjusted to each other, thus altering the measure-

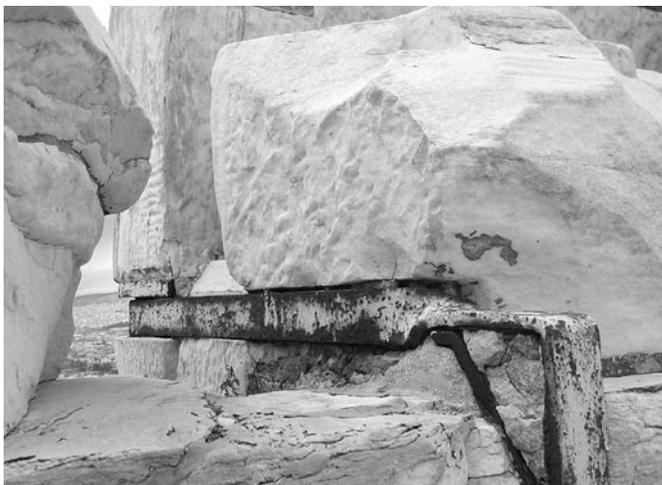
*View of the joining element (N. Balanos), length around 3.5 m. that joins the fifth orthostate of the tympanum with the backing wall.  
Photo YSMA Archive*

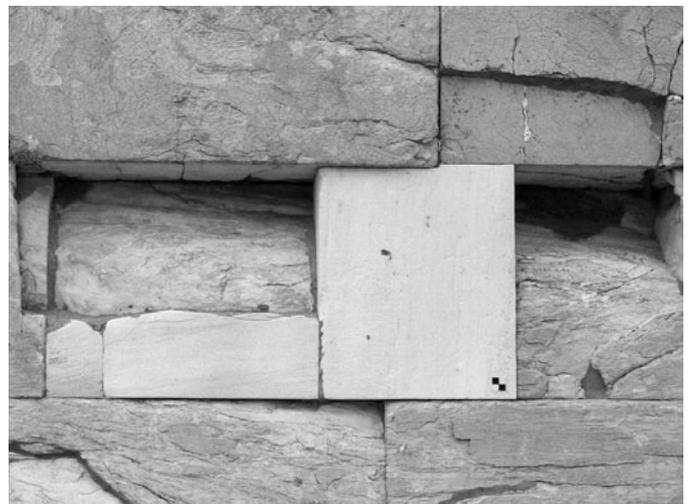
*Supplements of new marble from the intervention of N. Balanos.  
Photo YSMA Archive*

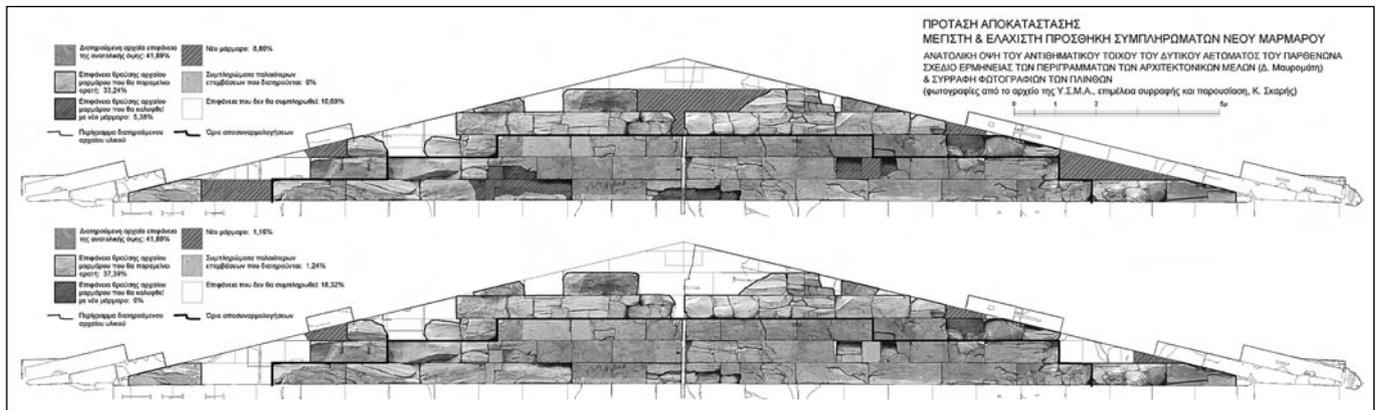
**Restoration proposal. Maximum and minimum addition of new marble. Study - Presentation: K. Skaris**

Analysis of the east side shows that 81% of the original surface of the ancient material has survived. Of this percentage, 42% is preserved ancient surface and the remaining 39% is surface breakage. The

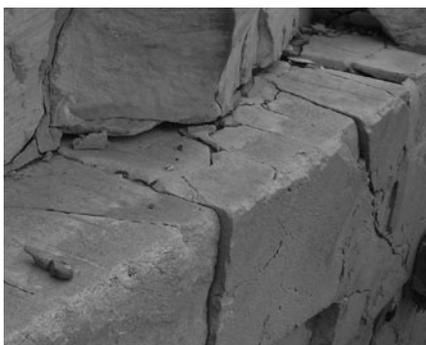
**Relative displacement between pieces of fragmented blocks.**  
 Photo YSMA Archive

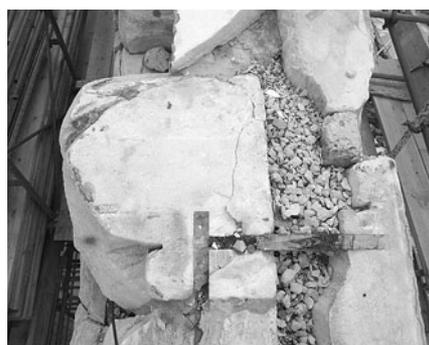
**Characteristic case of damage from the use of metal clamps during the intervention of N. Balanos.** Photo YSMA Archive

In detail, we must a) stop the continuation of the cracking of the marble that results from oxidation and swelling of the iron joining elements, b) remove all the crumbling and eroded mortar that is harmful to the ancient material, c) seal the construction, to the extent possible, to prevent rain water from getting into the joints and cracks, d) conserve the surfaces systematically in order to stop continuous

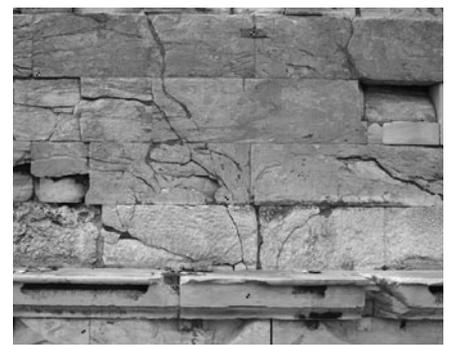
**View of the crack that runs through the courses of the backing wall blocks. The opening of the joint between the blocks of the diazoma is characteristic.** Photo YSMA Archive

ments of the members. A major constructional problem for the backing wall of the tympanum is the absorption of rain water. The fragmentation and loss of blocks in the upper courses creates conditions in which rain water can enter, accelerating erosion. Evident, furthermore, are problems of the shifting of a number of blocks from their original positions, while there is also a wedge-shaped

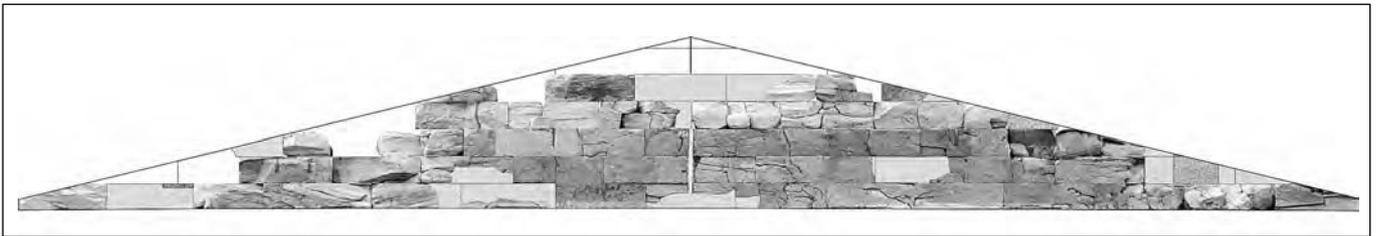
**Presentation of the proposed maximum incorporation of supplements of new marble in the east side of the backing wall (composite photograph). Study - Presentation: K. Skaris**

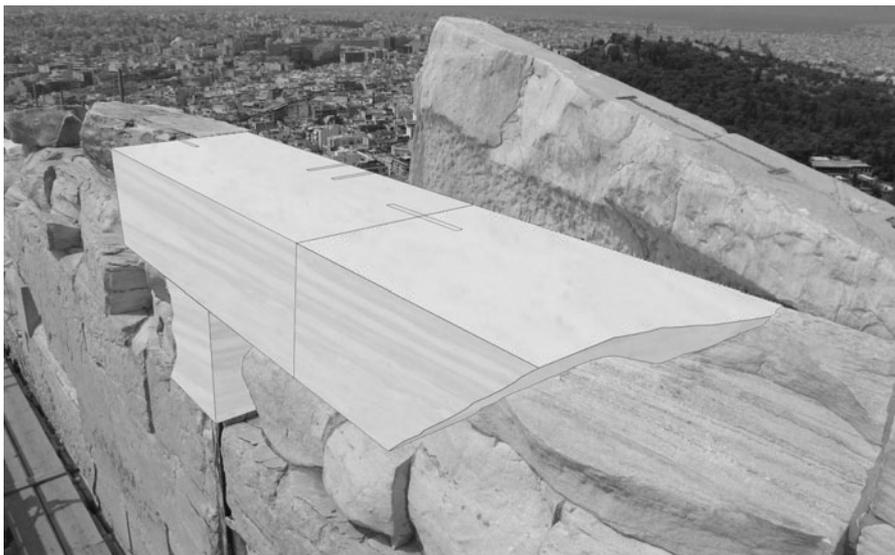
**View of proposed additions of new marble behind the axial joint of the tympanum orthostates. With this solution the pair of twisted clamps in the fifth course regains its original position.**

not fall out, and to support the raking cornices. Dismantling is restricted to the need for access to the upper resting surfaces of the blocks in the third course so that it is possible to replace the twisted clamps at that level. Dismantling in the fourth and fifth courses and selected blocks at the ends of the third and second courses is necessary in order to correct erroneous settings and improvised joins of the N. Balanos intervention. The decision

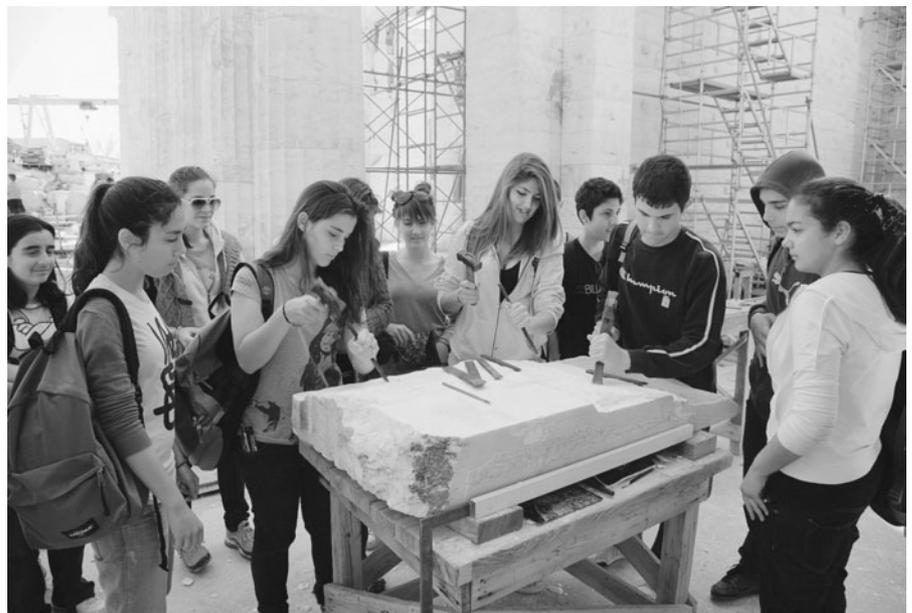
*Marble cutting workshop at the Propylaea.  
Photo T. Souvlakis, 2012*

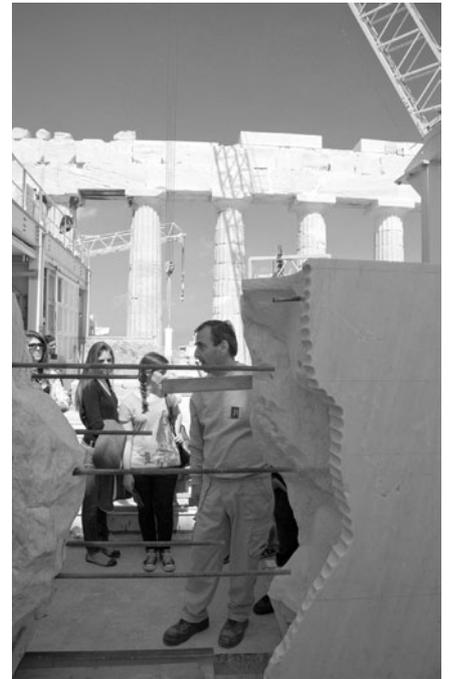
**A class watches the structural restoration of marble blocks on a rolling joining platform. Photo T. Souvlakis, 2012**

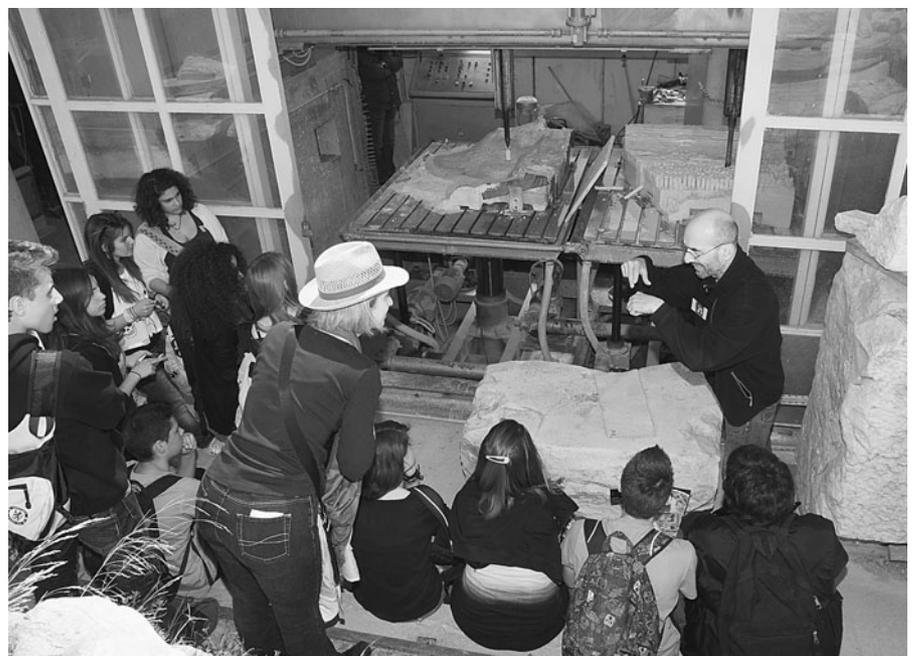
**A class watches the pantograph (copying machine) used for the construction of fillings from new marble. Photo T. Souvlakis, 2012**
