- V. Eleftheriou, 2011-2012, The progress of the restoration works on the Acropolis  
A. Vrouva, The problem of the structural restoration of the capital ΔΚΚ2 of the Parthenon west colonnade  
K. Skaris, The architectural study for the restoration of the Parthenon west tympanum backing wall  
Y. Alexopoulos, M. Katsianis, Digital applications for projecting the Acropolis restoration works on the internet  
I. Kaimara, A. Leonti, S. Paraschou, C. Hadziaslani, Educational programme "A day at the Acropolis restoring its monuments"  
E. Petropoulou, News from the Acropolis  
E. Karakitsou, Nikos Skaris (1923 - 2012)

## 2011-2012, The progress of the restoration works on the Acropolis

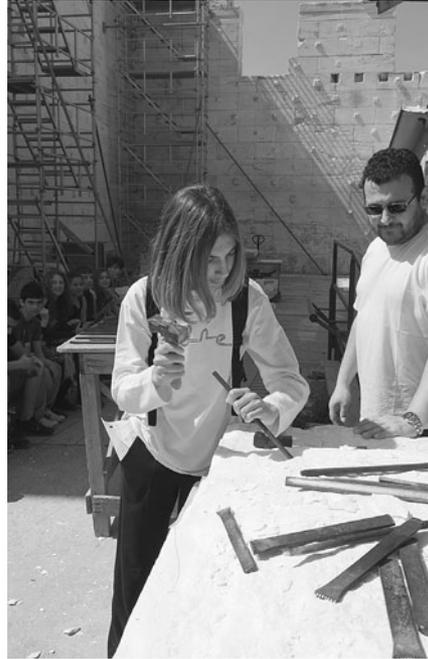
**Marble cutting workshop, at the Propylaea.**  
**Photo T. Souvlakis, 2012**

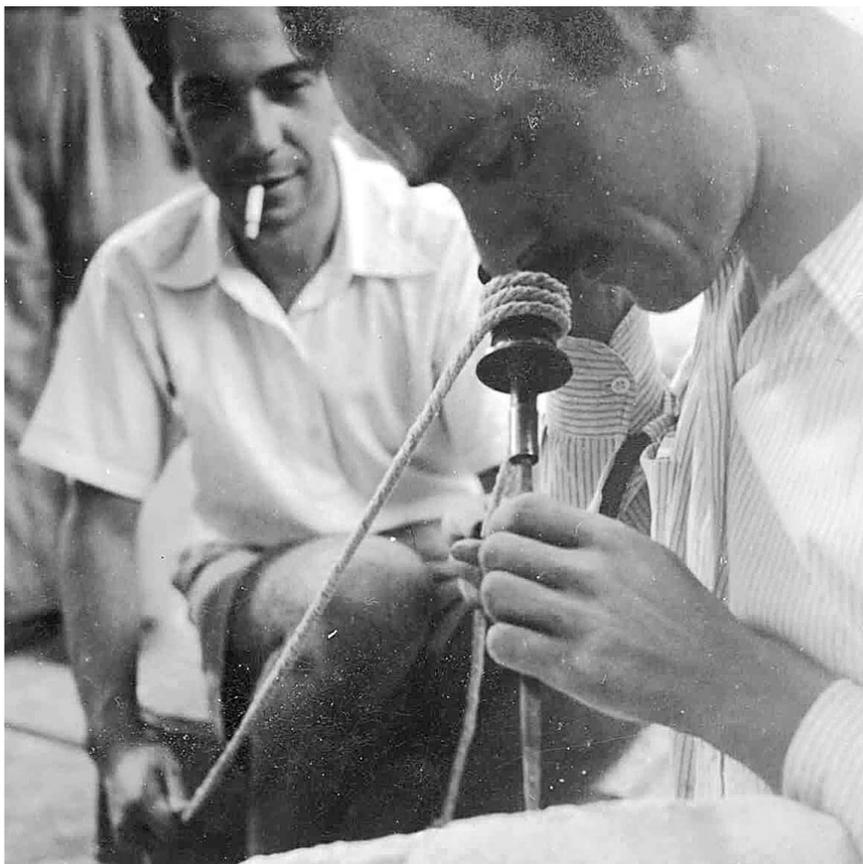
**Intervention in the Herodeion: N. Skaris working with the "aris" (hand-powered drill).  
Photo Archive of the Skaris family**
