Publisher
ACROPOLIS RESTORATION SERVICE

THE RESTORATION OF THE MONUMENTS OF THE ATHENIAN ACROPOLIS

MINISTRY OF CULTURE AND TOURISM - ACROPOLIS RESTORATION SERVICE

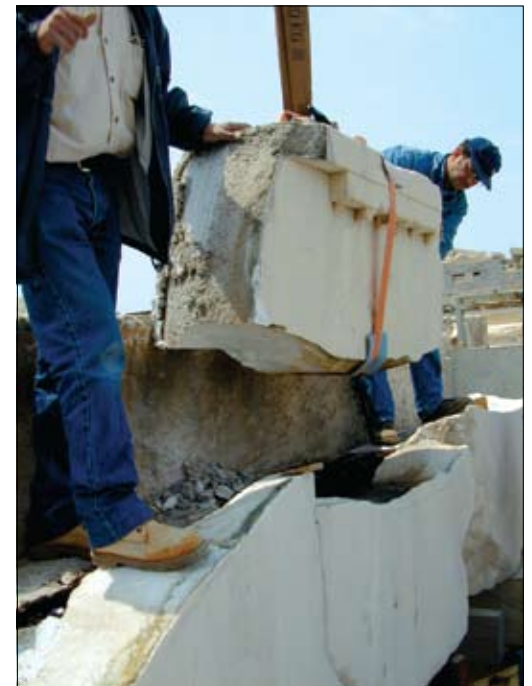
6

6. Dismantling a fractured architrave block of the north side of the Parthenon.

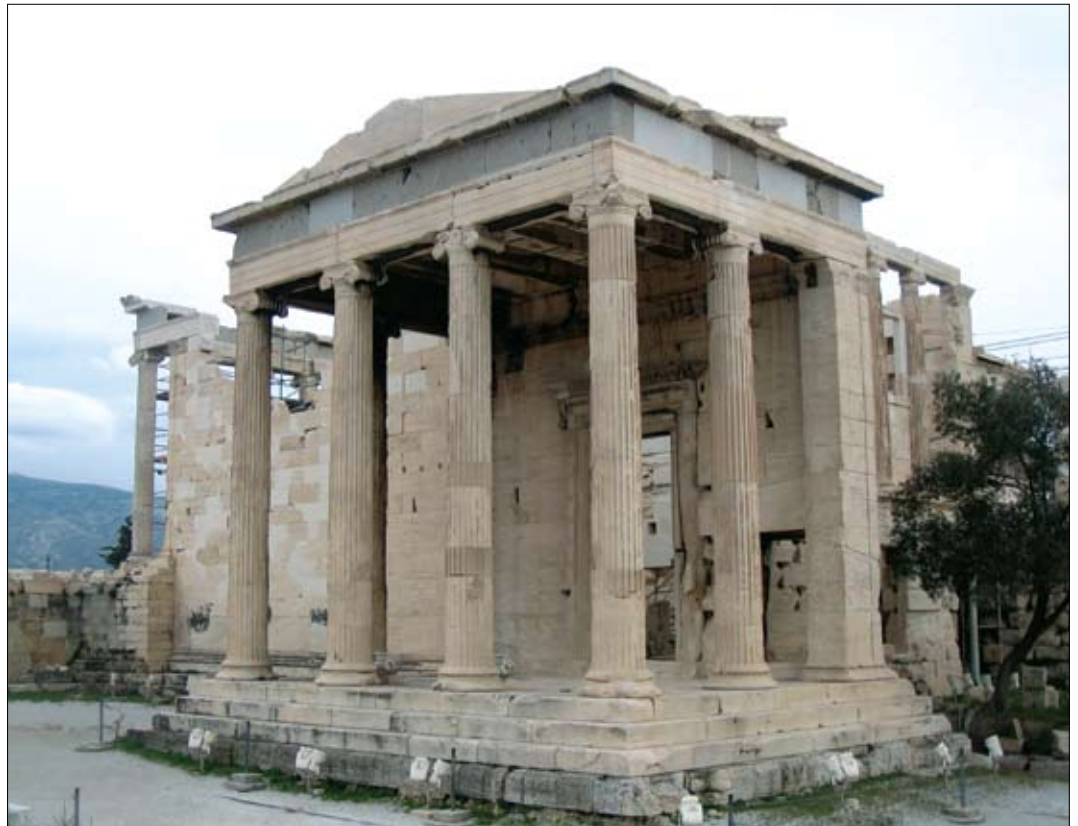
14. The Erechtheion. The north porch after its anastelosis. View from the northwest.

the monument. The Caryatids were taken to the Acropolis Museum for protection and replaced on the monument by precise copies in artificial stone. Dismantled after this were most of the north, the south and west walls and the ceilings of the north and south porches; their members were structurally restored, using titanium reinforcements. After systematic research, blocks of the north and south

walls that had been set in the wrong places in the previous anastelosis were returned to their correct positions. As a result, the side walls of the monument regained much of their authentic structure and their authentic constructional inclination. Blocks of new marble were used to fill in the north and south walls. To improve the static resistance of the entire building, and to regain its form, the northeast corner was also restored. The first column from the north in the east porch, which had been taken by Elgin together with one of the original Caryatids, at present in the British Museum, was replaced by a cast copy made of artificial stone. In addition to correcting the failures of the previous interventions, the restoration of the Erechtheion increased its static efficiency and improved its comprehensibility.

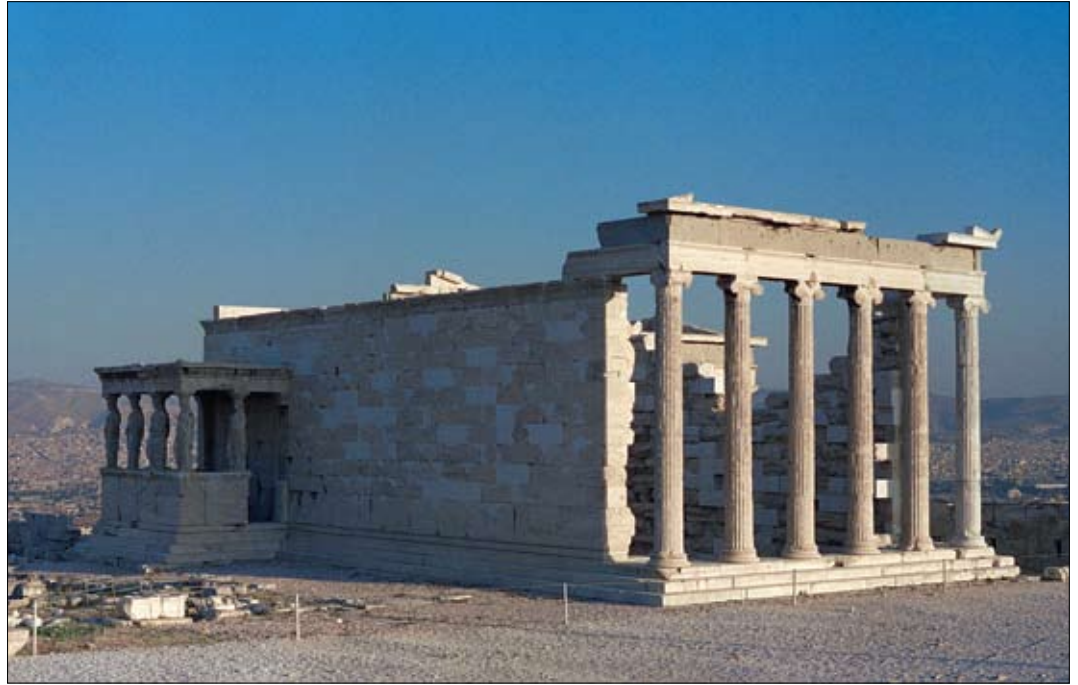
15

15. The Erechtheion after its anastelosis. View from the southwest.

under the scholarly supervision of the Committee for the Conservation of the Acropolis Monuments between 1979 and 1987, with the purpose of eliminating the errors of the earlier interventions. The parts of the building that had been restored earlier, as well as other parts with serious structural problems, were dismantled, the architectural members restored on the ground and reset on

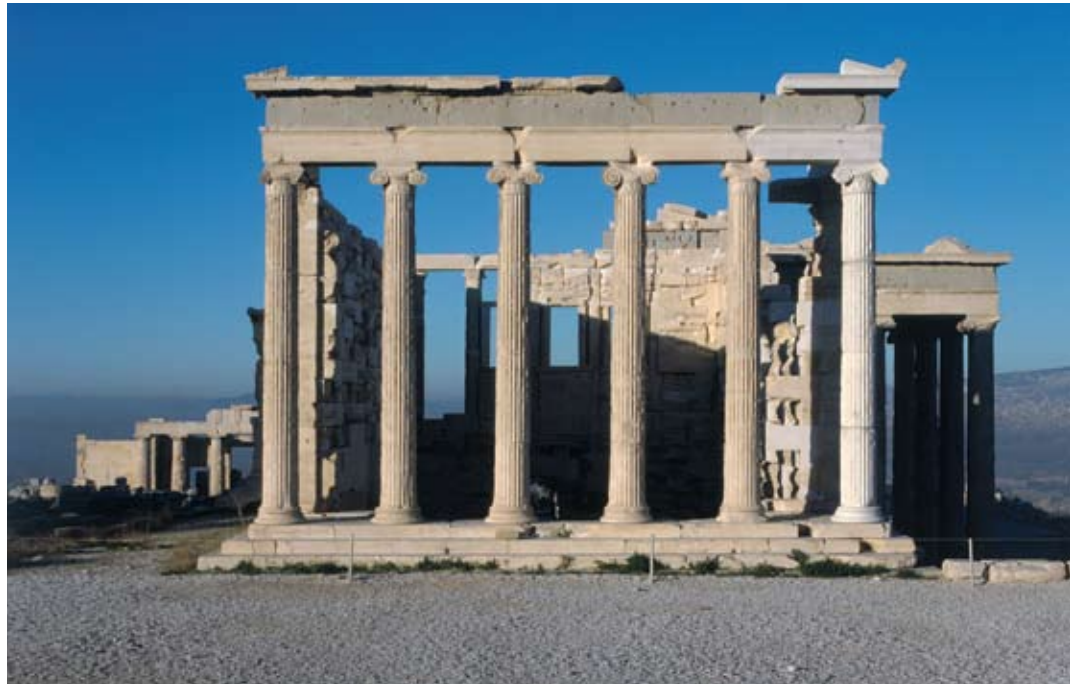
16

16. The Erechtheion. The east porch after its anastelosis. View from the east.

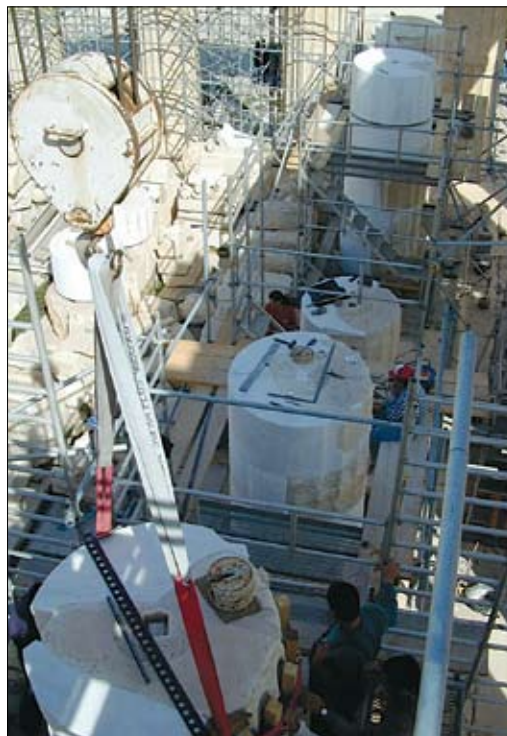
19

19. Parthenon. Resetting the column drums of the pronaos.

pronaos, filling in the drums with new marble included the full anastelosis of the three first columns from the south and partial anastelosis of the other three. Included in the monument apart from the drums were the ancient architrave blocks of the first two intercolumniations from the north. In place of the ancient wooden sockets (empolia) and centring pins (poloi), titanium elements of equal resistance have been set.

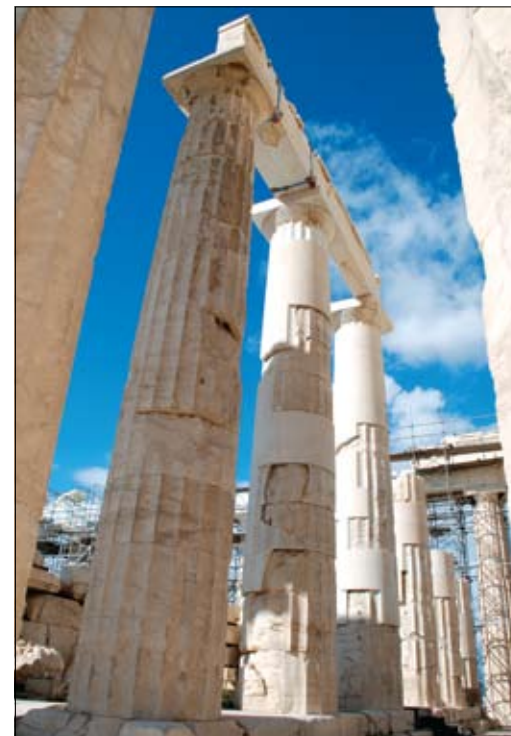
20

20. Parthenon. View of the east porch with restoration completed. View from the southeast.

The restoration of the **pronaos** was less a rescue work than an attempt to restore the form of the east porch of the classical Parthenon, based on the evidence found in thorough research and the identification of a significant number of scat-

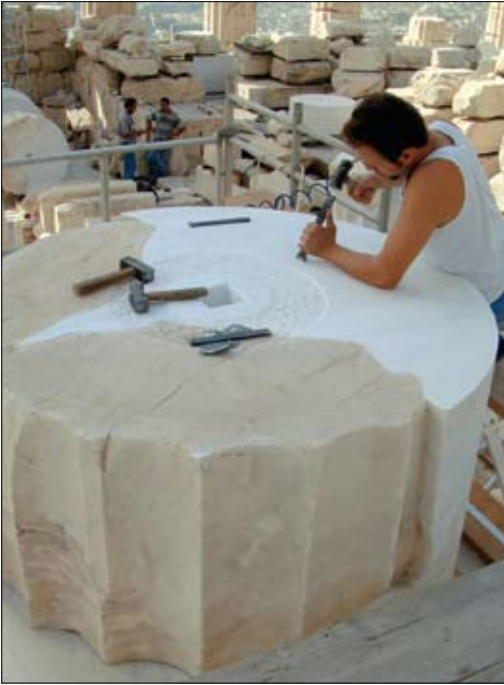
21

21. Working on the upper resting surface of a new filling in a drum of the Parthenon pronaos.

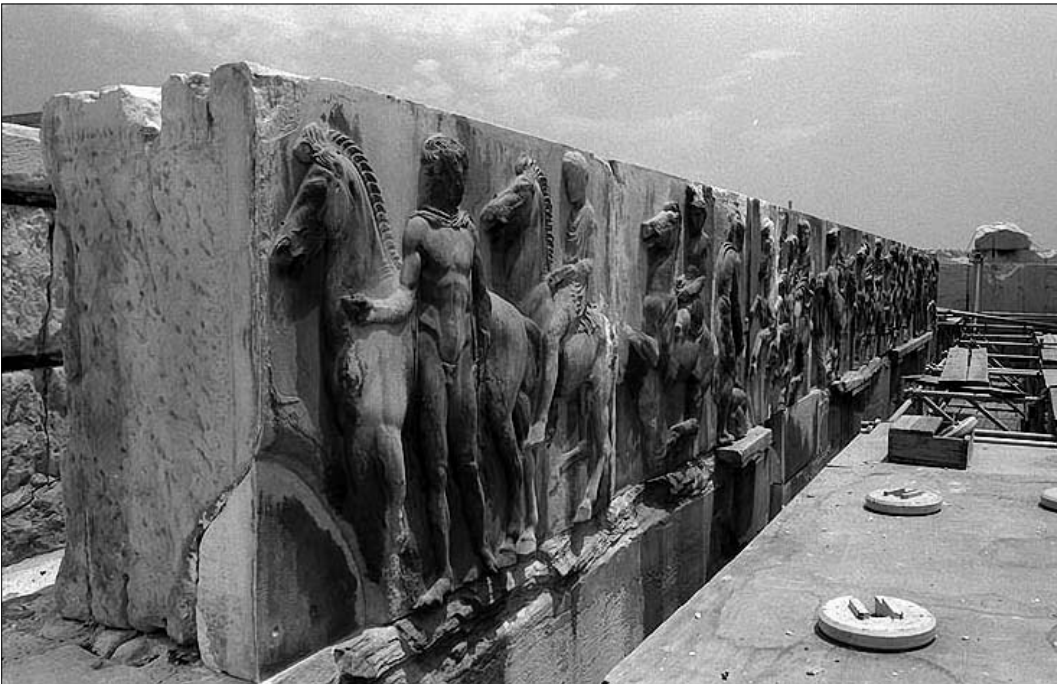
25

25. Parthenon. Opisthonaos. View of the west frieze during its dismantling.

tural members and the anastelosis of the north-west corner of the entablature. In the first phase of the work on restoring the opisthonaos (1992-1993), the preserved section of the frieze was removed to the Acropolis Museum in order to protect it. To avoid dismantling columns that had not been disturbed since antiquity, they were consolidated with special injections. The second phase of the programme (2001-2004) included the dismantling and structural restoration of the preserved members of the entablature of the west porch, two column capitals and two top drums. Four column capitals were also consolidated with special injections in situ. So as to assure a possible future replacement of parts of the copies of the frieze, without having to dismantle the underlying courses, the place of the frieze blocks that had been

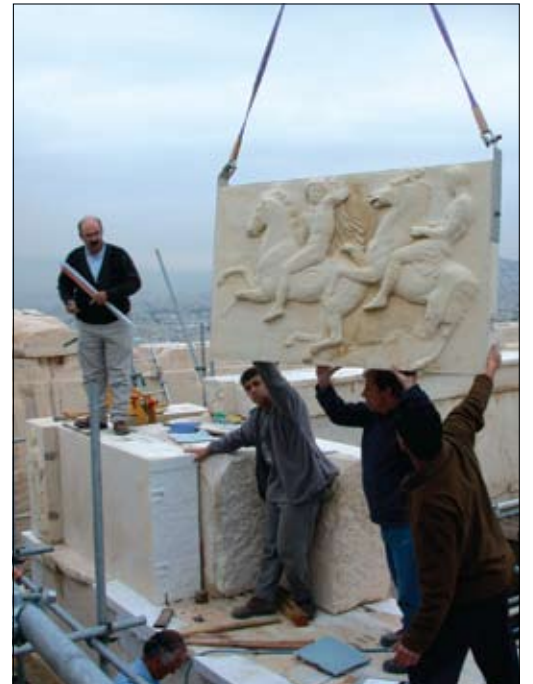
26

26. Parthenon. Opisthonaos. Setting the copy of the west frieze on the monument.

removed from the monument was taken by copies of the façade, with the sculptured decoration in artificial stone, which was anchored to marble blocks that took the place of the back part of what were originally single blocks.

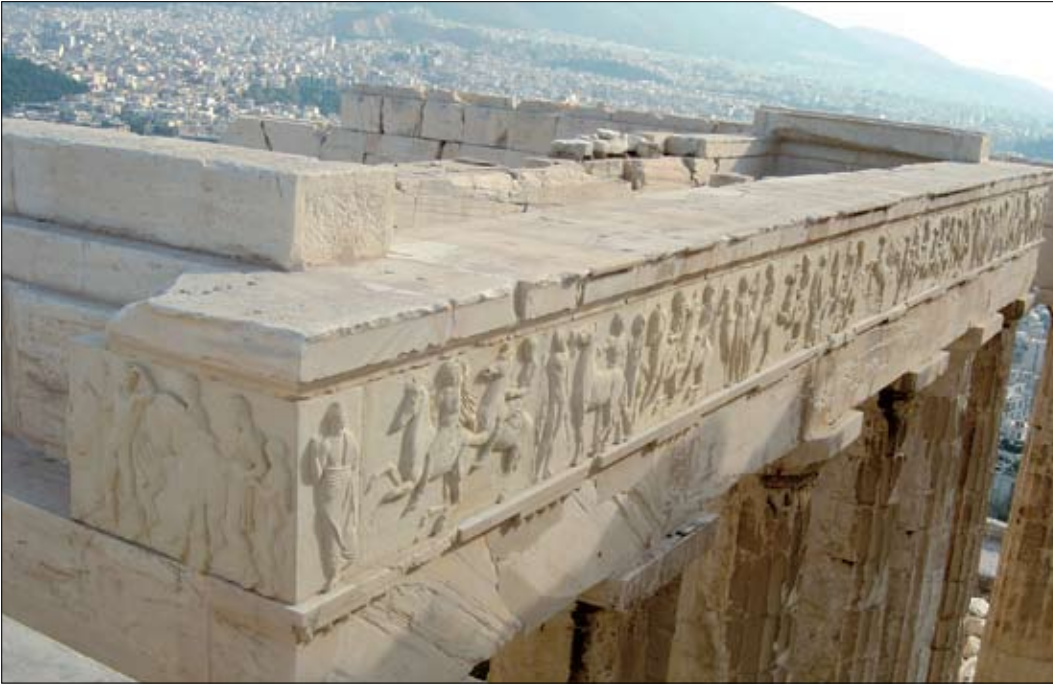
27

27. Parthenon. Opisthonaos. View from the northwest after completion of its restoration.

The work of restoring the **opithonaos** involved the restoration of the west six-columned porch of the Parthenon cella, where the entire west side of the frieze was preserved. Although this area had not suffered extensive destruction, serious structural damage and wear were apparent. The Balanos interventions (1895-1902) had involved extensive replacements and filling in of the architec-

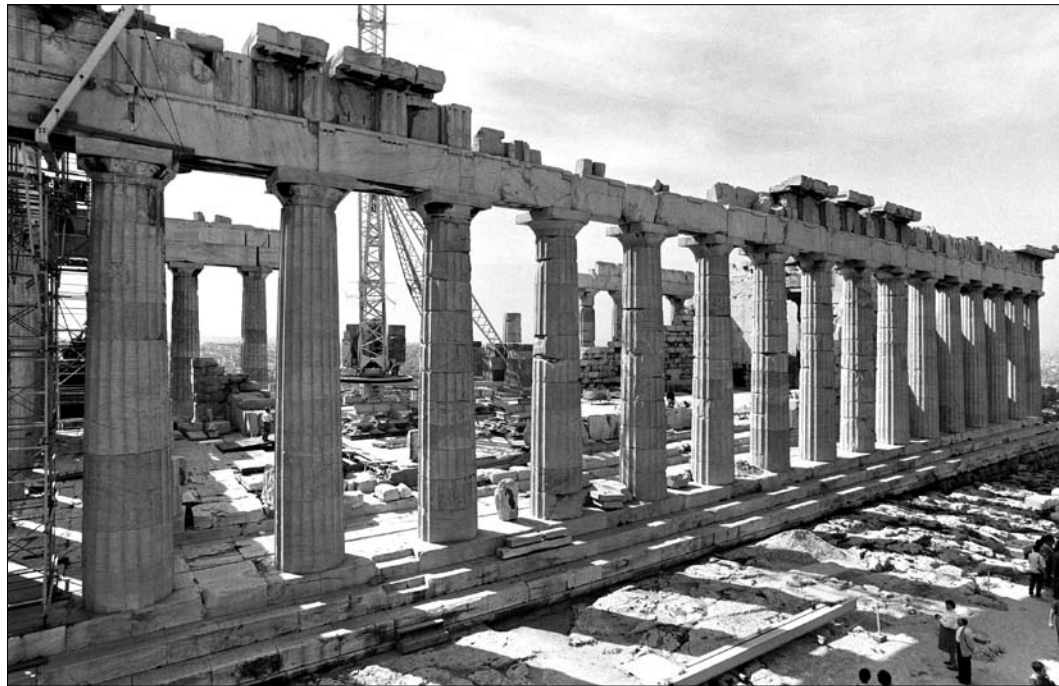
29

29. Parthenon. The north side before restoration. View from the northeast.

The very serious intervention on the **north side** of the Parthenon, where the explosion of 1687 had caused eight columns with the corresponding overlying entablature in the middle part of the colonnade to collapse, had been carried out during the years 1922-1931 under Balanos with a full anastelosis of the colonnade and a partial anastelosis of the entablature. The serious structural problems of this anastelosis (iron reinforcing, cement fillings) made a new intervention compulsory.

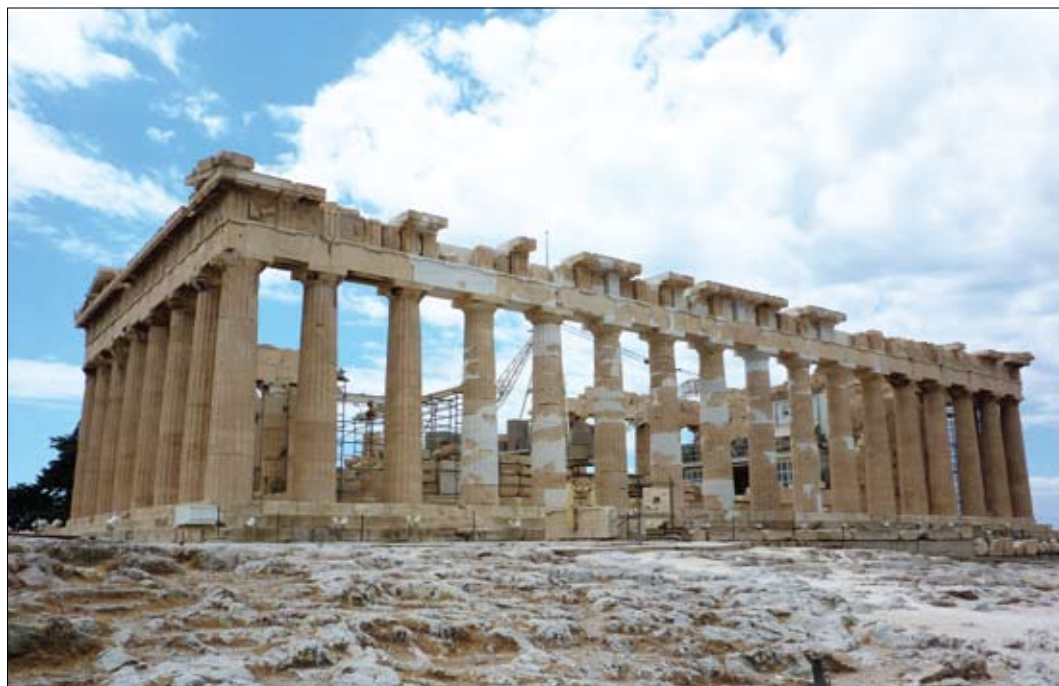
30

30. Parthenon. The north side after restoration. View from the northeast.

The purpose of the programme for restoring the north side –the most extensive ever undertaken on the monument– was to remove the rusted iron reinforcements that had been used for joining the members, to restore structurally the broken marble members and to remove wrongly placed architectural members, finding their authentic positions. During the period 2001-2003, eight middle columns of the north side (from the 4th to the 11th from the east) were entirely dismantled together with the corresponding areas of the overlying entablature. In 2007 it was considered necessary to extend the intervention to the west section of the entablature of the north side, so as to remove to the Acropolis Museum six authentic metopes in order to be protected. The metopes were replaced on the monument with copies in artificial stone.

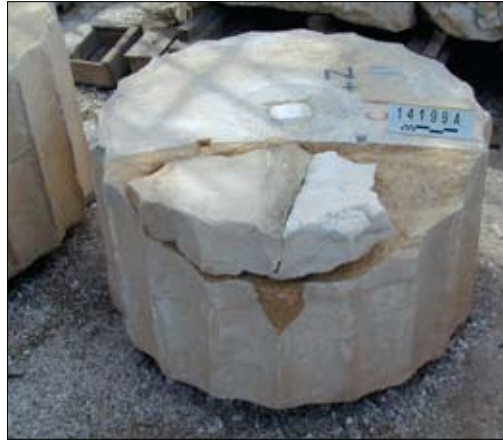
33

33. Identification of two scattered fragments from a column drum of the Parthenon north colonnade.

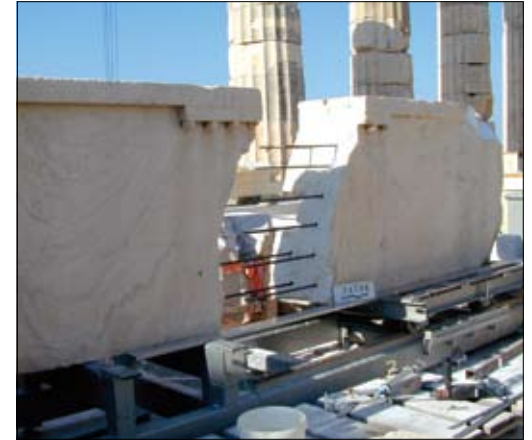
34

34. Mending an architrave block of the north side of the Parthenon.

The concrete fillings from the earlier intervention in the dismantled members were replaced by fill-

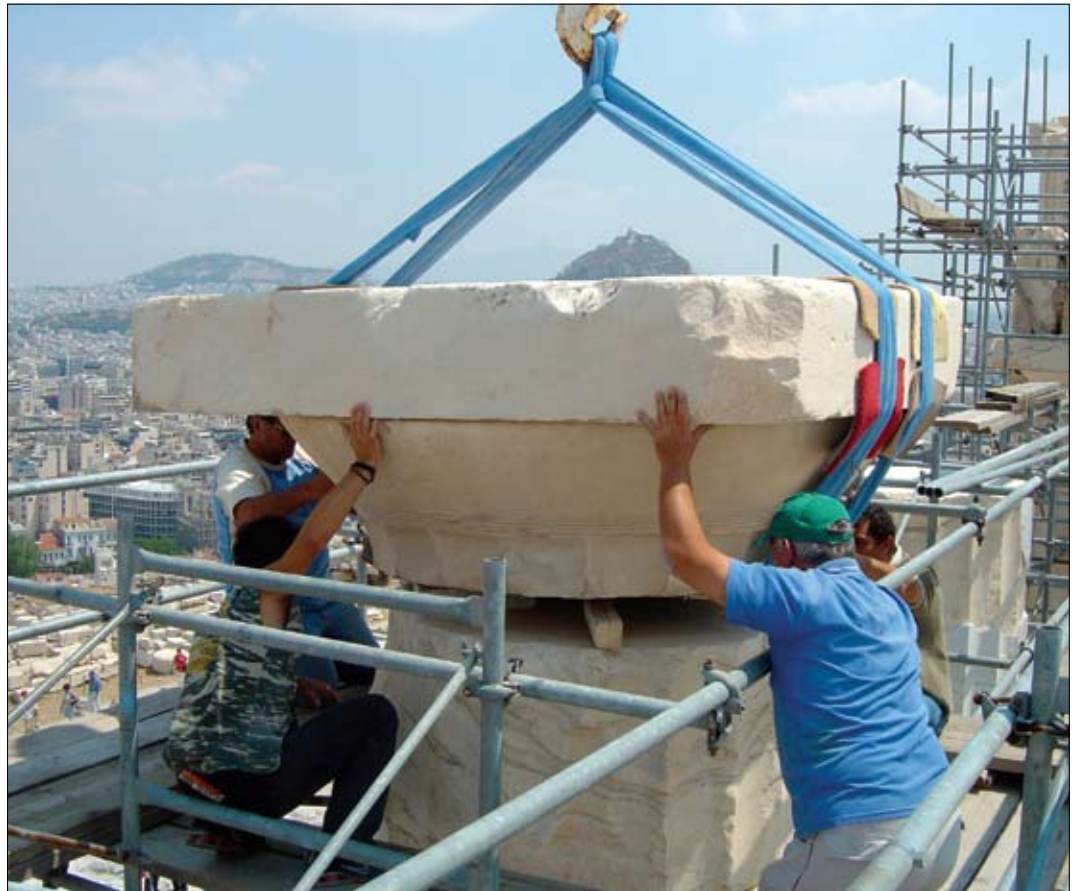
35. Parthenon. Resetting of an ancient column capital of the north colonnade.

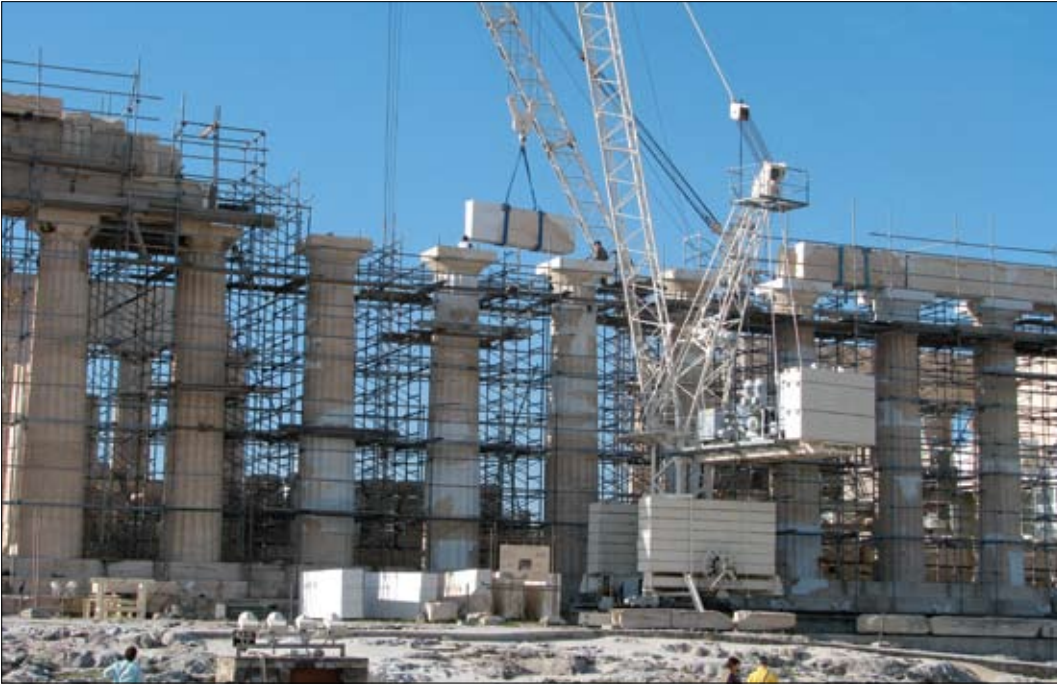
36

36. Parthenon. Resetting an architrave block of the north side. View from the north.

ings in new marble, all the ancient fragments that were identified were re-set on the monument, the existing clamps and dowels were replaced with titanium. Finally, the earlier incorrectly set and restored architectural members were placed in their authentic positions, which were found through study of the members that were dismantled. For reasons of formal and structural completeness, it was proposed to include a few members of new marble. The flutes on the new marble fillings and drums were carved with a special cutter before being set on the monument. The final working of the surfaces of the flutes of the fillings is accomplished on the monument by hand after the drums have been set in place. In this new anastolosis the attempt was made to adapt the members to each other, a characteristic of the unsurpassed quality of workmanship of the monument. This result was ensured through detailed calculations and many trial settings and minor shifts with the help of two cranes that are installed in the cella and outside the north side of the monument.

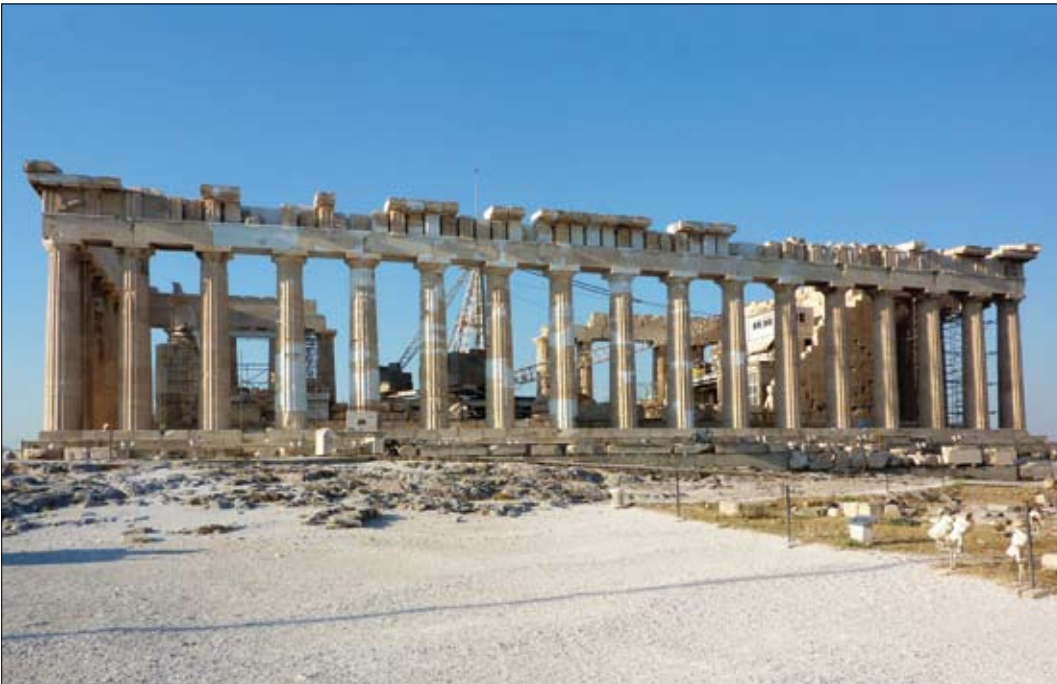
38

38. The Parthenon after completing the restoration of the north side. View from the north.

Completion of the intervention has given the monument not only static resistance, but also increased comprehensibility and aesthetic wholeness. Indeed the north side of the Parthenon, together with the west, provides one of the most complete views of the temple, both for the visitor to the Sacred Rock and to those who see it from most places in the city.

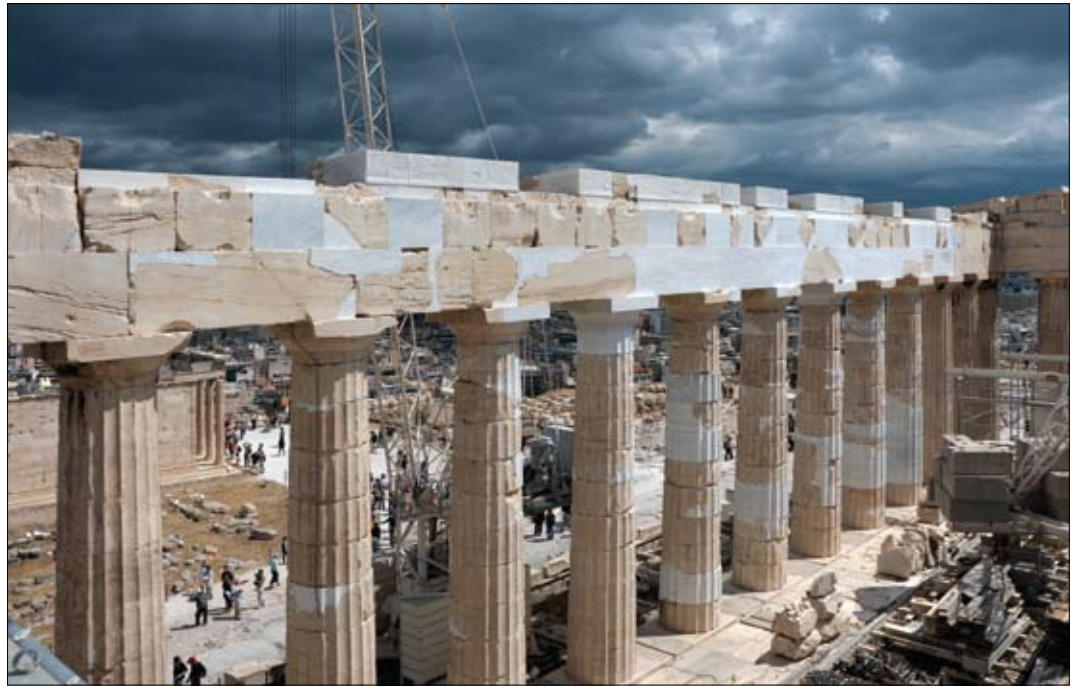
39

39. Parthenon. Interior view of the north side with restoration completed. View from the southwest.

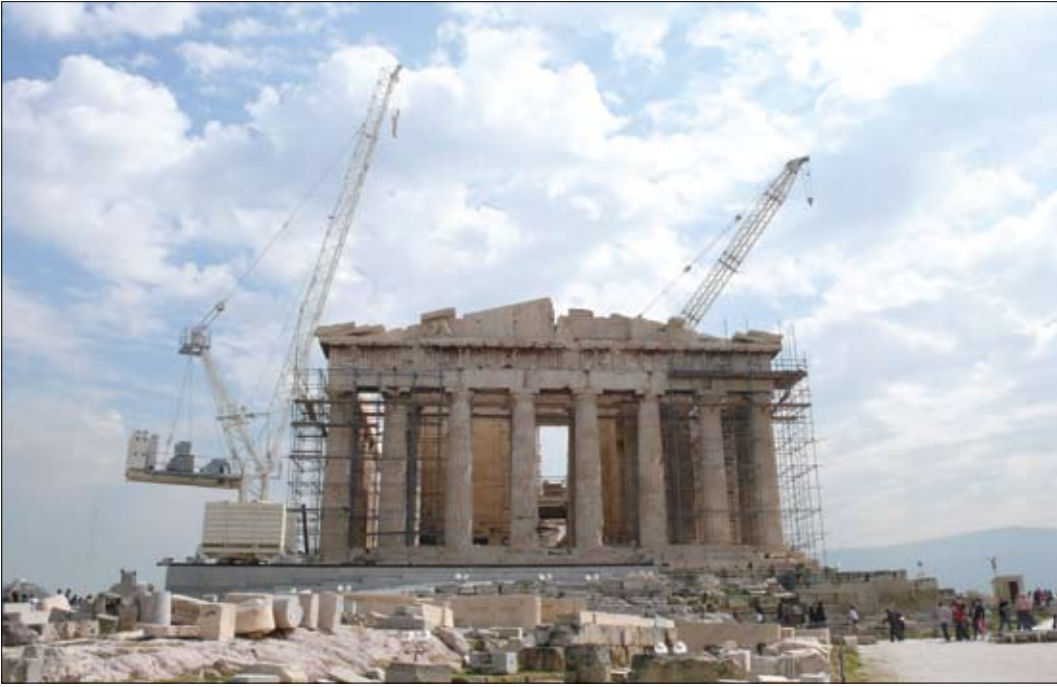
40

40. Parthenon. Restoration works at the two corners of the entablature of the west side.

tion and to earthquakes that have struck the monument. The purpose also is recovery of the form of the west view of the monument with the inclusion of a number of architectural members of new marble. The work includes the dismantling of the two corners of the entablature of the west side, the structural restoration of their architectural members, and their resetting with the addition of six more blocks of new marble (cornice and tympanon blocks of the pediment); likewise the removal and transportation to the Acropolis Museum of six metopes from the two corners of the monument for their protection and their replacement with faithful copies. The intervention focuses on the Balanos restoration of 1902 and will be extended to blocks of the architrave at the corner intercolumniations. These blocks will be structurally reinforced with interior rods of titanium in place of the large iron reinforcements that were set at that time in the façade of the monument. Planned for the same time is the in situ structural restoration of the column capitals and one more block of the architrave.

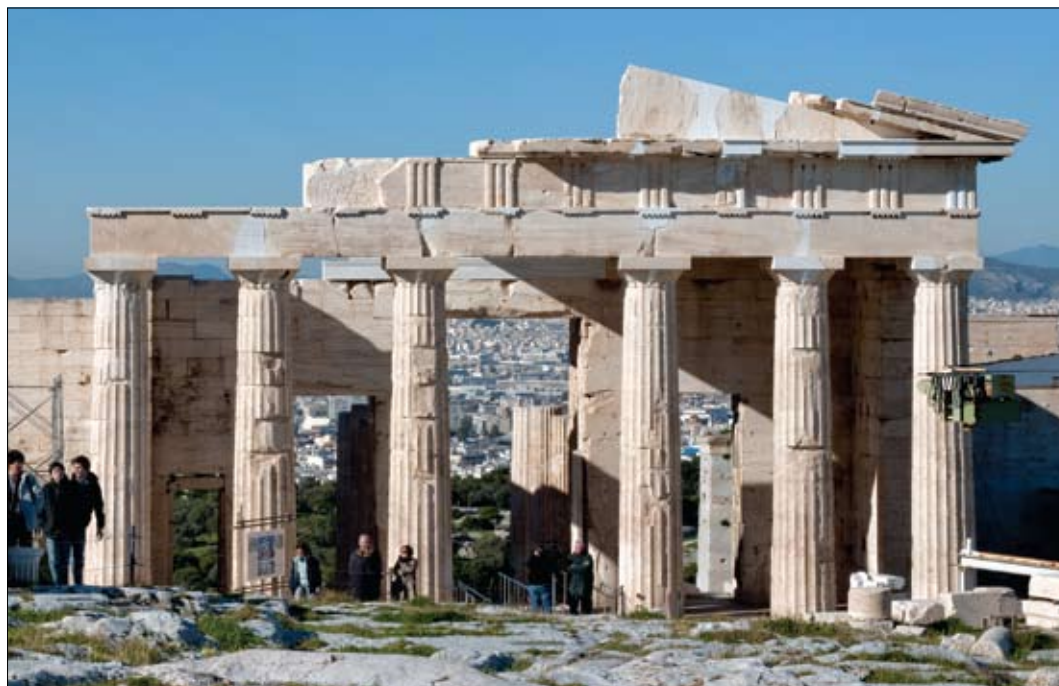
46

46. Propylaia. The east stoa after its restoration. View from the east.

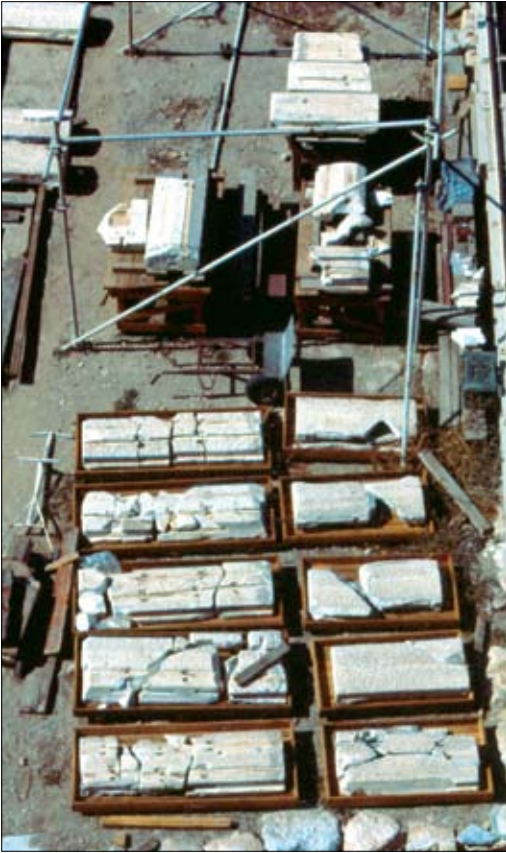
47a-b. Identification of fragments of the coffered slabs in the Propylaea worksite.

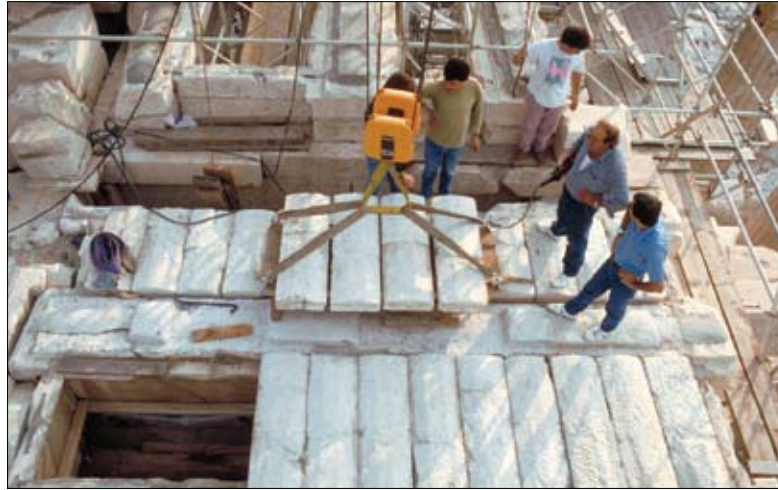
48

48. Propylaea. Dismantling the coffered slabs in the west hall.

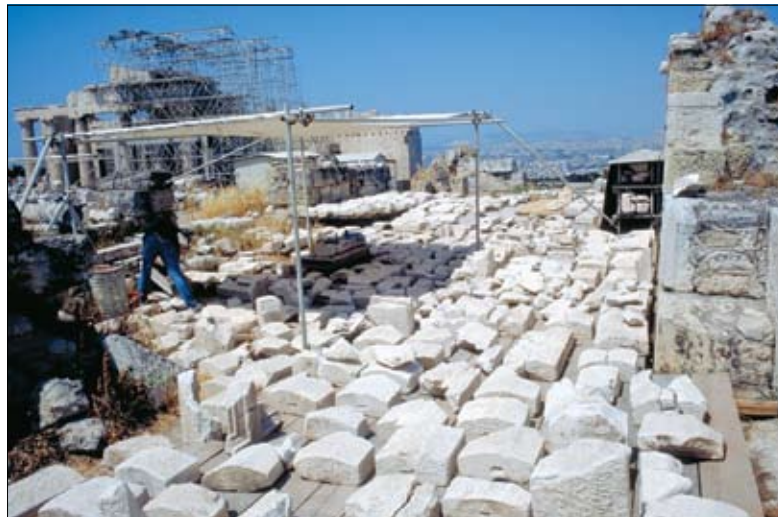
49

49. Fragments of the coffered slabs identified during research in the Propylaea worksite.

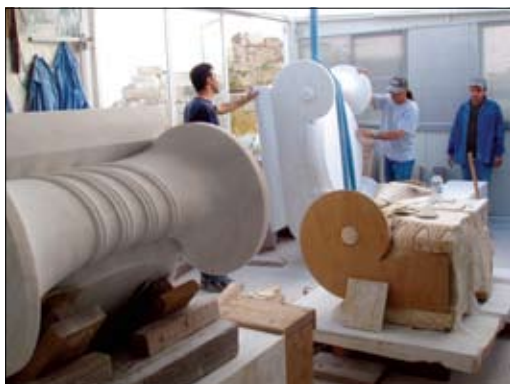
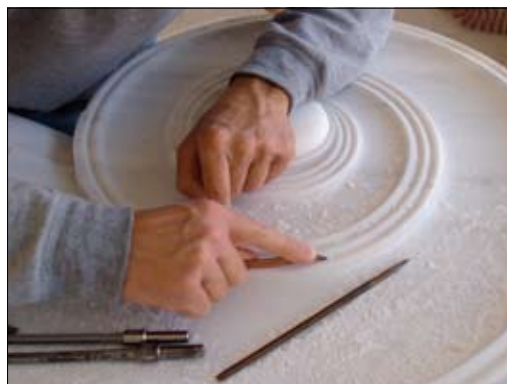
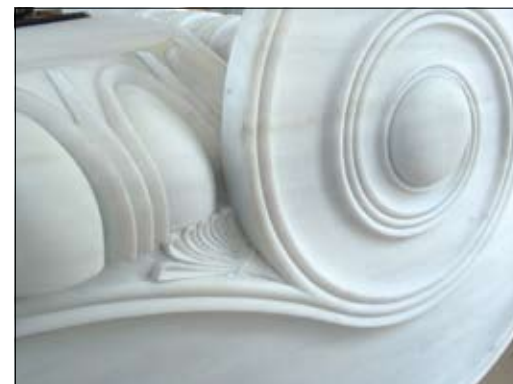
51. Carving the Ionic capitals from new marble in the Propylaea laboratory.

by the two Ionic capitals that have been restored in the west hall, one on each side of the central passageway. The column capital of the Balanos anastelosis was made up of four ancient fragments that did not belong together and it was decided therefore not to use them in the present intervention. Fragments of the capital will be displayed in a future exhibition in the Acropolis Museum. The new capitals, exact copies of the ancient originals, were carved by hand. Interventions of special significance included also the structural restoration of beam fragments belonging to the ceilings. The beams are counted among the largest of the architectural members of the Acropolis monuments for which a special computer methodology was developed. So too, the lintel in the doorway wall of the monument, one of the two stones of which was restored in situ with a special injection.

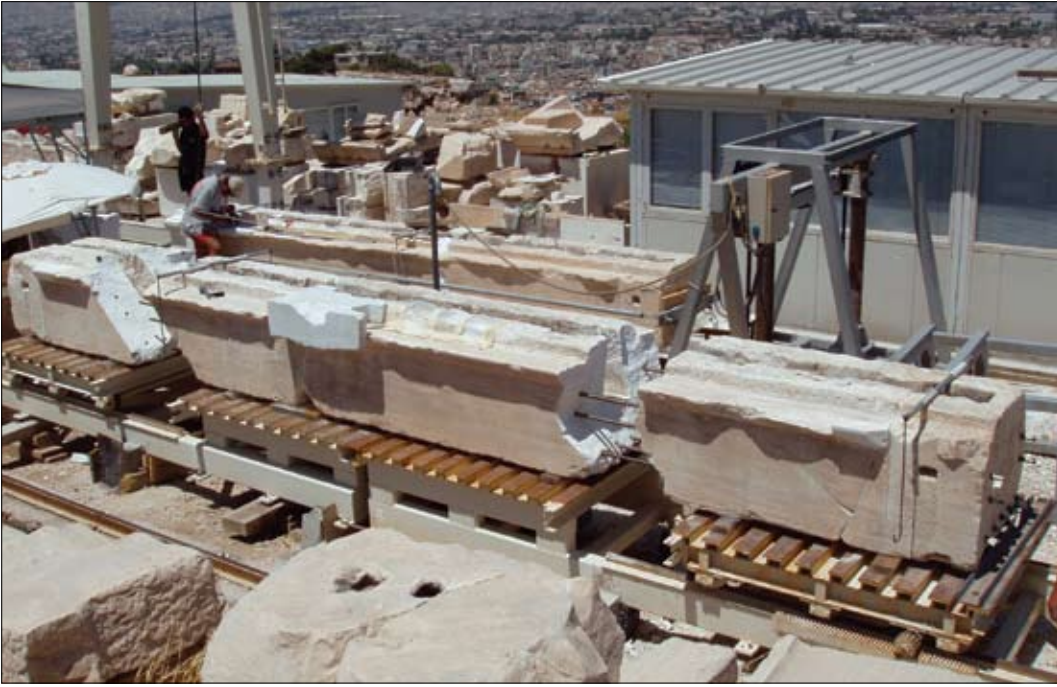
52

52. Mending joining fragments of a beam from the Propylaia east portico on the special joining table.

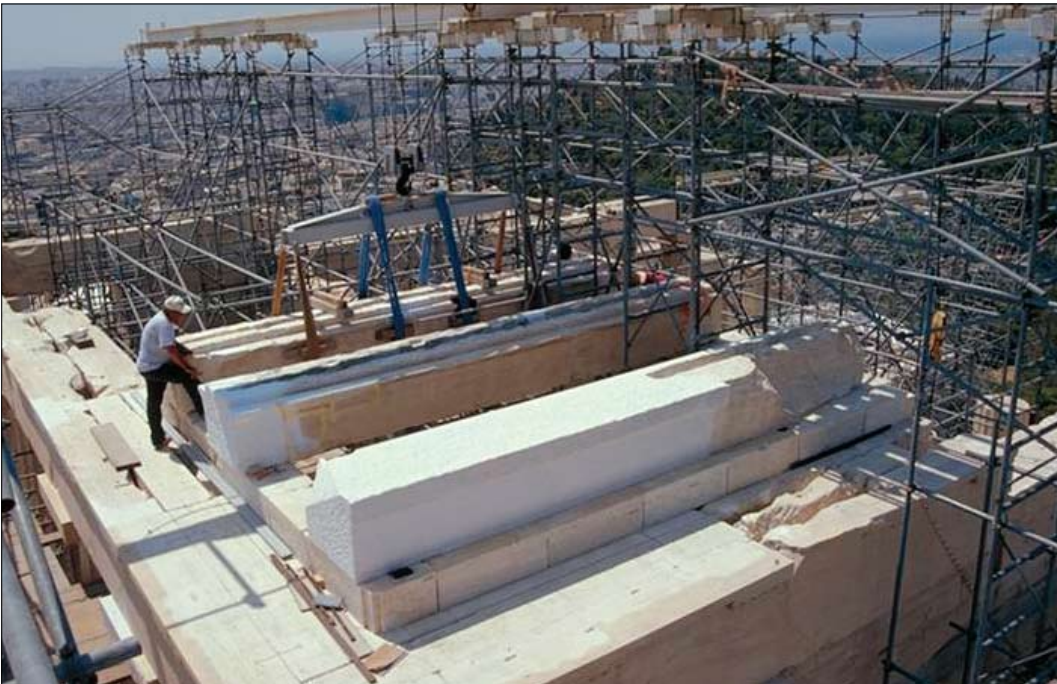
53

53. Propylaia. Resetting a beam in the east stoa.

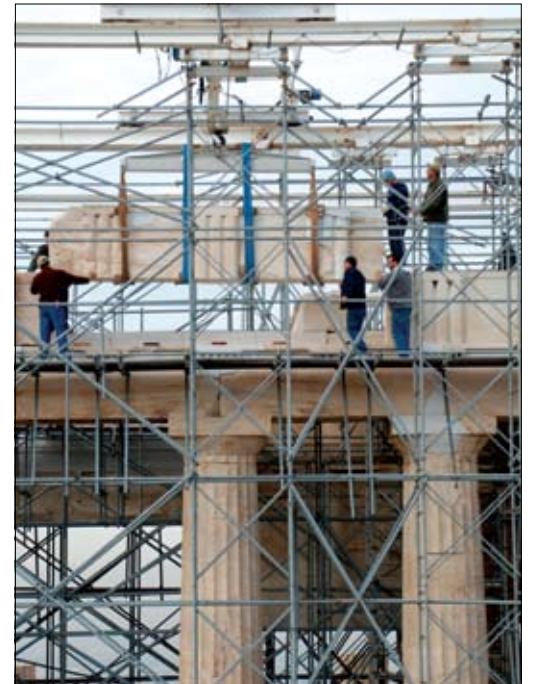
54

54. Propylaia. Resetting a frieze block in the east stoa. View from the east.

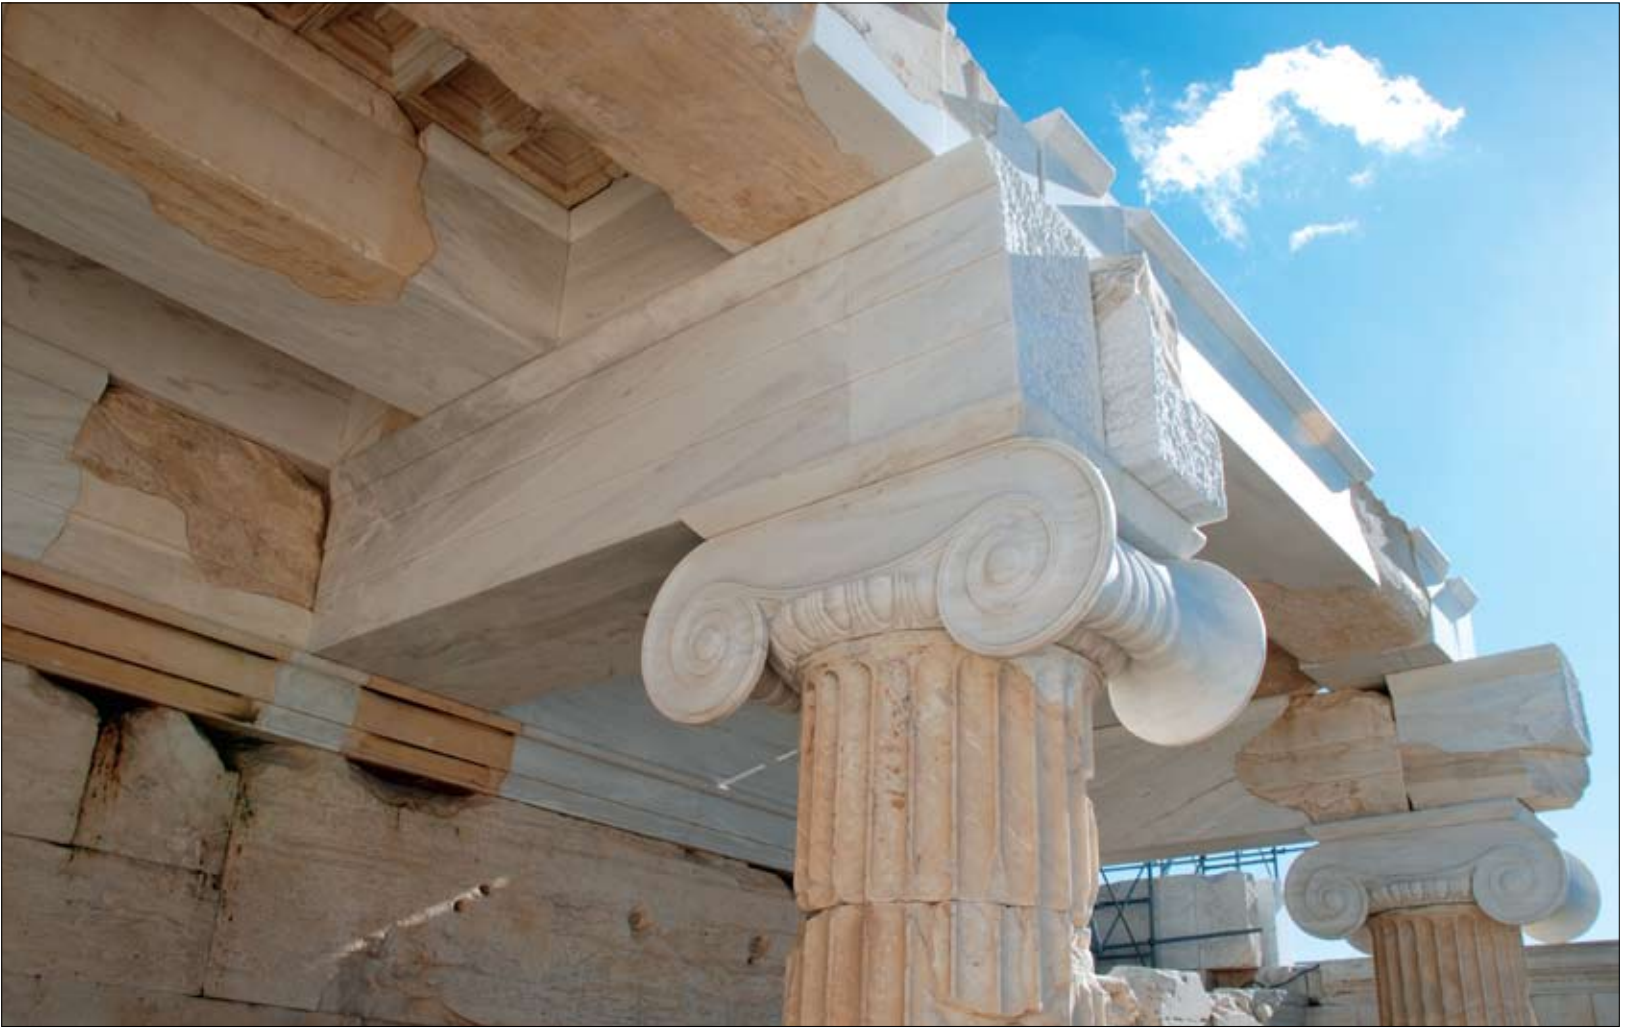
56. Propylaea. The ceiling of the west hall after anastelosis. Visible are the two copies of the Ionic column capitals. View from the northwest.

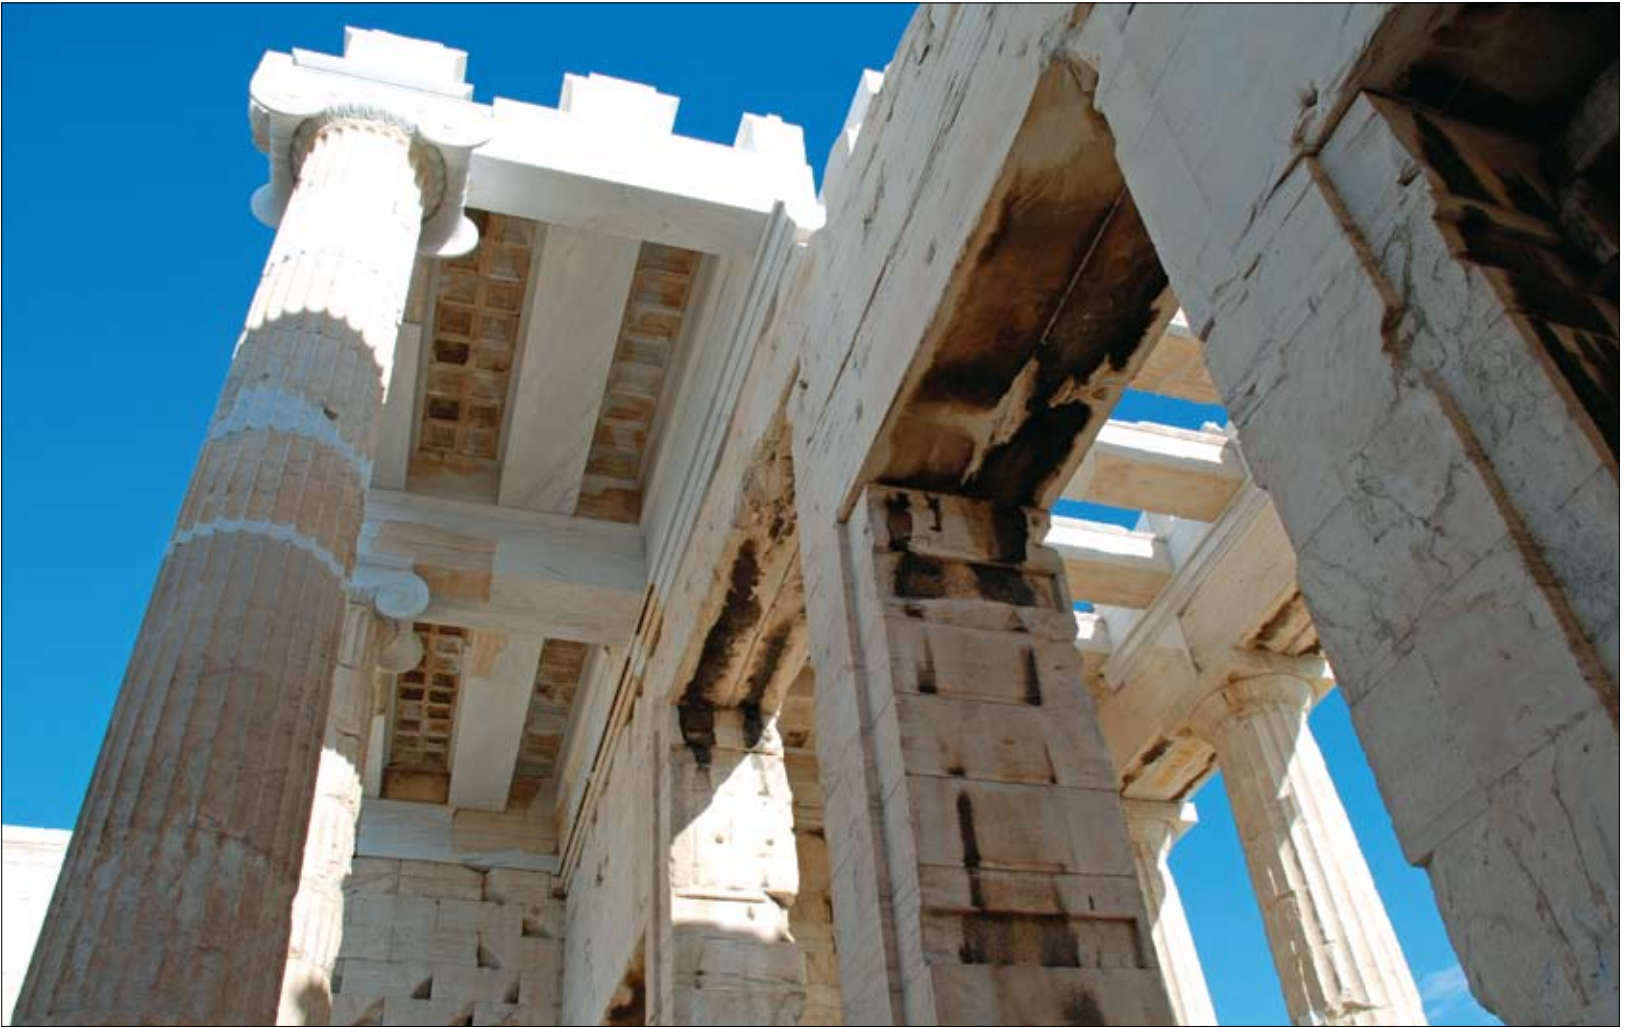
57. Propylaea. The restored ceilings of the west hall and the east portico from the south.
