Publisher
ACROPOLIS RESTORATION SERVICE

THE RESTORATION OF THE MONUMENTS OF THE ATHENIAN ACROPOLIS

MINISTRY OF CULTURE AND TOURISM - ACROPOLIS RESTORATION SERVICE

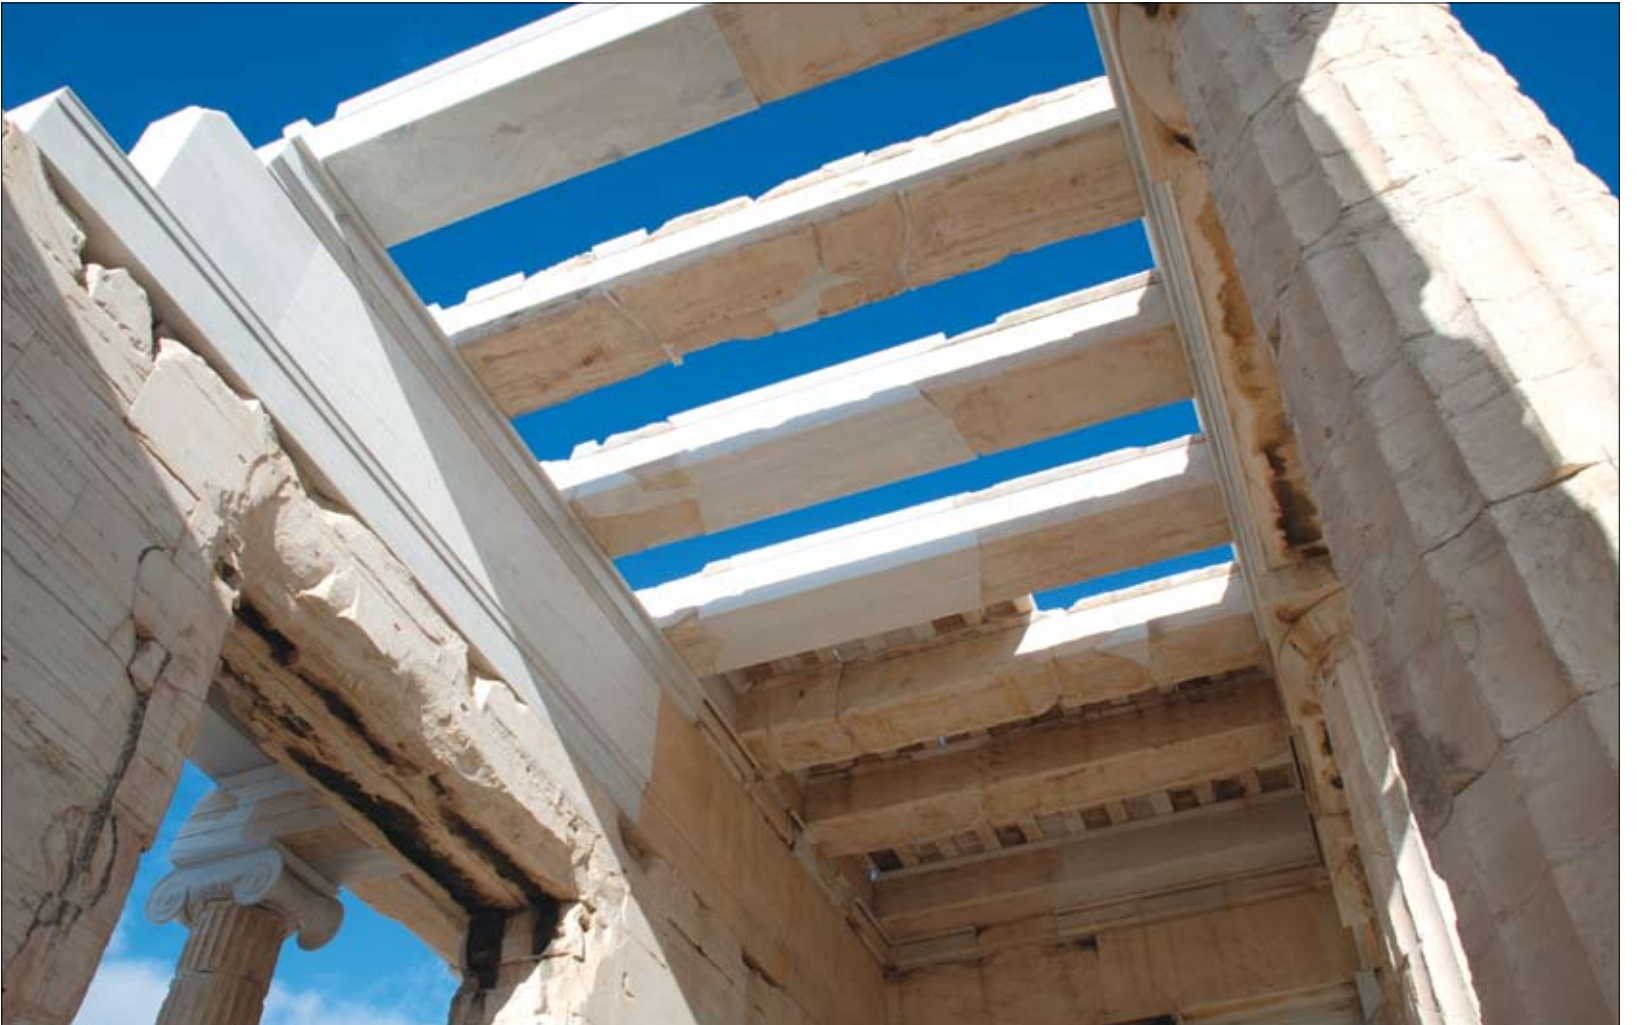
58. Propylaea. The ceiling of the east portico after anastelosis. View from the south.

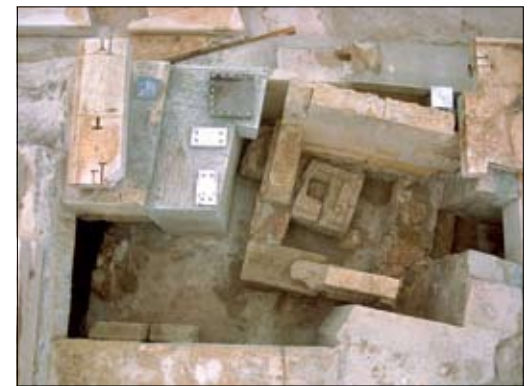
62

62. The poros shrine of Athena Nike in the basement area of the marble temple after its restoration.

The work began in October 2000. The new programme included both the marble temple and repair of the poros shrine. The wall blocks of the cella were dismantled, then the krepis of the monument, followed by restoration, the removal of fillings that did not belong to the monument, systematic documentation, study and structural restoration of the members. This last proved to be a particularly difficult task because of the fragmentation, scaling and damage to the members caused by the violent demolition in the 17th century and by the methods employed in the previous anasteloses. Research on the dismantled members yielded new evidence for the arrangement of the wall blocks of the cella, the column shafts (with the help of building traces going back to phases in

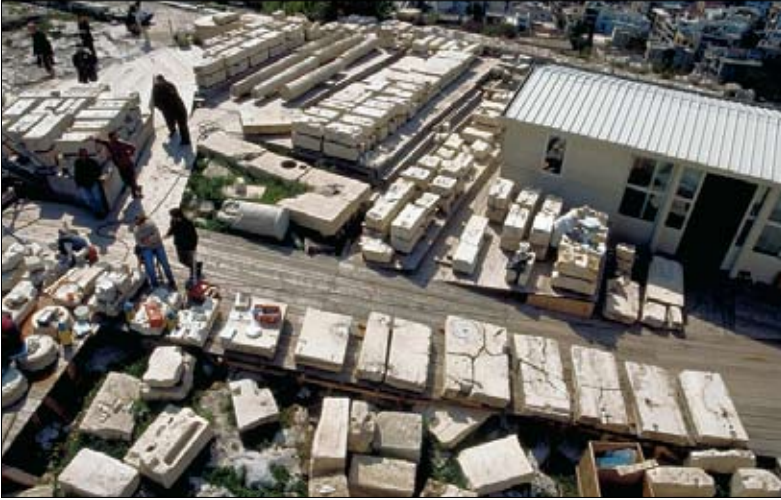
65

65. Members of the temple of Athena Nike in the worksite of the monument after being dismantled.

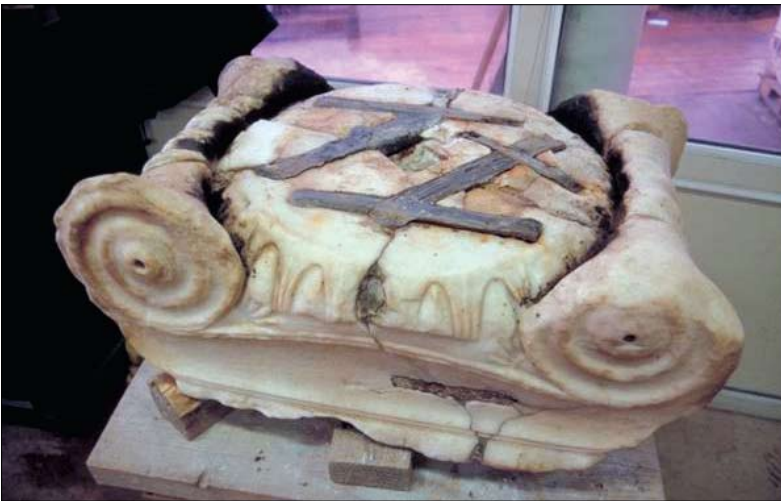
67

67. An Ionic column capital from the temple of Athena Nike after being dismantled.

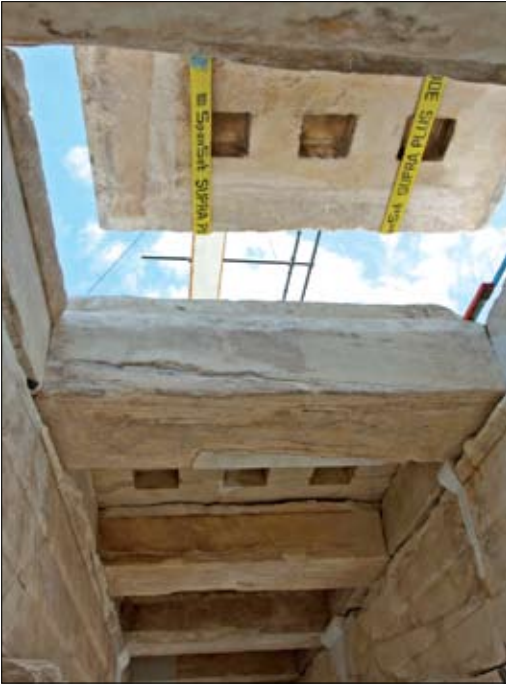
70

70. Temple of Athena Nike. Resetting a coffered slab.

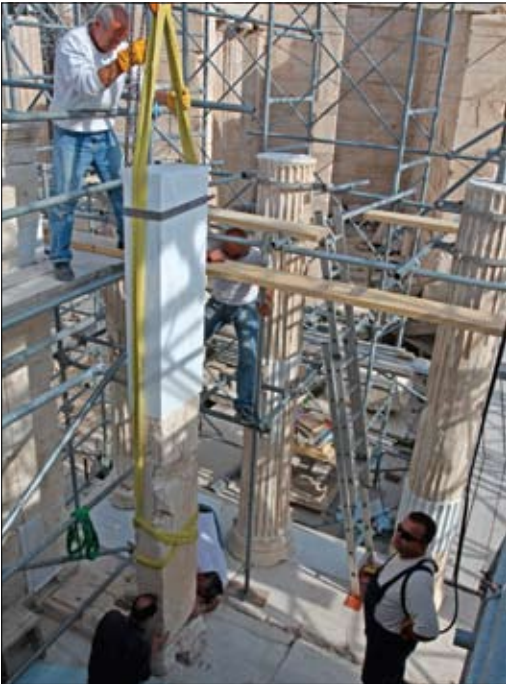
72

72. Temple of Athena Nike. Resetting the north anta of the doorway wall of the cella. View from the southwest.

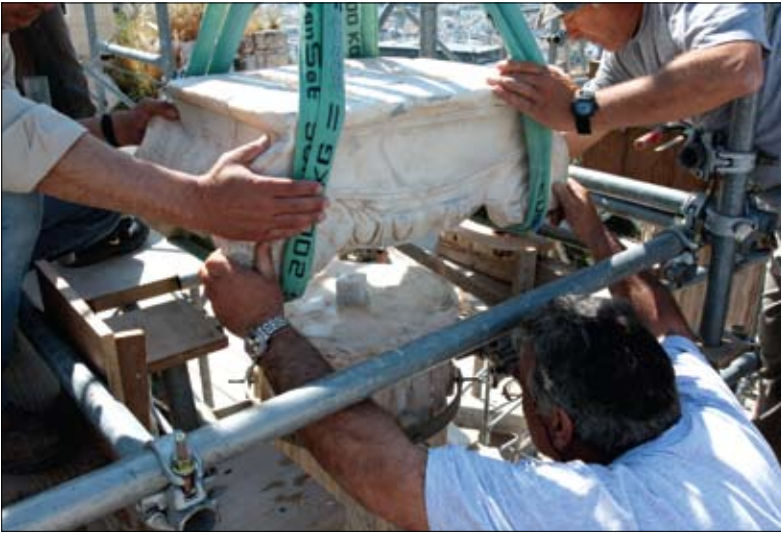
74

74. Temple of Athena Nike. Resetting a column capital in the pronaos.

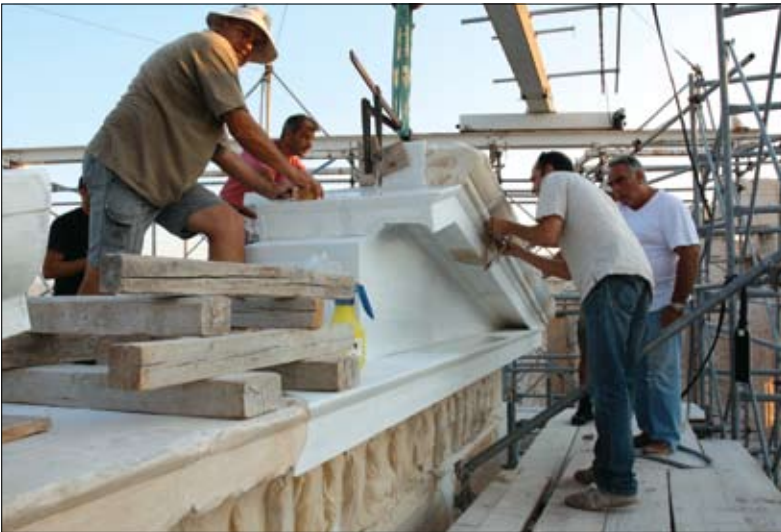
76

76. Temple of Athena Nike. Resetting the pedimental sima. View from the southeast.

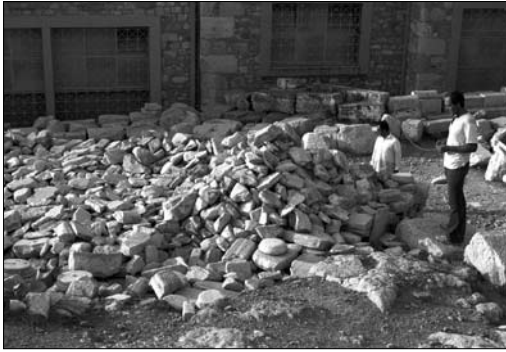
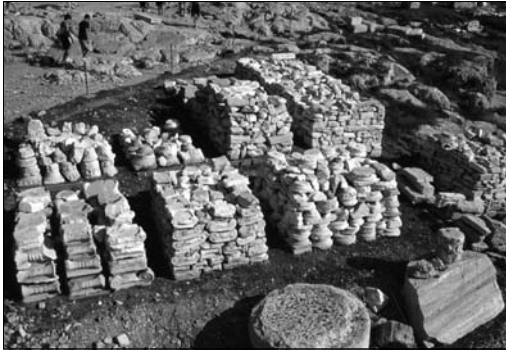
78a-b. Scattered architectural members before and after they were recorded, photographed and grouped, in stone piles north of the old Acropolis Museum.

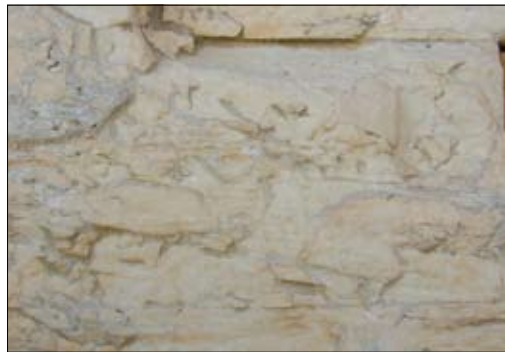
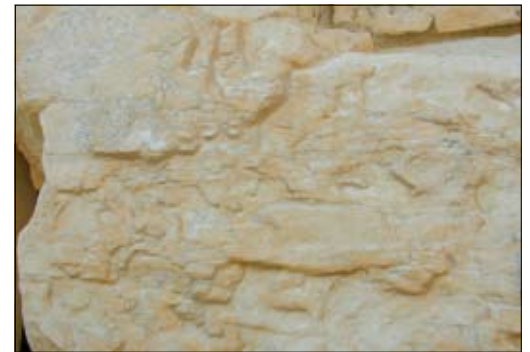
81a-b. Conservation work on the surface of the south wall of the Erechtheion. Condition of the surface before and after the interventions.

- Works of **surface conservation** were carried out on all the monuments of the Acropolis, on areas where anastelosis is under way and on other areas of the monuments as well, wherever the surfaces have serious problems of erosion. Among the most important works on the Parthenon was the conservation and cleaning of the sculptured surface of the west frieze, the purpose of which was to repair the damage it had suffered during its long history on the monument. The intervention began with the structural restoration of the blocks. The cleaning of the blocks from the soot deposits and black crust that had covered them was a most sensitive and delicate operation, since in the process the historical layers of the surface of the sculpture had to be preserved and retained, as they hold valuable information about the original workmanship and polychrome. The cleaning method chosen as the most permissible was the laser in an entirely original application, using simultaneously two wave lengths, ultrared and ultraviolet. It was developed after research in collaboration of the YSMA with the Institute of Electronic Structure and Laser of the Foundation for Research and Technology (FORTH). The works were carried out during the period 2002-2004 with excellent results. With this system, soot deposits and carbon and all types of black crust were safely removed without affecting the underlying layer of marble and coloured layers preserved on the sur-

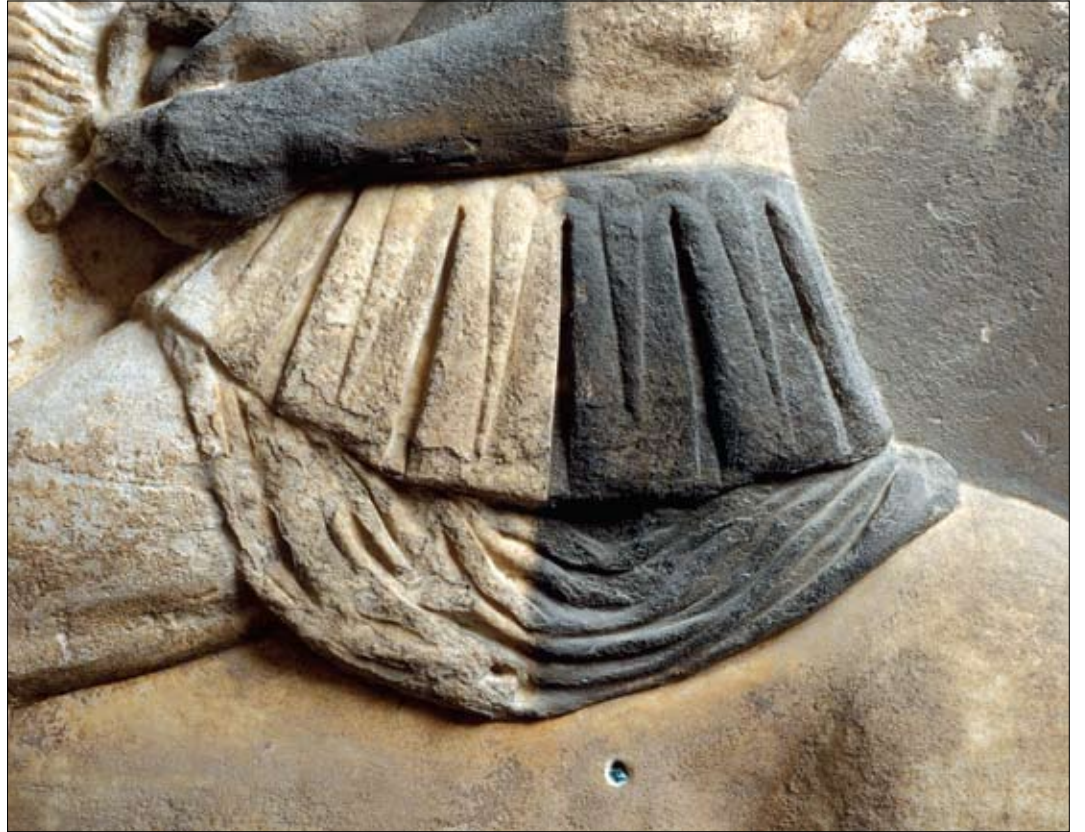
82

82. *Cleaning the west frieze of the Parthenon.*

face. In addition, significant information emerged about the art of carving, about ancient stone cutting tools; traces of ancient colour were found as well. This same method was applied also to the cleaning of the ceiling of the porch of the Caryatids in the Erechtheion. In the course of cleaning, traces of painted decoration and ancient colour were revealed.

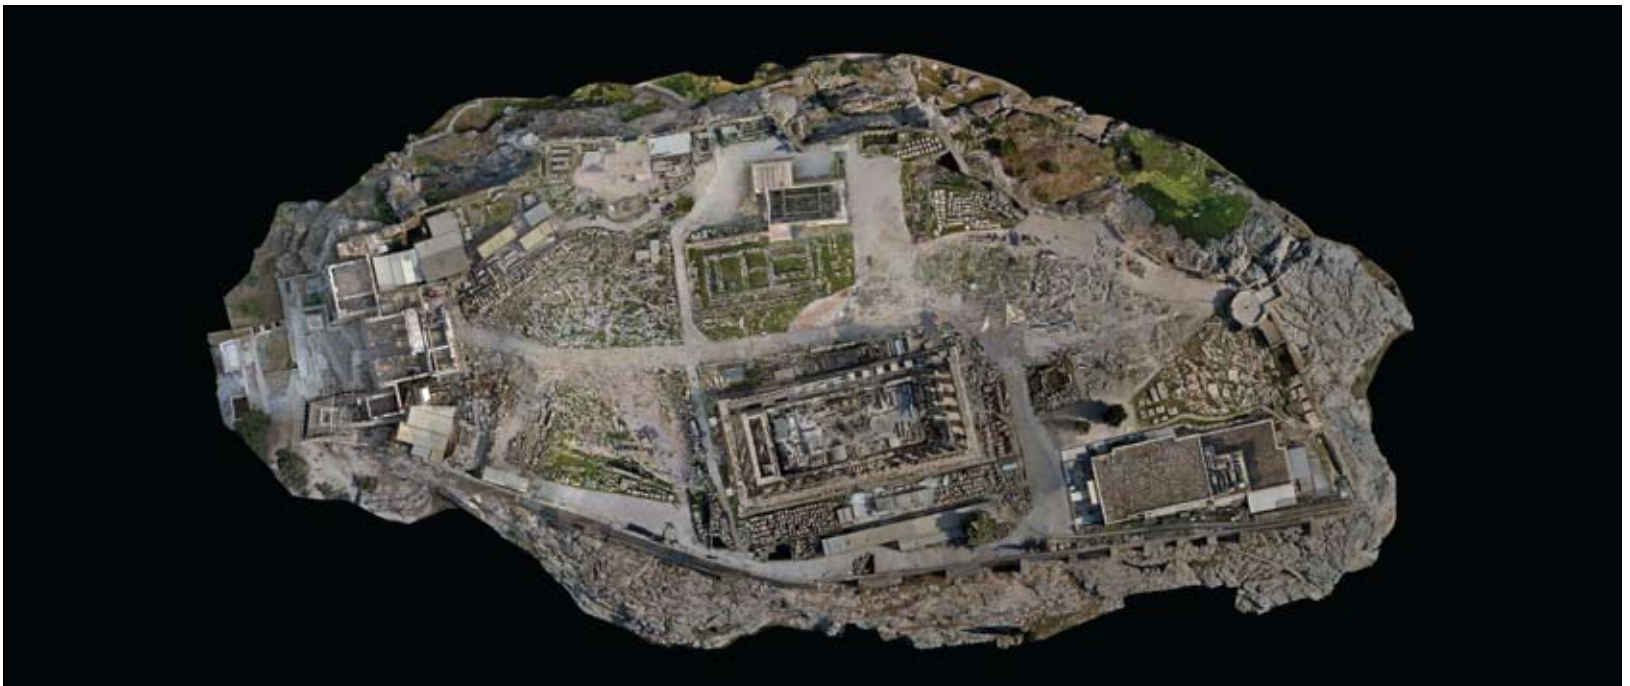
85. Orthophotomosaic of the ground surface of the Acropolis rock.
